**AGENDA
SAANICH HERITAGE FOUNDATION
VIA REMOTE MEETING
TUESDAY, OCTOBER 11, 2022 @ 5:30 P.M.**

1. **3579 QUADRA STREET (REGISTERED) – APPLICATION FOR REMOVAL FROM THE SAANICH HERITAGE REGISTER AND DEMOLITION BUILDING PERMIT** (The applicants will be making a presentation at the meeting)

To: Saanich Heritage Foundation
From: Silvia Exposito, Heritage Planner
Date: September 28, 2022
Subject: 3579 Quadra Street • Application for removal from Heritage Register and demolition building permit

INSPECTECH

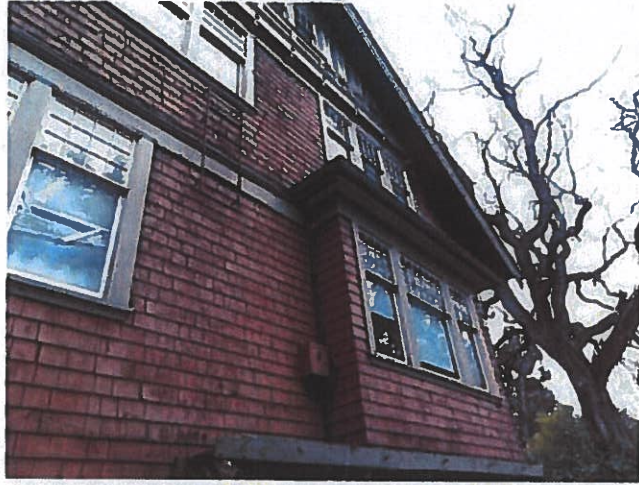
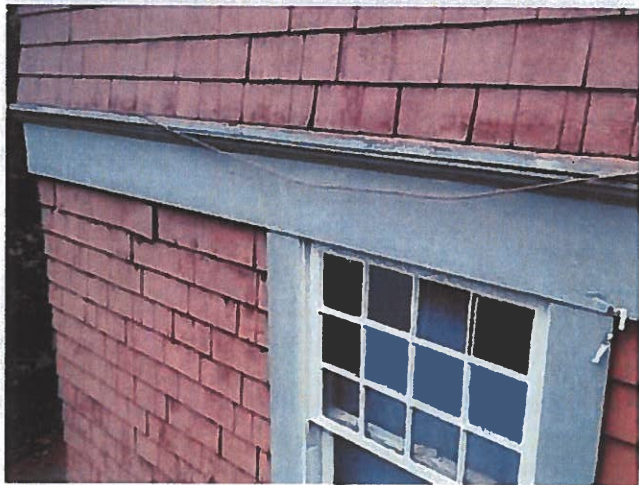
Limited areas of the exterior finishes were showing decayed wood, weathered paint, wear and tear and caulking deterioration. Small voids exist at building details and may permit water or pest entry. Special care should be taken

with respect to these items. It is important that building intersections and details are kept well sealed with a good polyurethane caulking to protect against damp and weather penetration. No obvious indications of major leakage or deterioration to these details were observed at the time of inspection. Finish restoration/maintenance of affected components is recommended to ensure necessary protection of weather exposed materials.

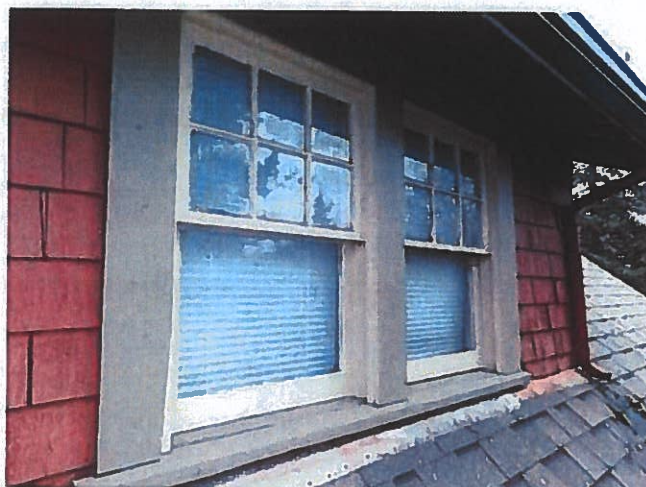
The windows are wood sash single glazed units. A newer vinyl window has been installed in a lower level bedroom near the NW corner. The windows were examined and operated. The window installations appear generally satisfactory and functioning in the manner intended. A few of the units are painted shut, do not latch securely and/or bind against their frames. Window locks were marginally secure and upgrade should be considered.

The exterior trim, sash and sill materials show limited finish deterioration, cracked putty, wood decay and cosmetic damage. The main exterior entry and exit doors were examined and appear operational. Jamb material, latches and locks appear in fair to satisfactory condition and functioning in the manner intended. Functioning dead bolts were not installed on all main entry/exit doors. Air leakage is a significant factor in the insulative and energy efficient properties of buildings. Weather stripping installed on the doors and windows is in poor to fair condition. The original wood windows have no weatherstripping. It is a standard recommendation that all doors and windows are well adjusted and fitted with the appropriate, good quality weather stripping products.

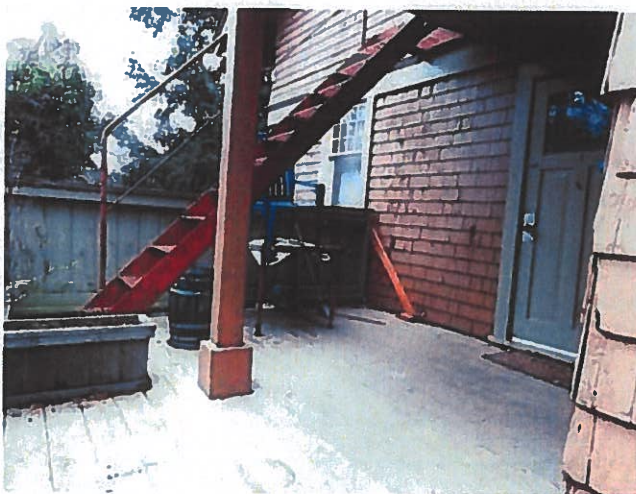
The residence has an attached wood frame sundeck, entry/exit porch and related stair sets. A steel fire escape ladder is located at the rear sundeck and provides emergency egress from the upper floor suite (#5). The work appears constructed of satisfactory materials.

The support structure is comprised of 2 by 8 joists attached to a ledger at the building and resting on 2-ply 2 by 8 beams bearing on wood posts and concrete footings at the perimeter. The railing assemblies appear of sufficient height and are secured. The deck surface is painted wood planking. No severe deterioration or unusual wear and tear was observed. Two rear sundeck stair treads were decayed and require replacement for improved safety.

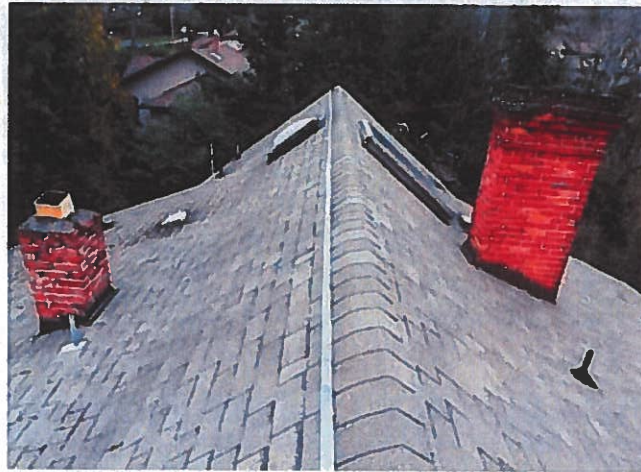
The roof was accessed by ladder and walked upon during the examination. The roof material is fiberglass laminate shingles of good quality and appearing in excellent condition. No irregularity was visible in the material placement or flashing details and it appears that the roof was professionally installed. No indications of surface failure such as unusual erosion of the silica coating, raised ridges, cracked, brittle or missing shingles were evident at the time of inspection.

Accumulations of moss and lichen were noted on portions of the roof surface and should be gently cleaned away.

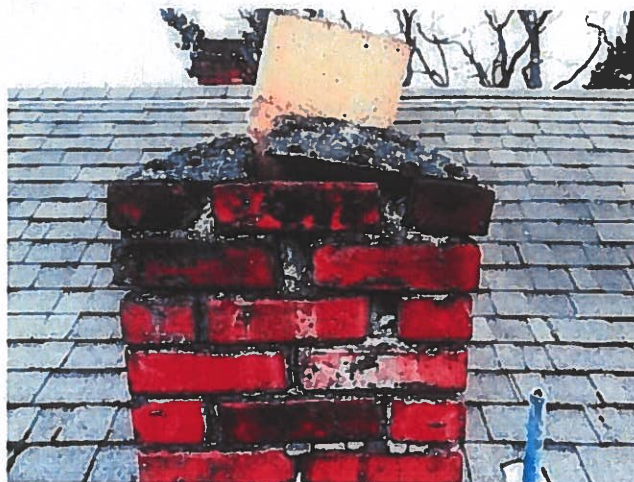
The home has two original unlined masonry chimneys serving three fireplaces and a now removed oil furnace. The chimneys appear adequately flashed where they penetrate the roof. The flues have a minimal build up of residue. Chimney sweeping is normally recommended on an annual basis subject to usage. The device and components appear to have been placed with adequate clearance to combustibles.

The interior suite fireplaces have been sealed over and are not in service. Typical for the era of construction, the fireplaces do not have dampers. It is believed that the fireplaces are eligible for upgrade to a wood or gas burning insert.

Deterioration of the chimney mortar joints and concrete caps was noted above the roofline and repair is recommended. Further review is referred to the attention of a licensed and reputable masonry contractor for full assessment, recommendations and cost estimate.

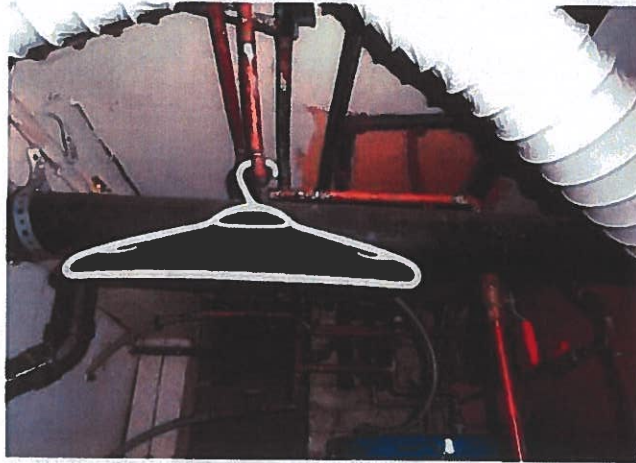
The plumbing system is assumed connected to the municipal supply and waste system. Most of the supply and drainage piping is concealed behind finished wall and floor surfaces. The visible sections of drainage and supply piping were examined and their condition observed. The work appears functional. Service piping to the home is unconfirmed with 1/2 and 3/4-inch copper and polybutylene plastic branch piping inside the building. The main shut off was not located.

The flow pressure is normal for the area and considered adequate.

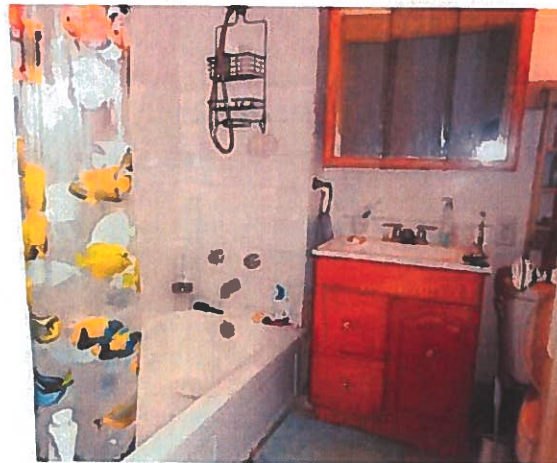
The plumbing fixtures are conventional glazed steel and ceramic units. There are 7 bathrooms, 7 kitchens and 1 laundry area in the home. The devices and fixtures were examined and operated. Tap sets and fixtures are original to the home and have been updated and show minor wear and tear to the finishes. The installations appear operational with no indications of severe deterioration, damage or failure noted.

The suite #1 toilet moved on its mounting and requires reinstallation. Slightly elevated moisture content was measured in flooring at the base of the #1B bathroom toilet. Replacement of the wax seal is recommended. The kitchen faucet in suite #1B was loose and also requires reinstallation. The kitchen sink and cabinet in suite #3 were deteriorated. Repair is not considered feasible and replacement of the installation is recommended.

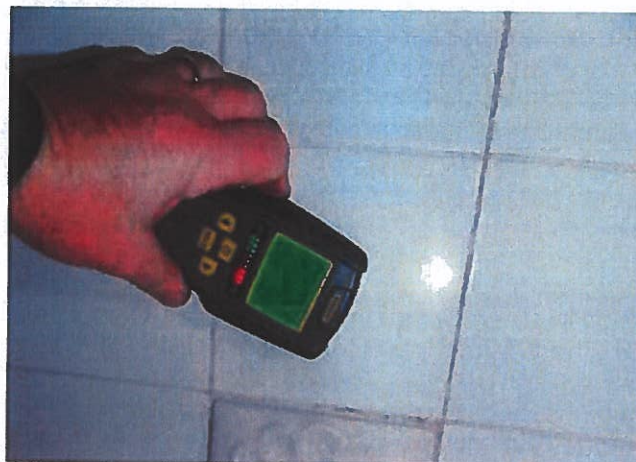
The shower areas are protected by walled vinyl and Formica panel tub surrounds and ceramic tile. The shower areas and fixtures were examined for leaks, damage or deterioration. No obvious indications of leakage or deterioration were observed in the installations. Elevated moisture content was measured behind wall tile in the suite #2 bathroom shower. Further review is referred to the attention of a licensed and reputable ceramic tile contractor for full assessment, repair recommendations and cost estimate.

The hot water heaters are located in the basement laundry room. The equipment is described as two electric fired hot water heaters manufactured by Rheem and John Wood with a 40 and a 60-gallon capacity. The main electrical shut offs a pair of double pole breakers in the main house breaker panel. The main water shut off for the tanks is located in the water piping adjacent to the units. The tanks are of good quality and show manufacture dates of 2007 and 2011. It is noted that the tanks have been fitted with a main shut off, TPR valve and discharge tube as recommended. The main elements and terminal bases were examined and show corrosion consistent with the age of the older 2007 tank. Typical service life for hot water tanks of this type and quality is 8 - 12 years. The 2007 40-gallon Rheem tank is considered to be at the end of its reliable service life and requires replacement.

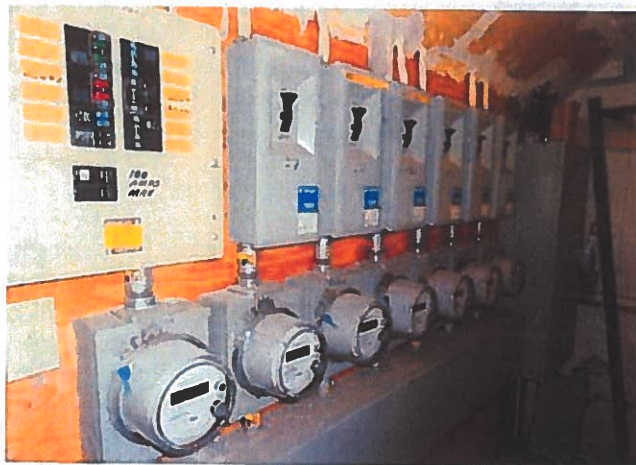
The main electrical installation is located in the basement utility room. The equipment is described as a 120/240-Volt 400-Amp system manufactured by Westinghouse and configured into 7 independently metered 100-Amp electrical services. The main service conductors are routed overhead and connected to a wall mounted meter service mast and weatherhead at the front left corner of the building. The service ground conductor is assumed connected to a buried grounding rod system. The main shut off is a 400-Amp fusible switch. The distribution wiring is conventional copper Lumex cabling.

The service appears to be grounded with room for future upgrades. A representative number of controls, switches, electrical outlets, lighting fixtures, exhaust fans, cable installations, polarity and grounding, breaker panel and sub panel installations were examined. Devices are tested using the normal user controls typically accessible to the homeowner or resident. Circuit breakers are not switched on or off during the examination. No obvious evidence of active knob and tube wiring was found in the residence.

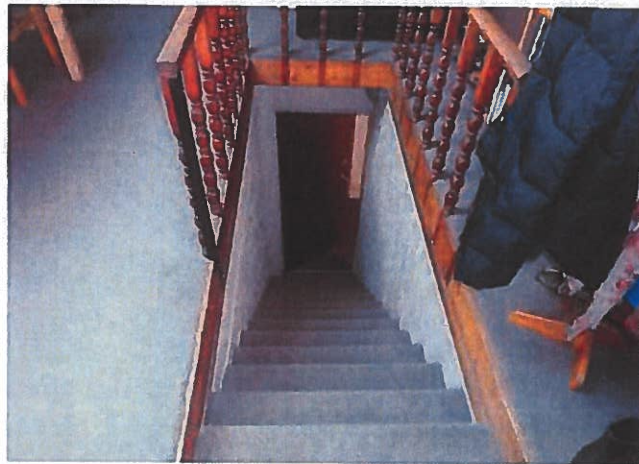
Concern is noted that sufficient guardrail and stair handrail are not in place at the stairwell in suite #5. An unprotected fall into the stairwell may cause serious injury. Installation of a suitable railing material should be completed without delay.

The cabinets are European and face frame style units. Countertops are Formica. Wear and tear were noted. A representative number of doors, drawers and attached devices were operated at the time of inspection and appear to be functioning in the manner intended.
