TECHNICAL MEMORANDUM

Reference No. 1895826-029-TM-Rev0

CORDOVA BAY ROAD IN PKOLS (MT DOUGLAS PARK) BANK STABILIZATION, SHORT-TERM REMEDIATION DESIGN MEMORANDUM, SAANICH, BRITISH COLUMBIA

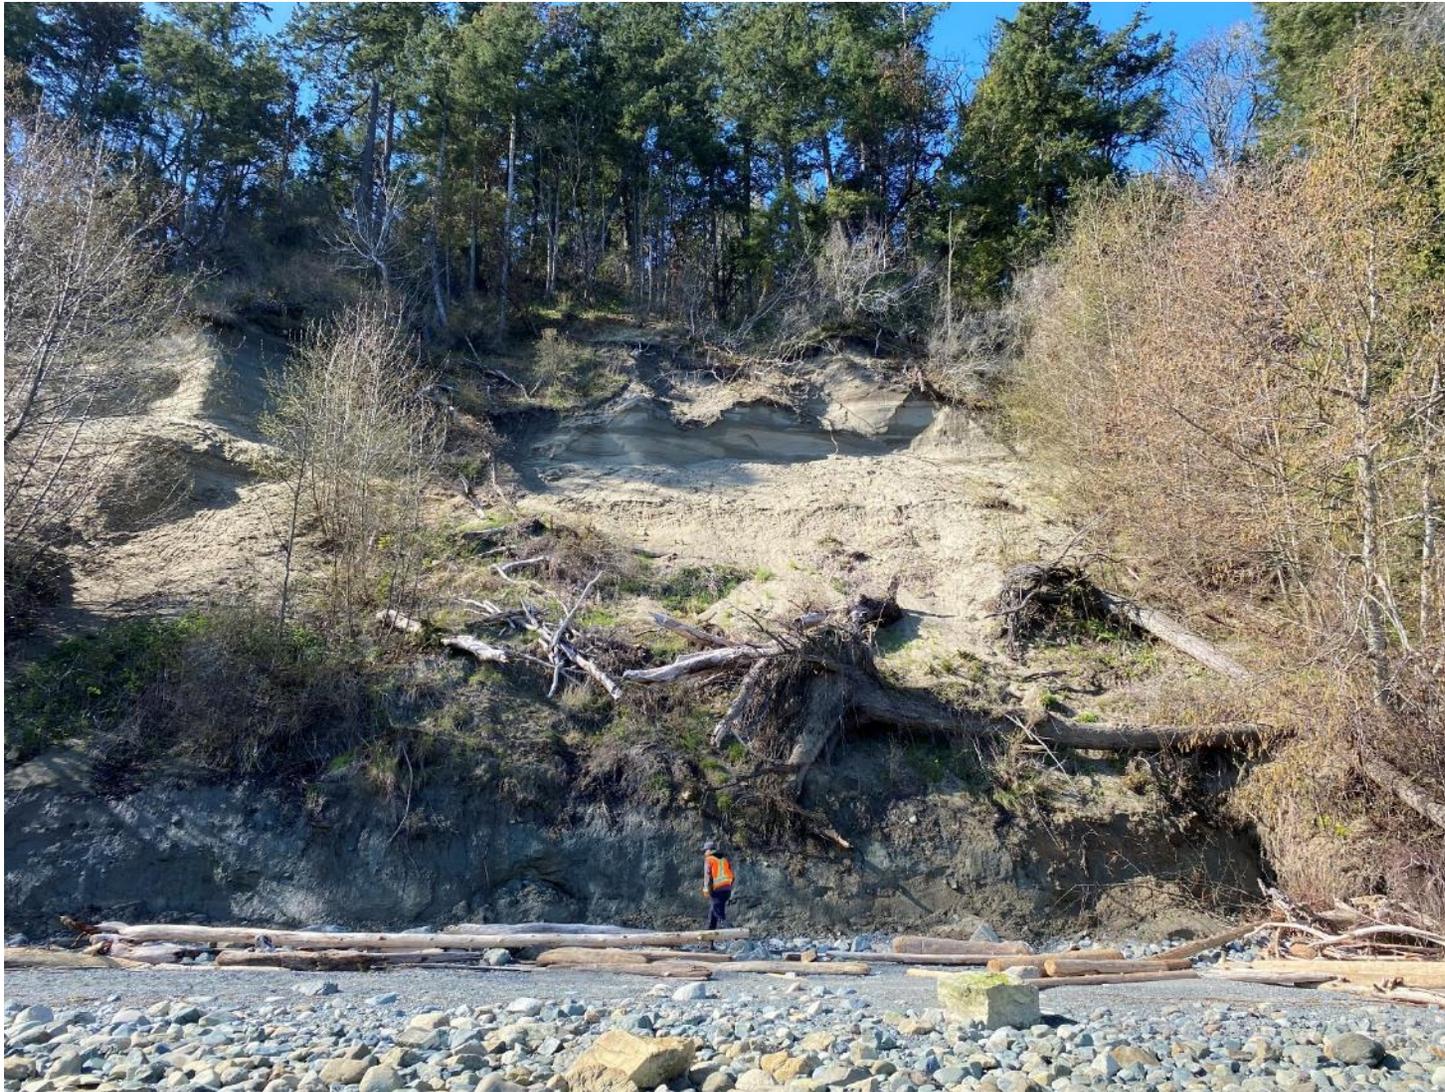
- 1) **Mid-slope scarp from Station 11+60 to 12+40 (Photo 1 in Attachment 1).** The head scarp appears to have receded about 1 to 4 m over a slope length of about 75 m. The change detection appears to show some soil deposition immediately below head scarp, but it is also possible that failed material had been deposited on the beach below the slope toe and subsequently been washed away by wave action. This area of the slope has lacked vegetation cover for many years.
- 2) **Slope toe failure at Station 9+45 (Photo 2 in Attachment 1).** An area about 8 m wide, 5 m long, and 2 to 5 m deep appears to have failed near the toe of the bluff.

Recent inspections of the project area have found instances of subvertical slopes at the slope toe, as in Section I and shown in lower portion of Photo 1 and in Photo 3 in Attachment 1. The slope stability analysis results at the toe of the slope indicated a FS between 1.2 and 1.5. Note, however, that these slopes are subject to high seepage pressures, coastal wave action, and other coastal processes that may impact their stability.

Photo 1: Exposed mid-slope sand bluff scarp from Station 11+60 to 12+40 (taken 27 March 2023).

WSP recommends addressing these areas with wattle fences. Wattle fences involve installing live local plant species using hand tools. Refer to the Polster reports in Attachment 2 for more information on wattle fences. This bioremediation option provides immediate near-surface support due to the benching of the wattle fences and the shear resistance of their implanted stakes. The support provided by the vegetation will improve with time as the wattle fences continue to grow and as other species move into the area. As previously mentioned, wattle fences also improve the stability of the slope through erosion protection and water absorption and protect deeper soils from deterioration due to environmental factors. Additionally, given that the wattle fences can be installed with hand tools and use natural material, WSP believes that this solution will be less disruptive and more attractive to the District and the public compared to other traditional engineering alternatives.

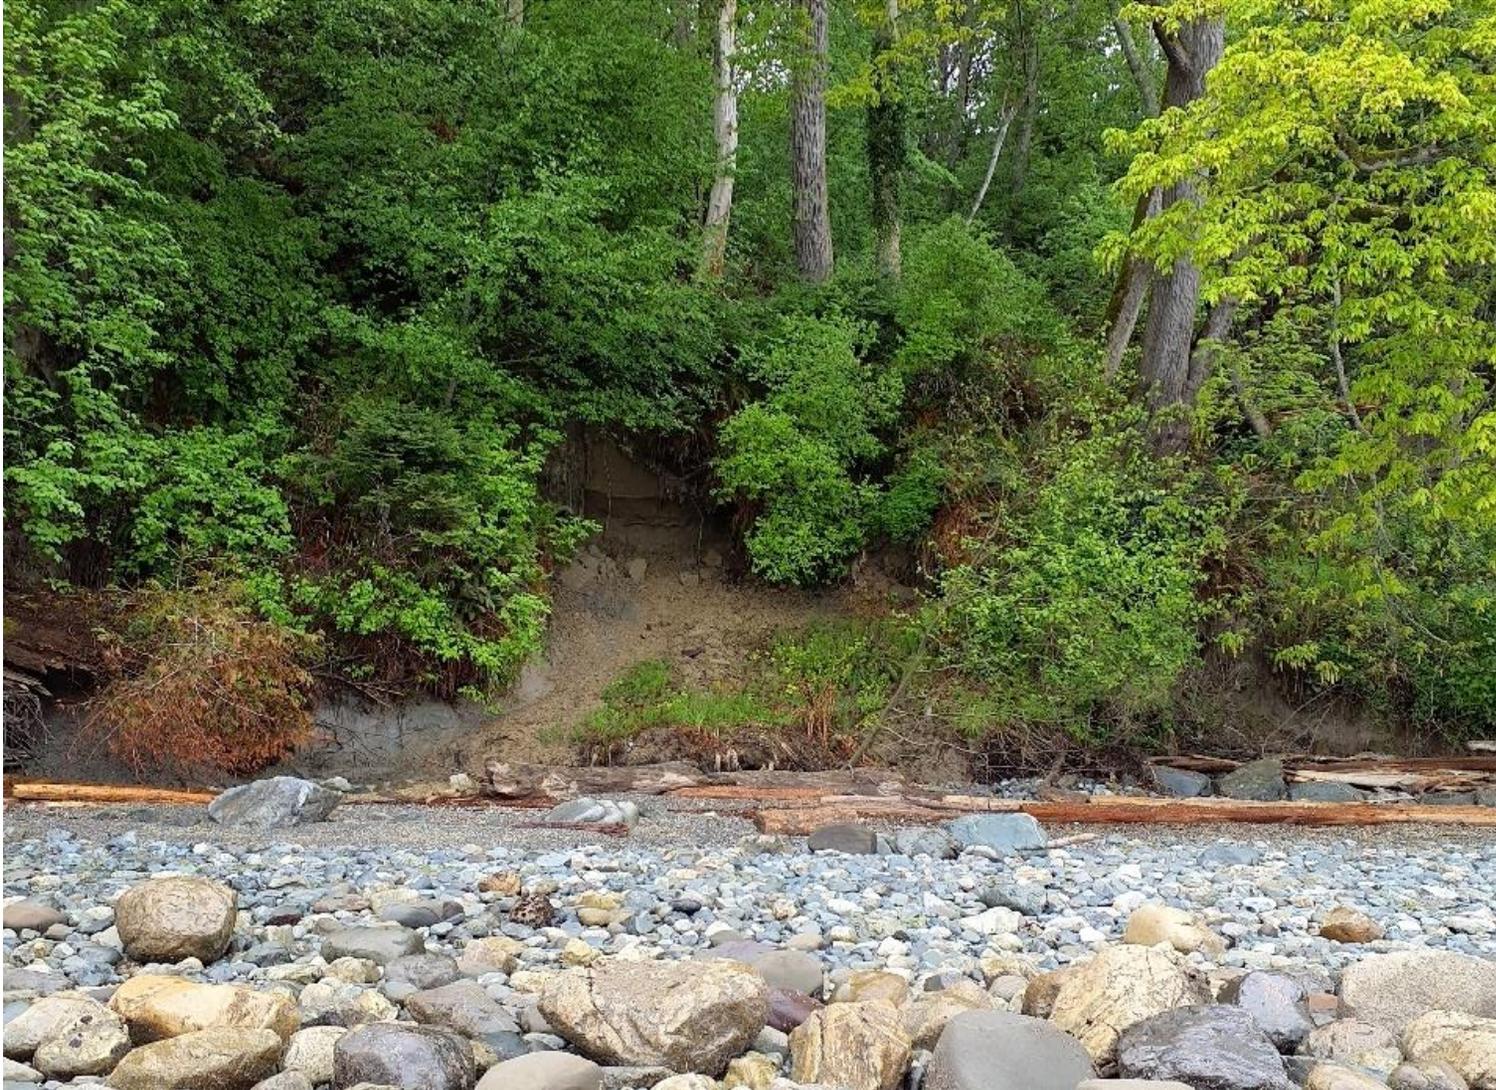
Other slope areas with recent failure activity, such as at the toe of the slope at Station 9+45, do not appear to pose an elevated risk to Cordova Bay Road in the short-term. The slope angle is shallower in this area and the crest of the slope is not anticipated to be affected within the next five years should retrogression continue at a similar rate as from 2019 to 2024. Additionally, the slope failures at the toe of the slope are interpreted to be related to high seepage gradients and wave action at the toe of the slope, which would require a more rigorous design solution than wattle fences. Slope stability issues at the slope toe would be more appropriately addressed with a long-term solution. In the meantime, however, failures at the slope toe will continue to lead to slope retrogression and eventually pose a risk to the road in the long-term.

Photo 2: Slope toe failure at Station 9+45 (taken 24 April 2024).

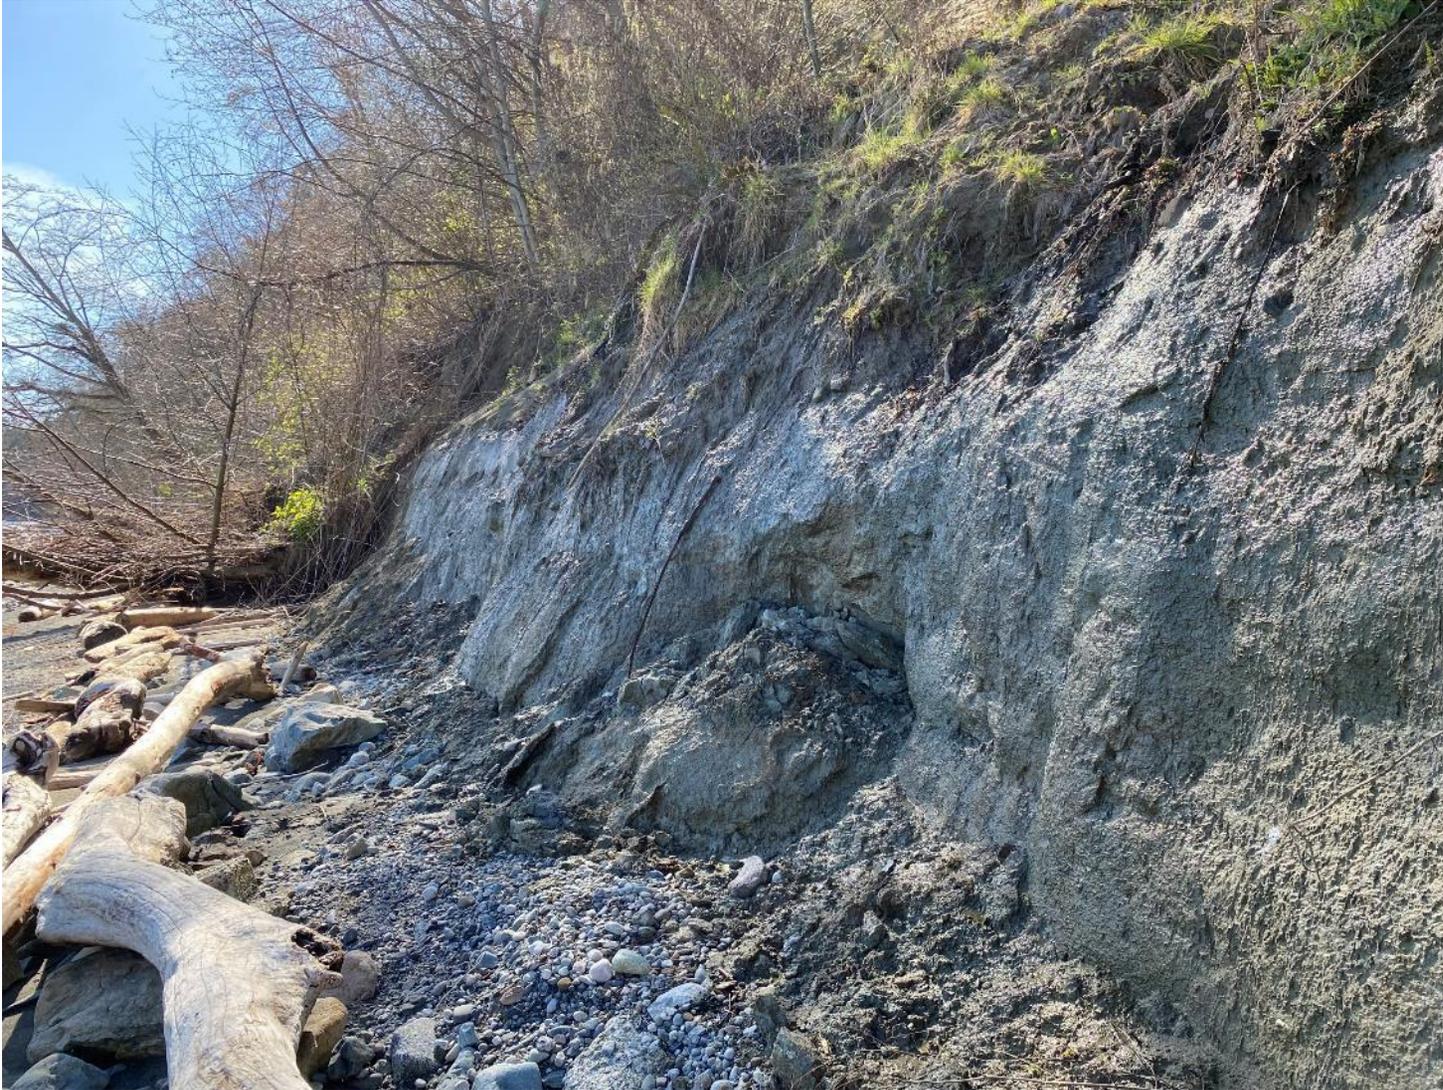
Photo 3: Steep toe slope at about Station 12+10, looking east (taken 27 March 2023).

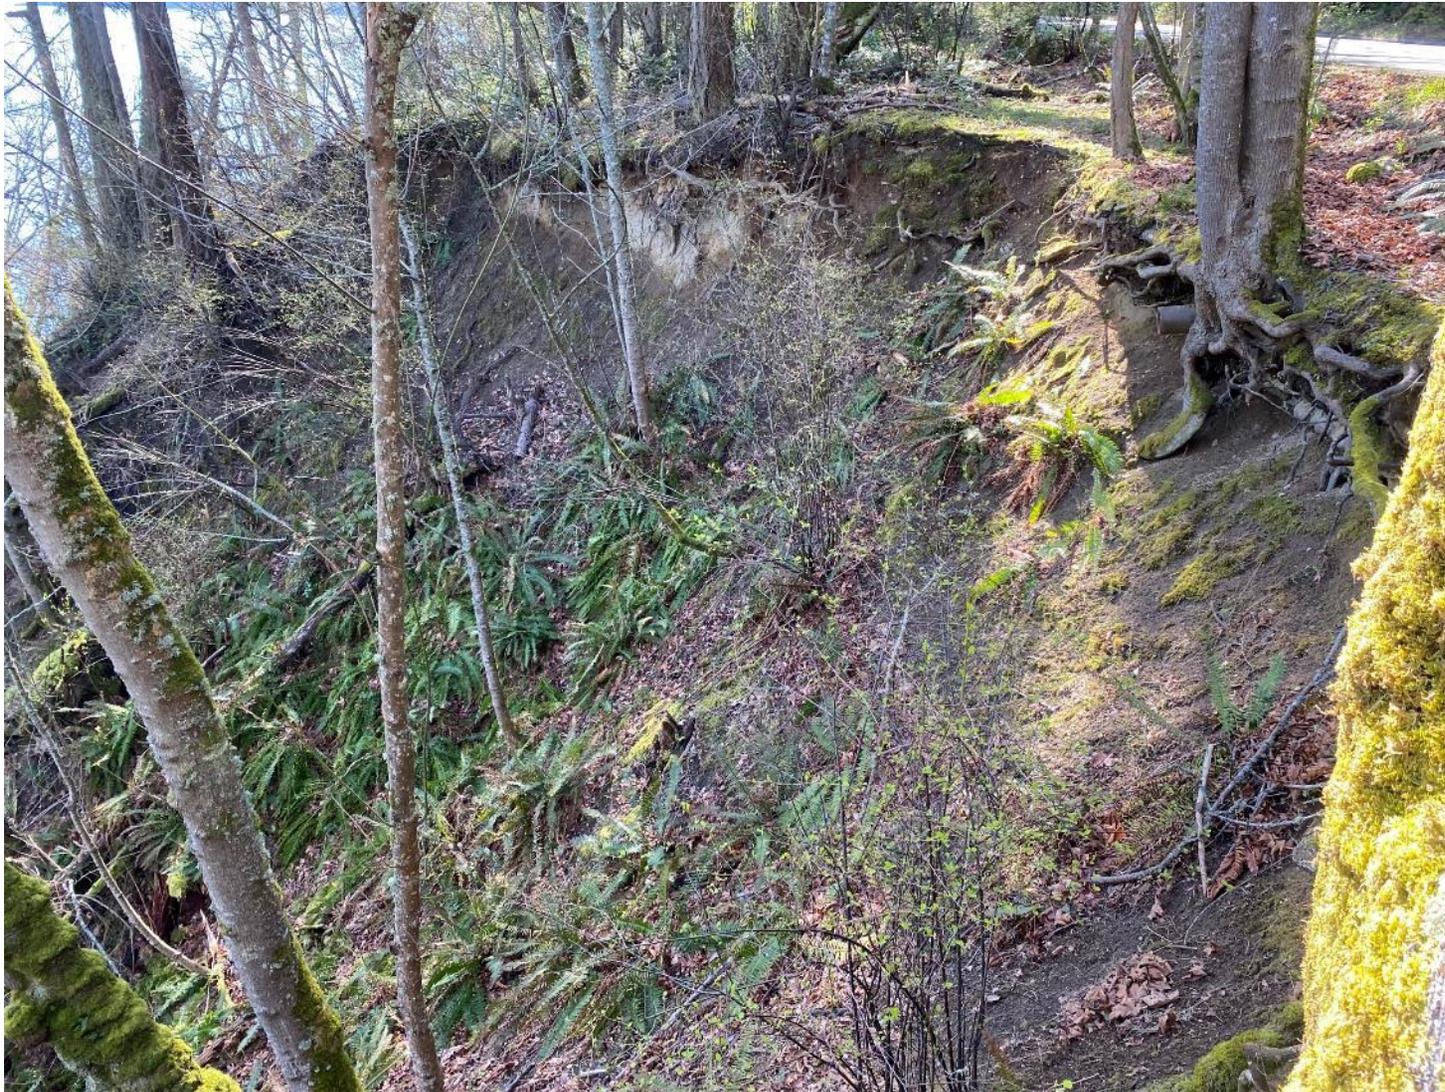
Consideration was given to addressing other gullies on the upper slope that approach Cordova Bay Road. However, given that they did not appear to show significant displacement between 2019 and 2024 based on the LiDAR surveys and that they have been consistently well-vegetated, WSP judged these gullies to be lower risk compared with the conditions observed in the gully between Station 10+80 to 11+00. While this gully has also not shown significant displacement based on the LiDAR, the slopes are relatively steep and generally sparse of vegetation, and so pose a higher risk of erosion and/or slope failure. Therefore, this area would likely benefit from installation of the wattle fences.

Photo 4: Gully headwall on upper slope from Station 10+80 to 11+00 (taken 27 March 2023).

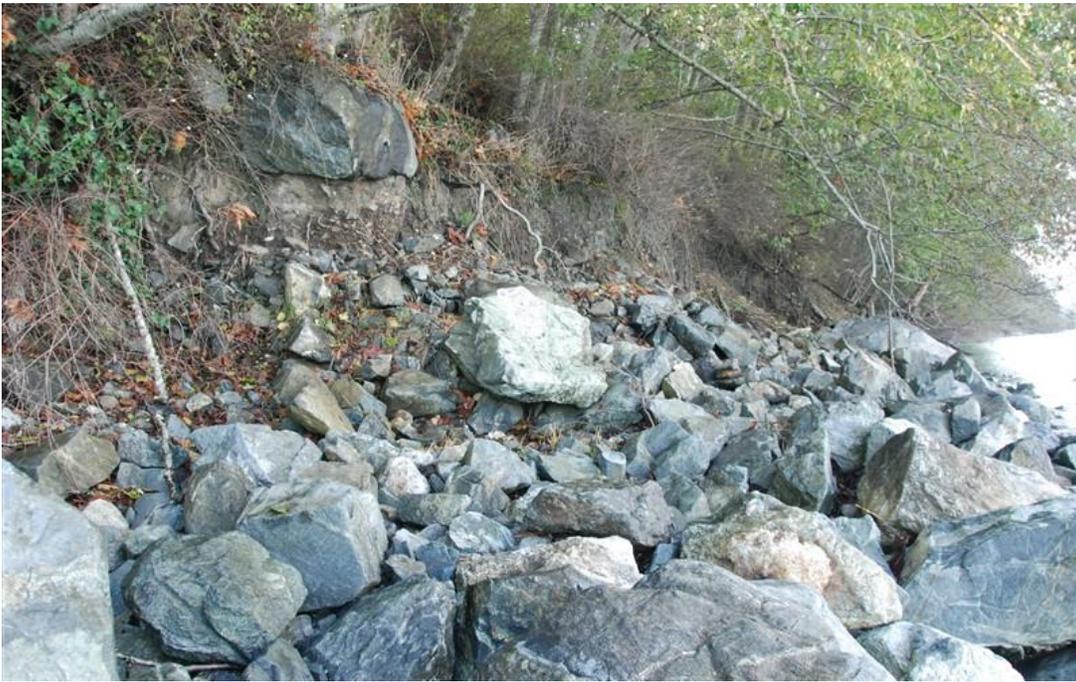
FAILURE OF THE RIP-RAP REVETMENT AT MOUNT DOUGLAS PARK HAS ALLOWED CONTINUED EROSION OF THE SHORELINE.

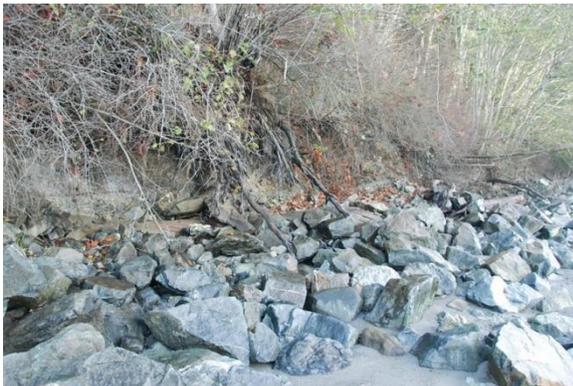
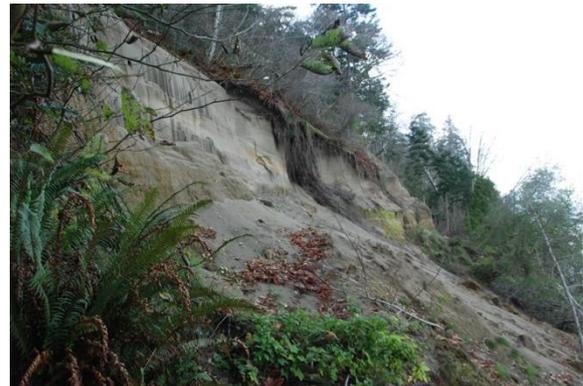
The historic rip-rap shore protection that was installed along the beach at Mount Douglas Park is failing to protect the slope from erosion (Photograph 1) and has resulted in the active slumping of the Quadra sediments above (Photograph 2). The key to solving the slope problems is to provide an effective shoreline protection system.

Photograph 1 & 2. Failure of the rip-rap shore protection (left) has allowed continued erosion of the toe of the Quadra sediment slope (right). This has resulted in slumping of the slope.

The failing rip-rap can be moved off shore to provide a reef that will benefit near shore aquatic organisms. This can be done as the new system is installed so the added cost of removing the old rock will be minimal but might add about 25 percent to the cost of the excavator. Full removal of the old rock would be much more expensive. Permits will be needed to do the work on the beach and to move the rock away from the shore.
