Tod Creek Flats Integrated Management Plan

Prepared For:
The Corporation of the District of Saanich
and The Friends of Tod Creek Watershed

November 2009

Prepared by: Murdoch de Greeff Inc.

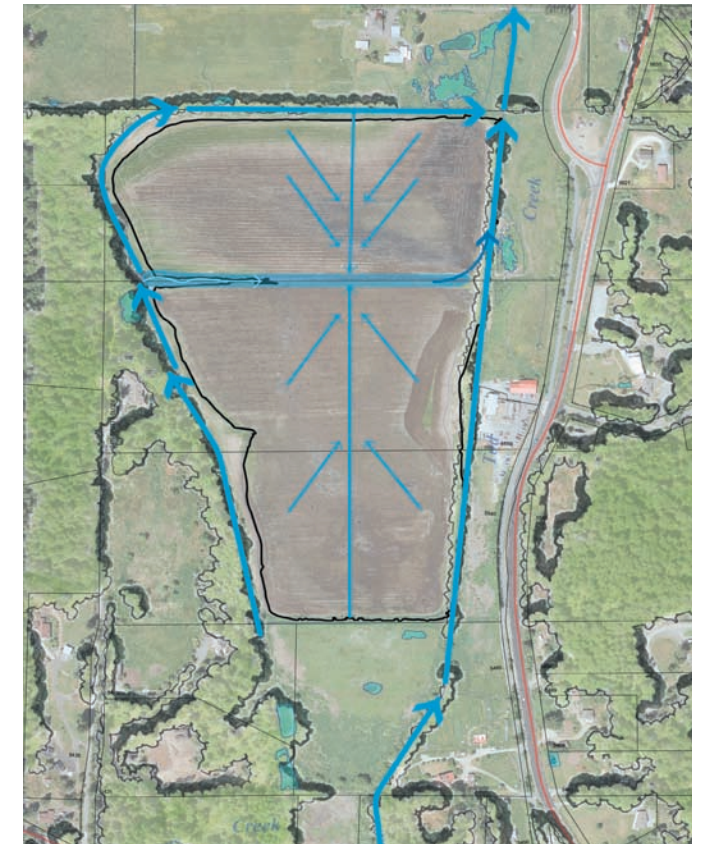
Current Drainage Patterns & Soil Subsidence

deposition zone in the watershed and accumulated organic material and sediment over time. Records indicate the ditches were cleaned ever 30 years. They were often over excavated to improve drainage capacity. This would result in the lowering of the water table, more oxidation of peat soils and continued subsidence.

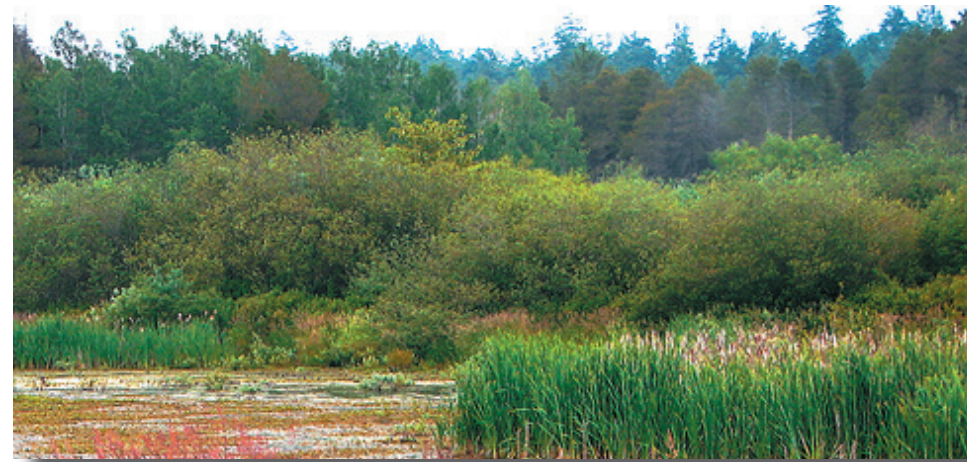
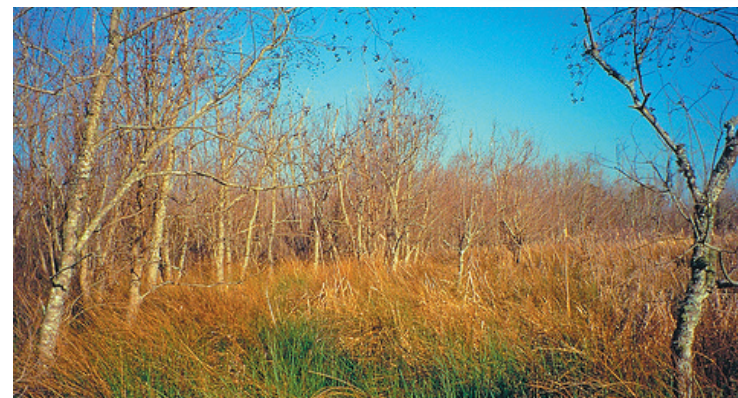
framework plan option 1

- 15 to 30 m wide stream with flood plain on east side
- Excavated material moved to west side to increase land height to 45.38 m (above max. recorded water elevations).
- Create mudflats habitat and seasonally flooded field areas suitable for *Callitriche marginata* (winged water starwort) and *Bidens amplissima* (Vancouver Island Beggarticks).
- Mudflats inundated from early fall to late July
- Seasonally flooded fields inundated November to May.
- Mudflats inundated from early fall to late July.
- Irrigation ponds developed for each property.
- Stormwater from West Saanich Road diverted into vegetated swales and rain gardens developed in abandoned Tod Creek ditch. Swales to follow existing property lines. This will act to clean runoff but also to separate agricultural crops for road runoff.
- Seeps and springs from western slope tied into new channel

- See Habitat Analysis Fact Sheet Chart for habitat created
- Mud flats will provide unique habitat presently lacking in CRD for migratory birds.
- Over 1.4 km of functional stream habitat
- Create 6 ha of functional riparian habitat
- Create 6-7 ha of aerable farm land

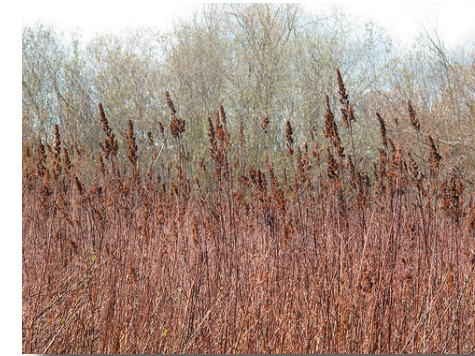
Program Elements

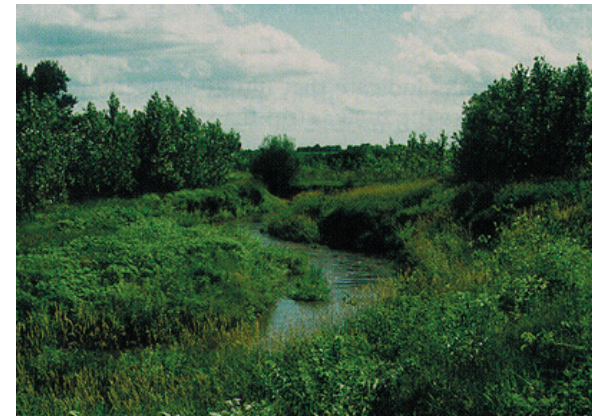
framework plan option 2

The program elements are the same as option 1 with the following exceptions:

- Large permanent wetlands will be created within the riparian area of the stream. These would be deep, water bodies that would remain wetted year-round.
- Mudflat habitat would be limited to the margins of the seasonally wetted fields (as is presently the case)

- Similar habitat benefits to option 1
- Large wetlands would create additional habitat diversity for fish and waterfowl
- Large wetlands would be a significant aesthetic feature and provide year round water views for visitors and residents of the area
- Permanent wetlands/ irrigation ponds could support populations of invasive bullfrogs (life cycle requires 2 years of standing water)
- Reduced mudflat habitat to margins of seasonally wetted fields

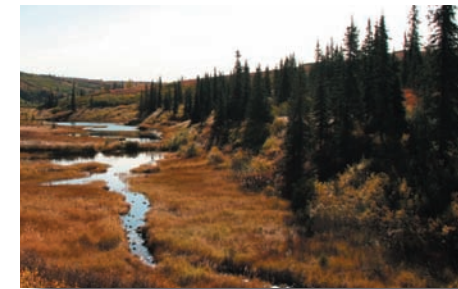
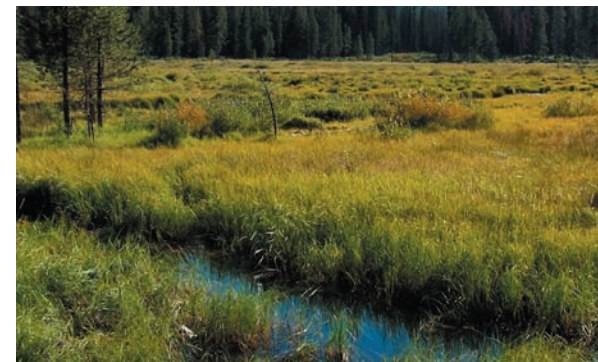
Program Elements
