**Overview of 4216 Wilkinson Road (Colquitz Gaol & Barn / Wilkinson Road Jail
June 2019**

Legal Address:	Lot 1 Section 5 Lake District Plan 20520 Correctional Institution Old Goal (Wilkinson Road Jail)
Proposed:	Application for a Heritage Alteration Permit for Roof Repairs
Heritage Status:	Designated
Current Zoning:	P-3 (Personal Care) Zone
Minimum Lot Size:	n/a
Actual Lot Size:	99,962 m ²
Owners:	BC Buildings C/O IWS Ministry of Citizens Attn: Property Tax
Applicant:	WSP Canada Inc.
Application received:	April 12, 2018

**Proposed repairs at the Wilkinson Jail
May 27, 2019**

Copper / Metal Roof Replacement Vancouver Island Regional Correction Centre Victoria, B.C.

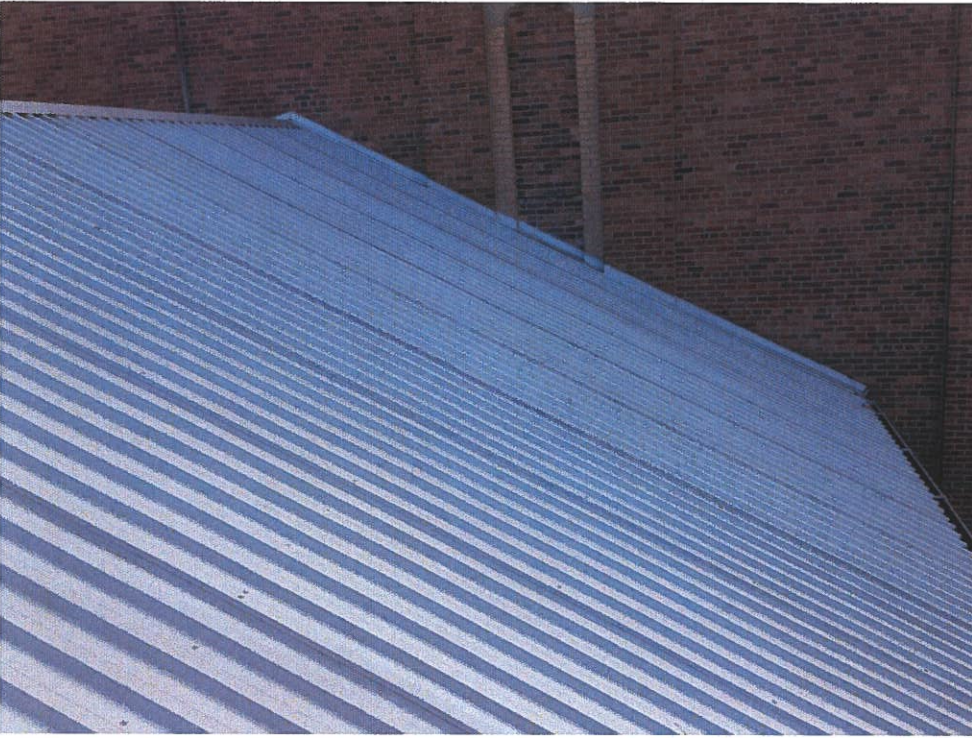
Proposed profiled metal roof

2. What is the roofing material on the centre roof?
What is it being replaced with?
WSP: The original design was a copper roof, but the Owner would prefer profiled metal roofing, as per most of the other roofing on the property. The roof surfaces are not visible from anywhere except directly overhead.

3. Why profiled metal?
WSP: Our default on heritage buildings is to replace like-for-like, but to improve thermal performance and waterproofing, and to reduce maintenance costs, the Owner would like to change the material.

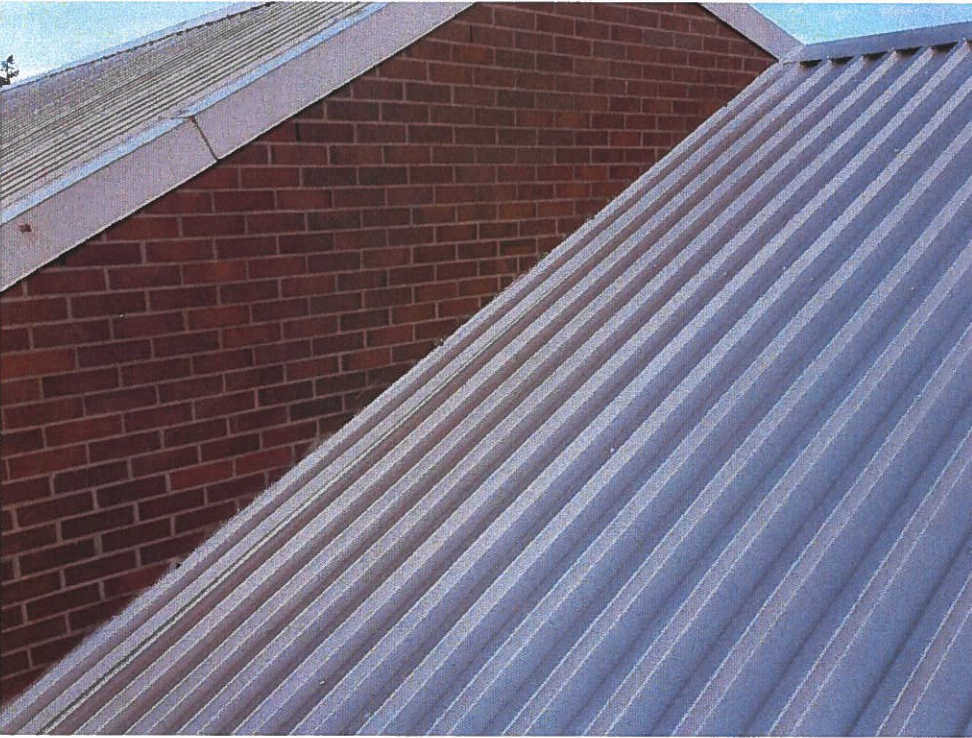
Proposed profiled metal roof

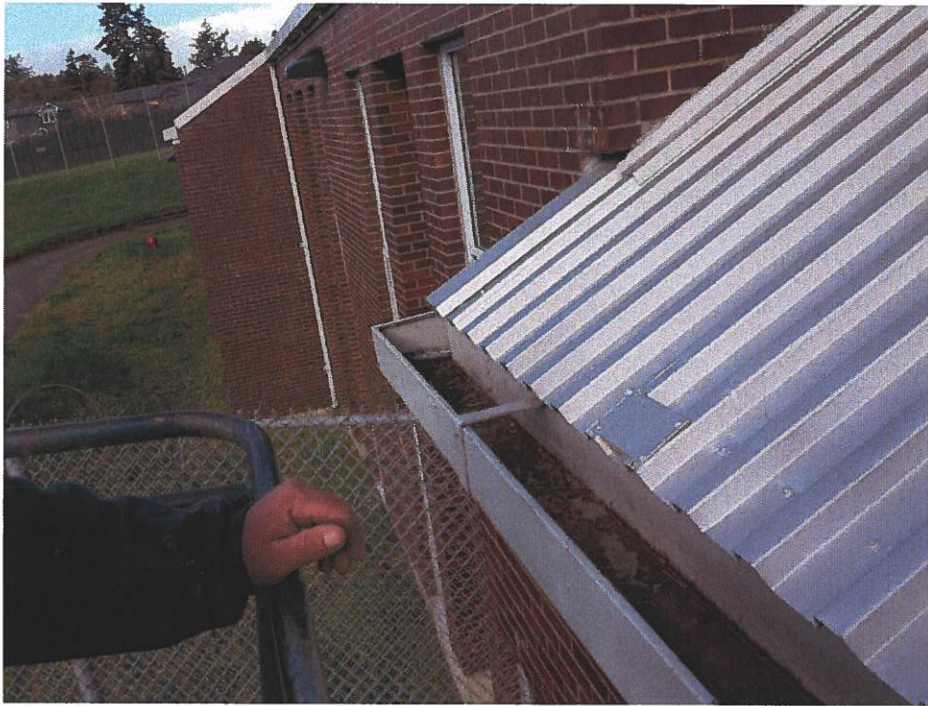
Proposed profiled metal roof

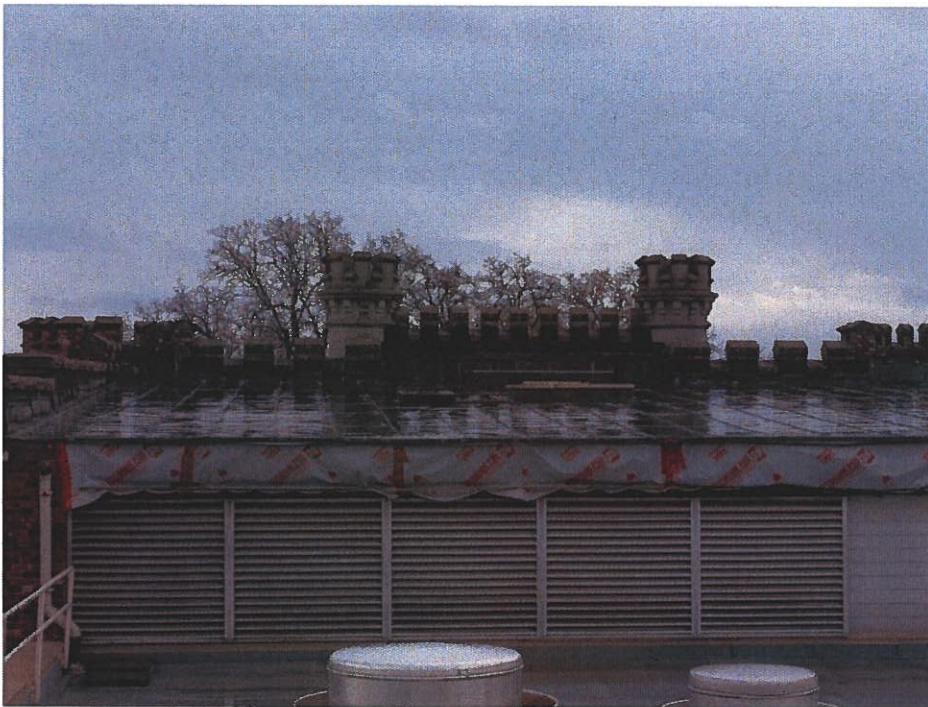
Section of roof to receive a new roof

1. What is the issue with the roof?
Why does it need to be replaced?
WSP: The roof was leaking and was opened for review and then the copper was torn off in a recent windstorm. The roof is temporarily being covered with a roofing membrane until permanent repairs (i.e. the project under review) can be completed.

- As was mentioned during the [SHF] meeting – I believe by Mr. Shuya – a copper roof is not recommended for low-sloped roof areas, which is what we are dealing with at VIRCC. Copper roofs are appropriate for 3-in-12 slopes or higher, and what we have is a 1-in-12 at best;

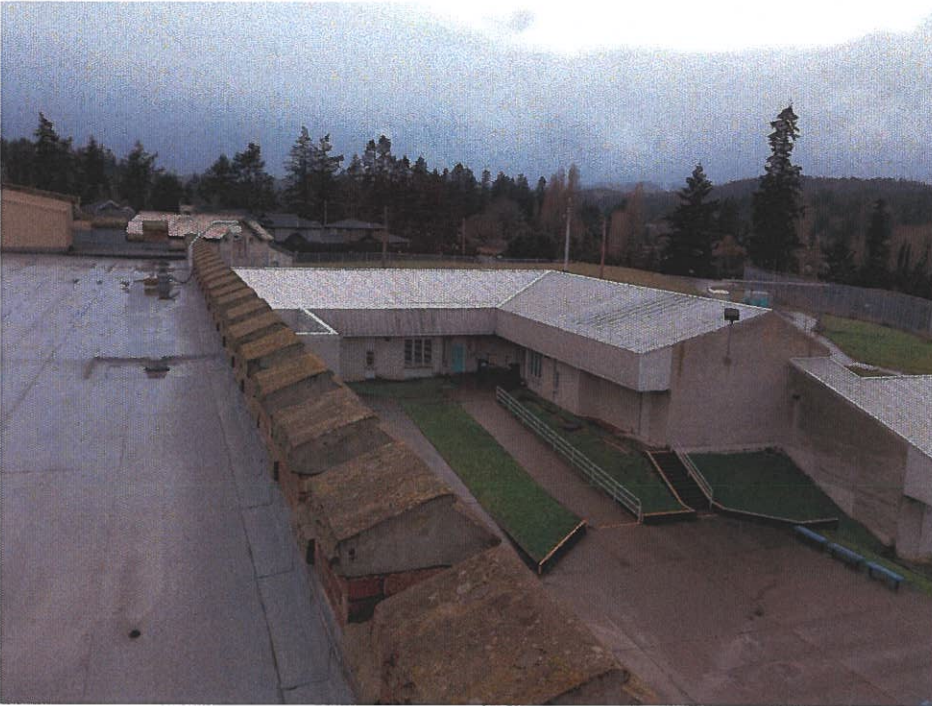
Profiled metal roof on another building on the property

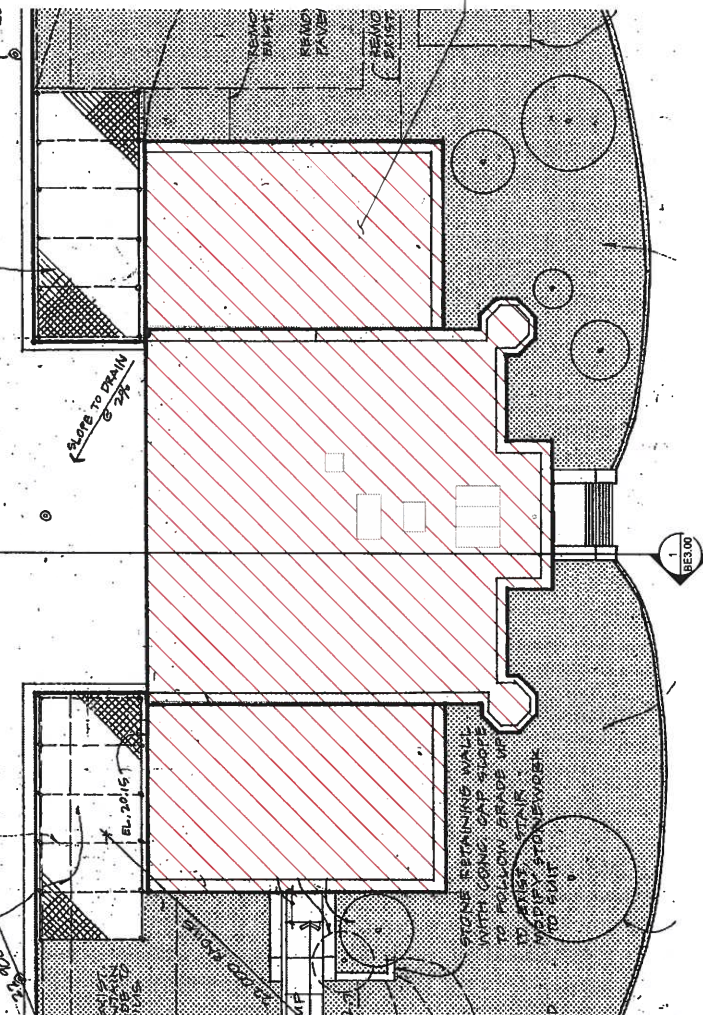
1 ENTRANCE BUILDING - SOUTH WING ROOF PLAN
1/16" = 1'-0"

- LEGEND**
- EXTENT OF EXISTING COPPER ROOF TO BE REPLACED AS PER SPECIFICATIONS.
 - EXISTING BUILDING (U.N.O.)
