**Haro Woods - Finnerty
Creek, Saanich, BC**

December 3, 2020 | Revision #0

**DRAFT Overview
Environmental
Assessment (EA) &
Hydrology Assessment**

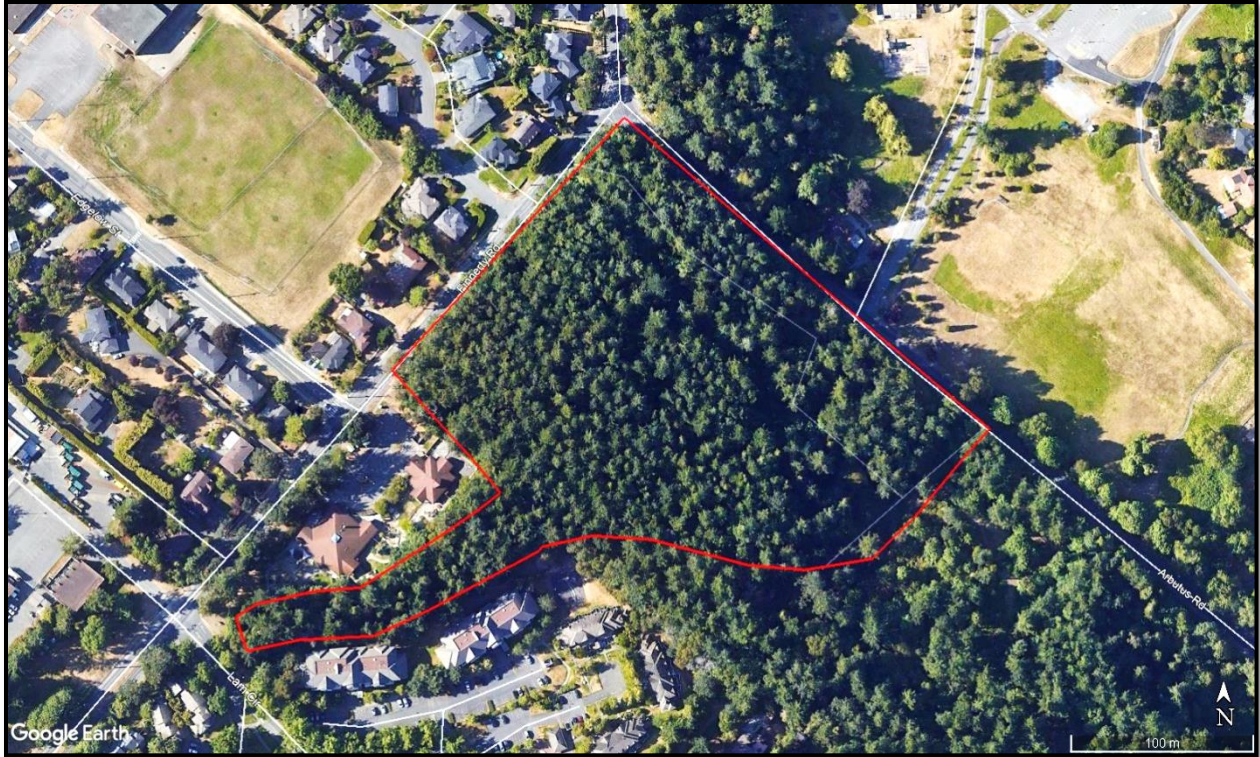
Figure 2. The Finnerty Creek study area (red outline) located along Arbutus Road, in Saanich, BC (image courtesy of Google Earth).

McElhanney Ltd. (McElhanney) has been retained by the District of Saanich (the District) to prepare an Overview Environmental Assessment (EA) and a Hydrology Assessment for the Haro Woods - Finnerty Creek located in Saanich, BC (Figure 1). The study area for the creek assessment is outlined on Figure 2.

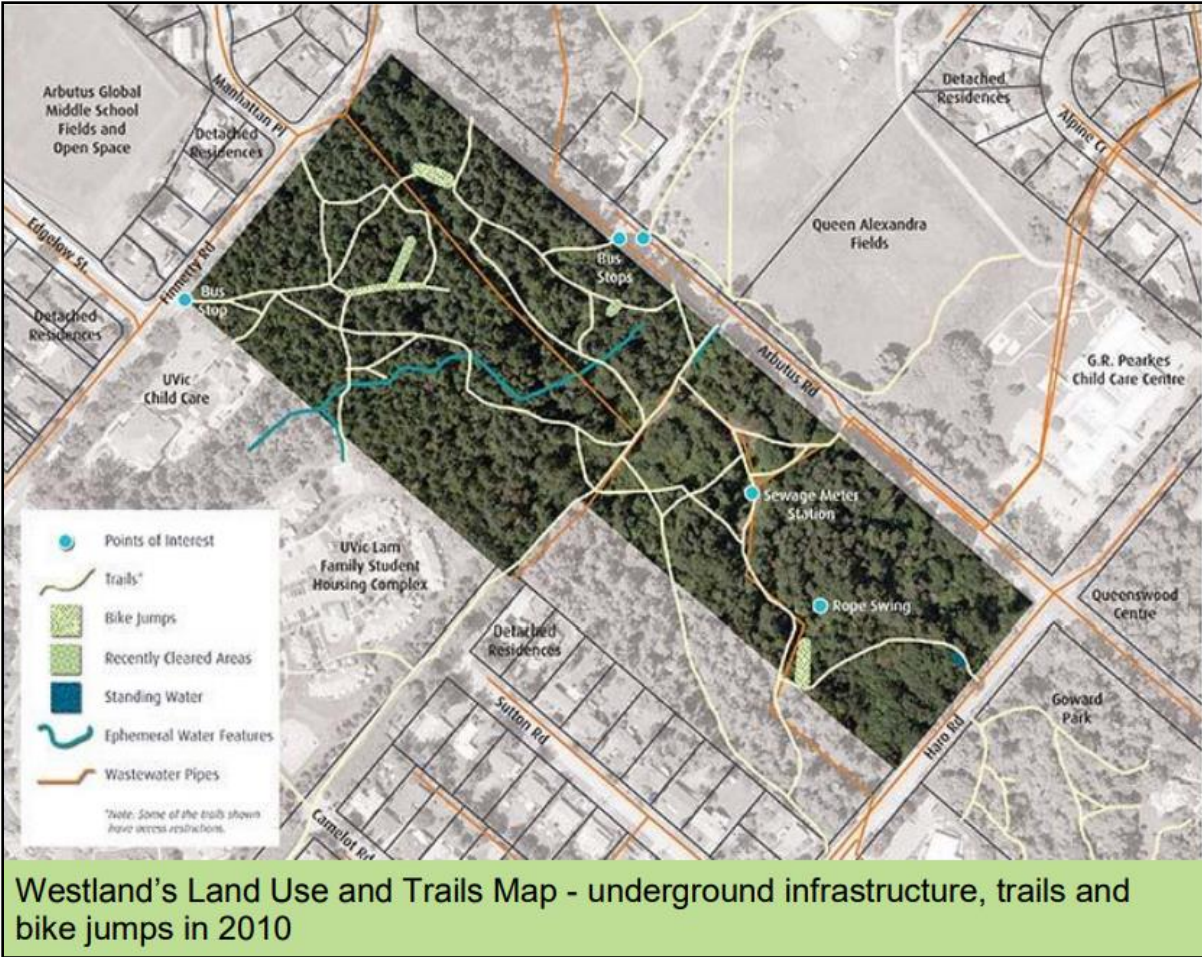
The park is riddled with “non planned” trails which have been mapped by the District and included in the Haro Woods Park Management Plan. [Figure 4](#) illustrates the intersections of the trails and the sewer line on the natural channel of Finnerty Creek. Note that Finnerty Creek is mapped in its natural channel on [Figure 4](#) which differs from the alignment on [Figure 3](#).

Figure 4. Land use and trail map in Haro Woods (Saanich 2018).

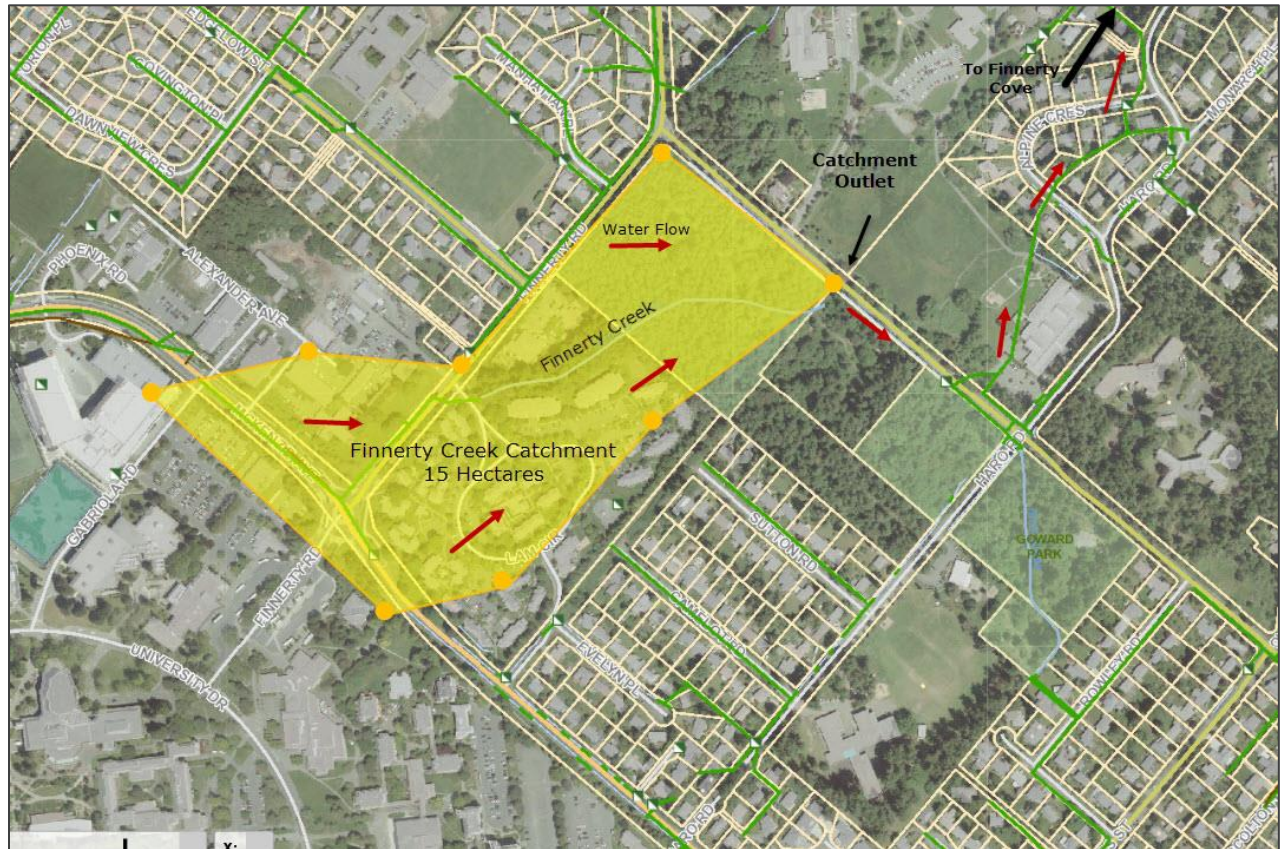
The time of concentration was derived using the Hathaway Formula in the BC MOT Supplement to TAC section 1020 and the corresponding rainfall intensity was pulled from Table 2b in the Environment and Climate Change Canada Short Duration Rainfall IDF data (ID 10108611). *Figure 7* highlights at creek's catchment area.

Figure 7: Finnerty Creek Catchment Area

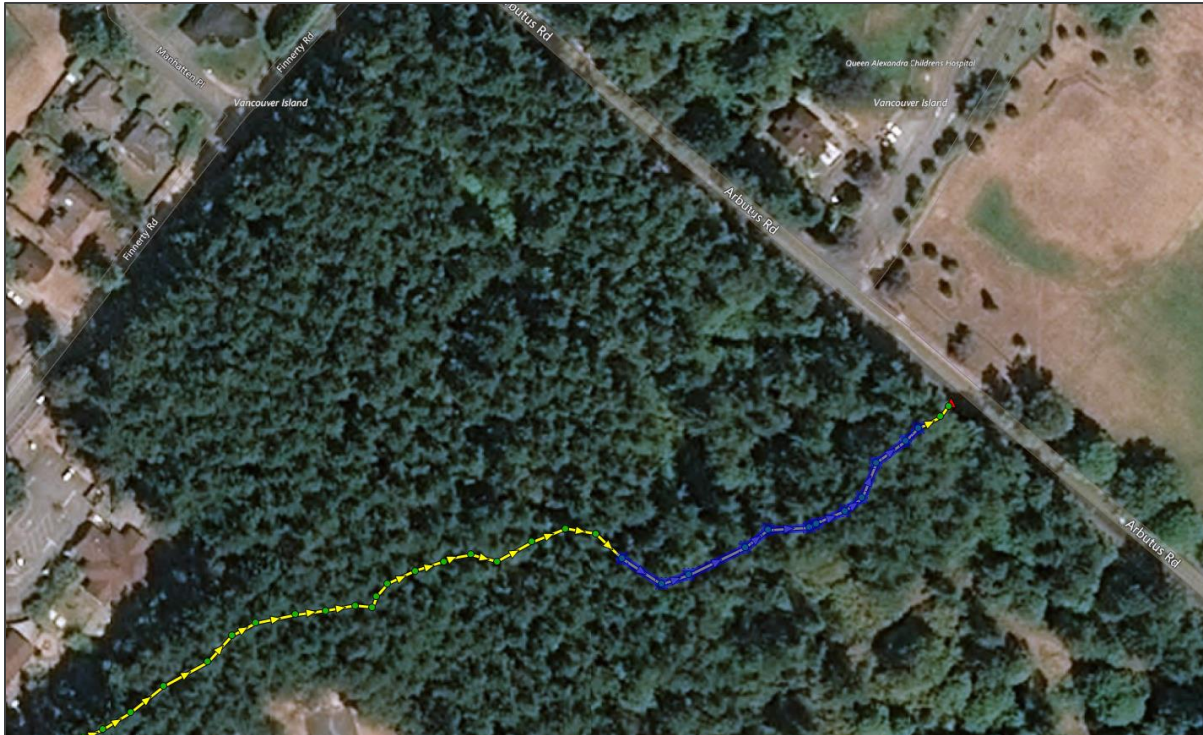
A plan view of the derived from the PCSWMM model is shown in *Figure 9* below. The highlighted section of the model is also shown in profile with the peak HGL displaced with respect to the ditch depth. As shown, the HGL is maintained within the proposed ditch section alignment.

Figure 9: Plan View of PC SWMM Model

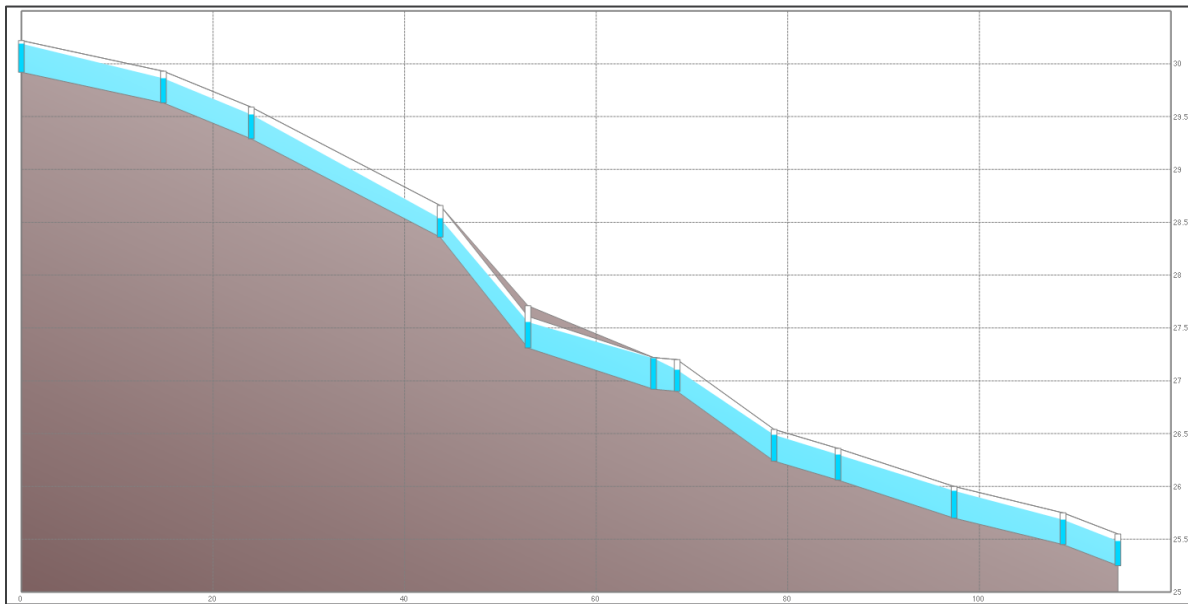
Figure 10: Profile of Proposed Ditch - Peak 25-Year HGL

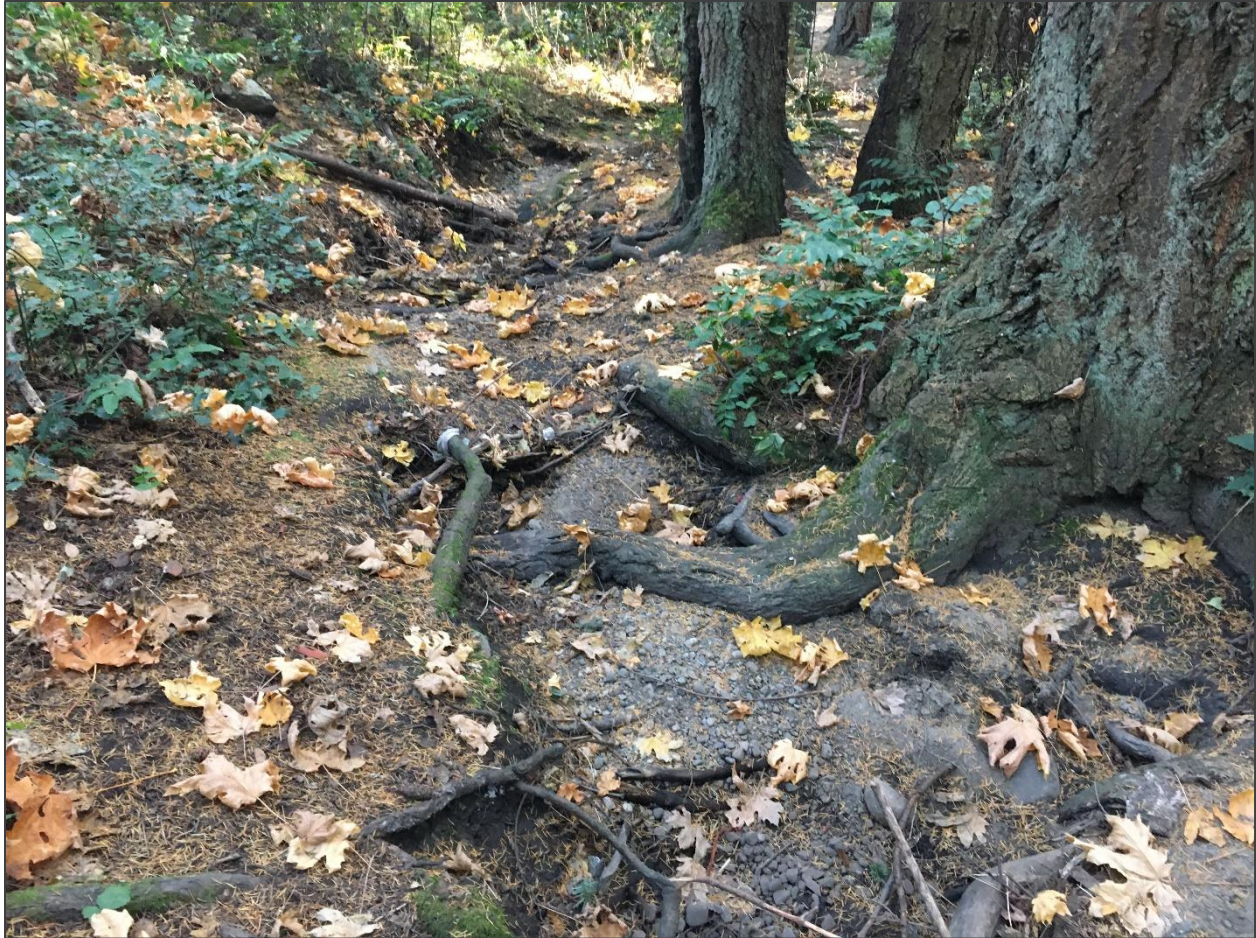
Photograph 1. Typical riparian vegetation included Douglas fir, Big leaf maple and Dull Oregon-grape (photograph taken at Transect 6)

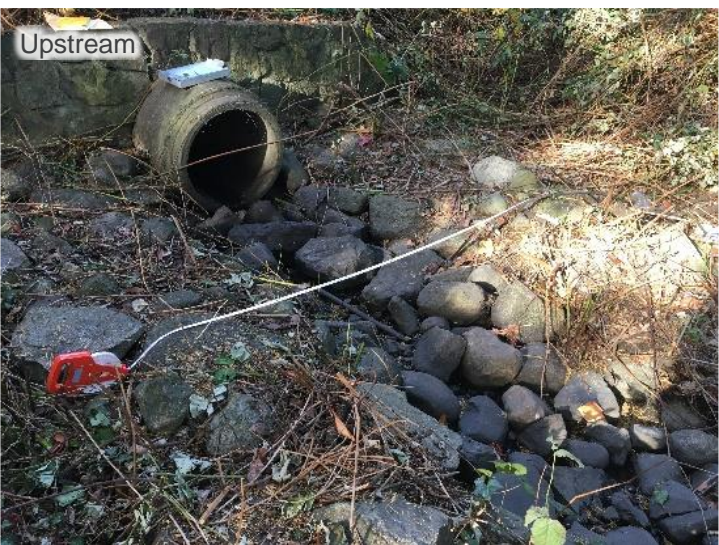
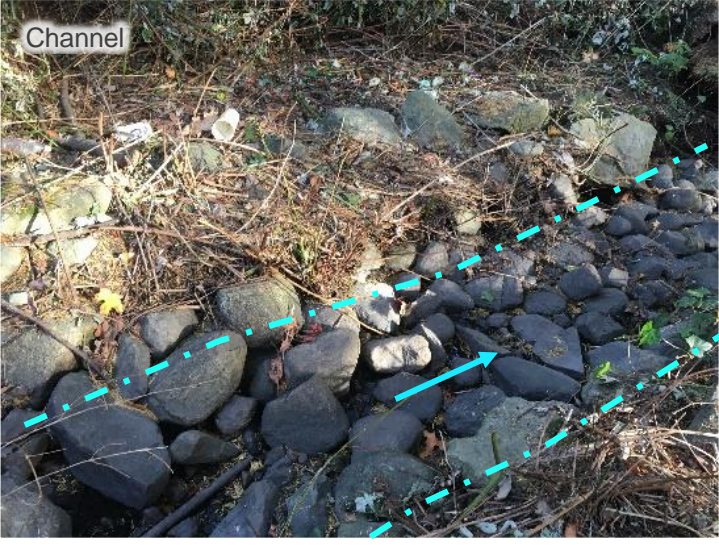
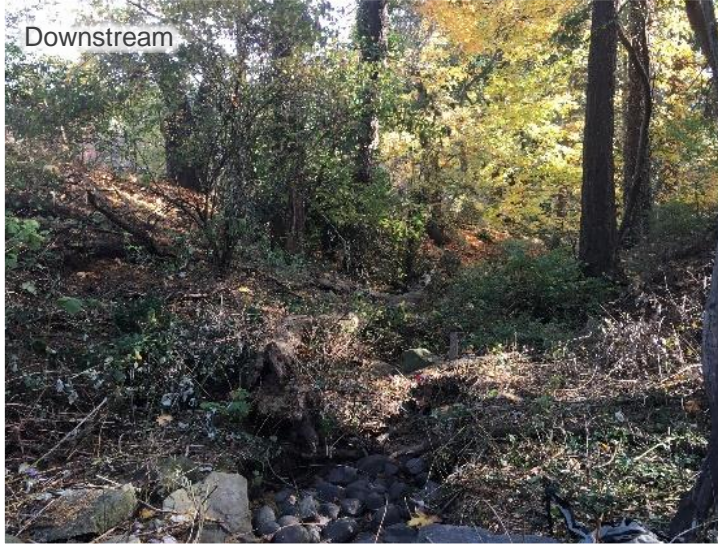
Channel Characteristic	Riparian Vegetation	Disturbance
Transect 1	<ul style="list-style-type: none"> •Channel Width (to top of rip-rap): 2.6 m •Wetted width: (estimated – no flows, is width of constructed channel 1.1 m) •Dry/Intermittent flow •Primary Channel •Channel pattern: straight •Confined in a ravine •Bed material: rip-rap 	<p>Mature Forest: Douglas fir with > 1 m diameter at breast height Himalayan Blackberry (Dominant) English Ivy Laurel spurge Ocean spray Snowberry Arbutus English holly</p>	<ul style="list-style-type: none"> • Headwaters through a culvert with flows over rip-rap. • Channel width here is the width of the rip-rap. • There is a retaining wall, upstream flows are subterranean in an engineering piping system. • Dominated by invasive species
	Photographs

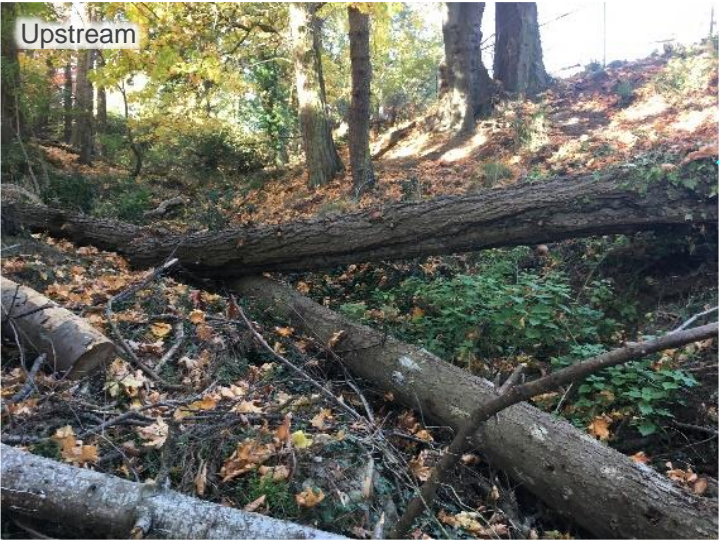
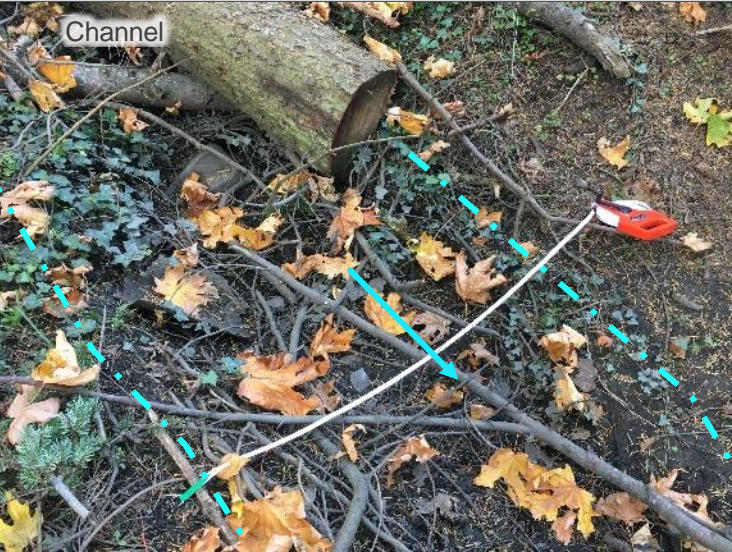
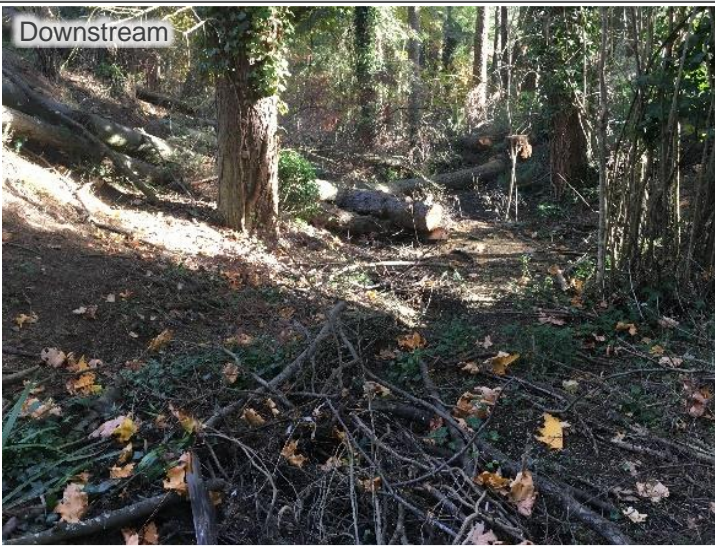
Channel Characteristic	Riparian Vegetation	Disturbance
	<ul style="list-style-type: none"> •Channel Width: 1.4 m •Dry/Intermittent flow •Primary Channel •Channel pattern: sinuous •Confined in a ravine •Bed material: fines 	Mature Mixed Forest: Douglas fir Big leaf maple English holly English Ivy Laurel spurge Snowberry Stinging nettle Grand fir Ocean spray	<ul style="list-style-type: none"> • Felled trees were situated directly in the channel
Transect 2	Photographs

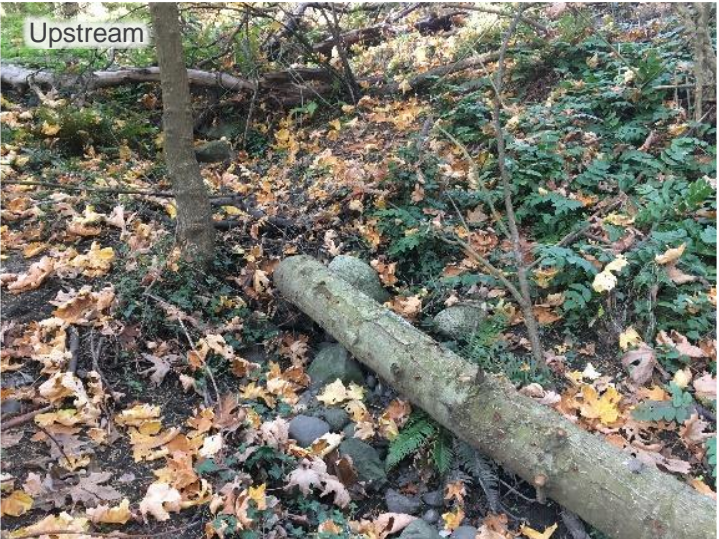
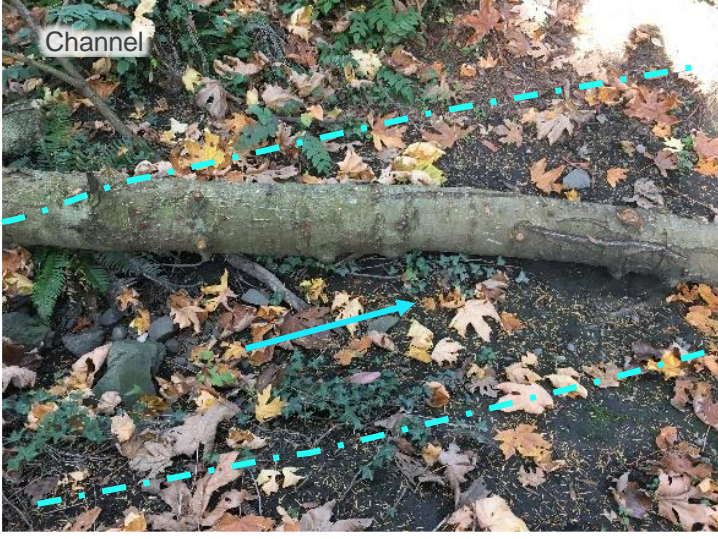
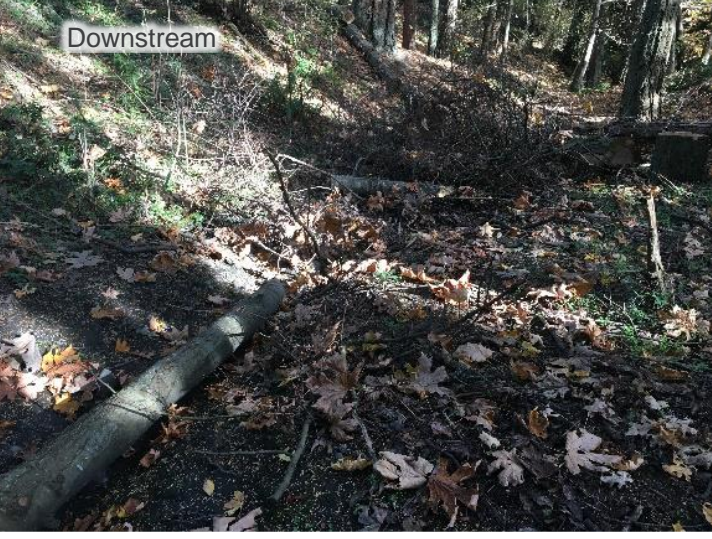
Channel Characteristic	Riparian Vegetation	Disturbance
	<ul style="list-style-type: none"> •Channel Width: 1.0 m •Dry/Intermittent flow •Primary Channel •Channel pattern: straight •Confined in a ravine •Bed material: fines with some cobbles (3 cm to 50 cm) 	<p>Mature Mixed Forest:</p> <ul style="list-style-type: none"> Douglas fir Big leaf maple Garry oak Arbutus Ocean spray (dominant) Dull Oregon-grape (dominant) Sword fern English Ivy Laurel spurge English holly 	<ul style="list-style-type: none"> • Felled trees were situated directly in the channel • Hiking trail denudes the channel by passing perpendicular through it
Transect 3	Photographs		
	<p>Upstream</p>

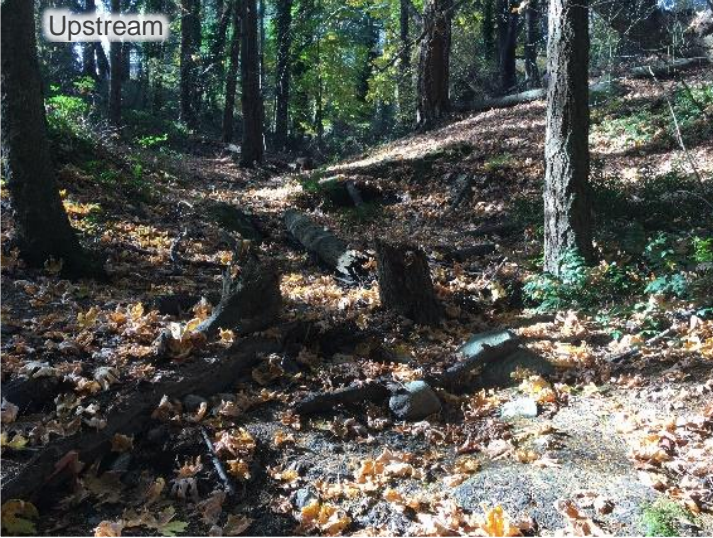
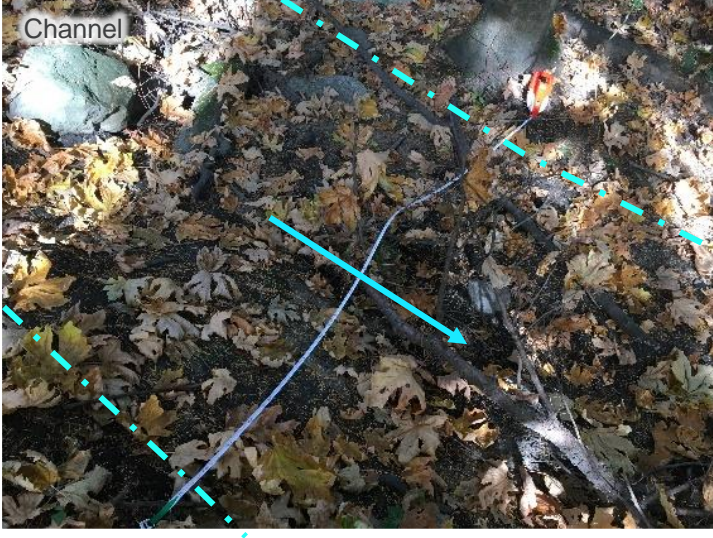
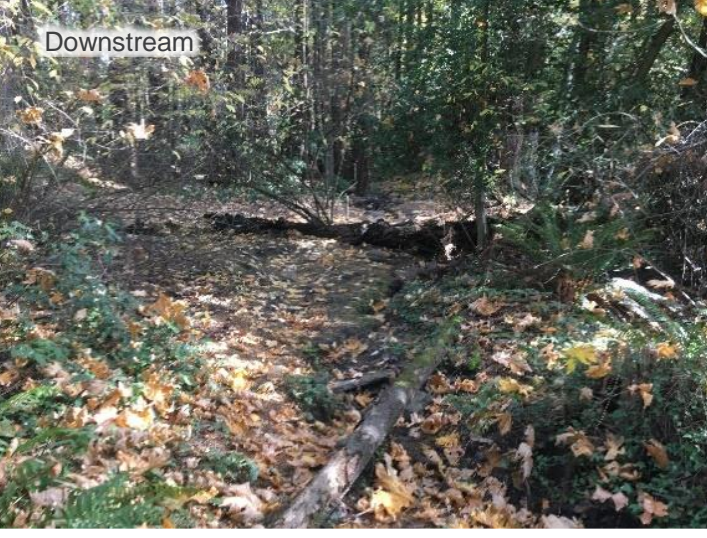
Channel Characteristic	Riparian Vegetation	Disturbance
	<ul style="list-style-type: none"> •Channel Width: 2.6 m •Dry/Intermittent flow •Primary Channel •Channel pattern: straight •Confined in a ravine •Bed material: fines with some cobbles (20 cm to 50 cm) 	Mature Mixed Forest: Douglas fir (dominant) Big leaf maple Ocean spray (dominant) Dull Oregon-grape (dominant) Sword fern English Ivy (dominant) English holly Snowberry	<ul style="list-style-type: none"> • PVC culvert with headwall, direct stormwater flows into the primary channel. • Rip-rap placement in the engineered stormwater discharge channel (note channel characteristics describe the primary channel)
Transect 4	Photographs

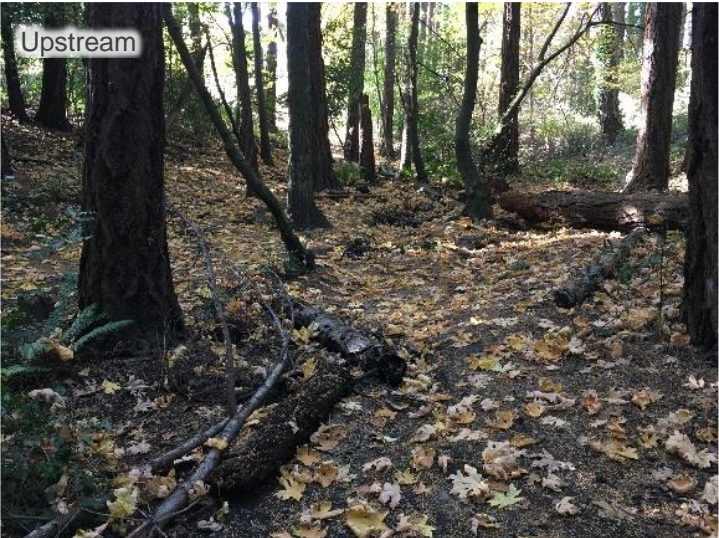
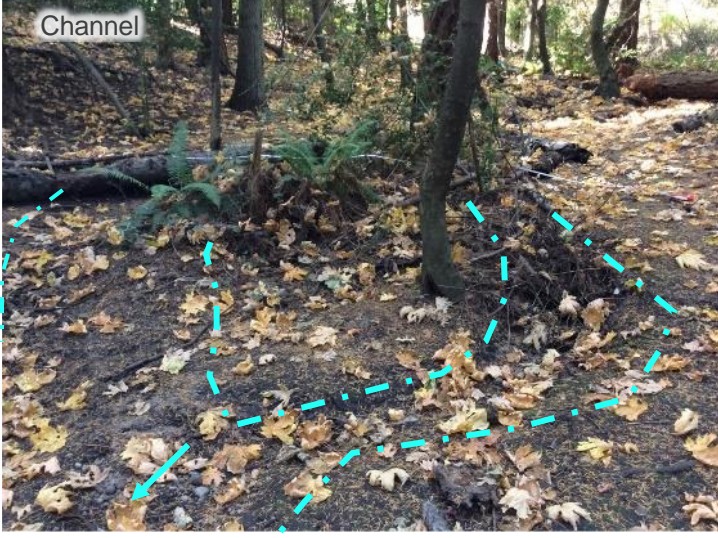
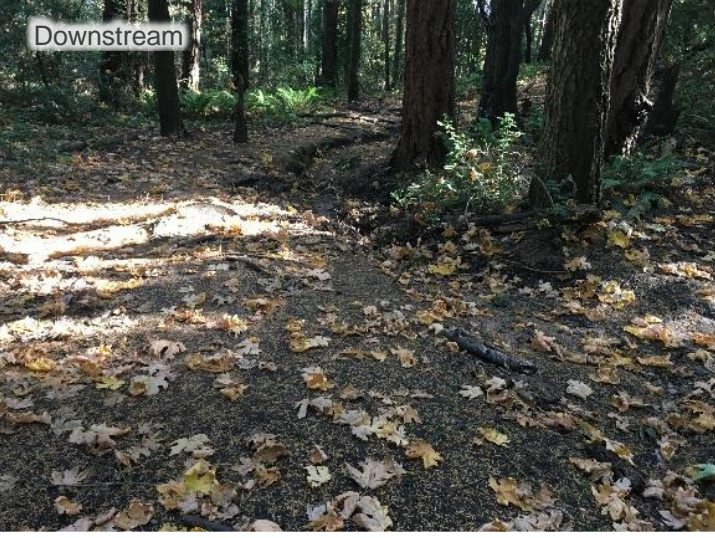
Channel Characteristic	Riparian Vegetation	Disturbance
	<ul style="list-style-type: none"> •Channel Width: 1.4 m (primary) and 0.7 m (secondary) •Dry/Intermittent flow •Primary Channel undercut on left bank depth approximately 20 cm •Channel pattern: sinuous with occasional islands •Confined or frequently confined •Bed material: fines with some gravel 	Mature Mixed Forest: Douglas fir (dominant) Big leaf maple English holly Sword fern Dull Oregon-grape	<ul style="list-style-type: none"> • The channel is braided at this location. • It is denuded which is inferred to be the result of foot traffic from hikers
Transect 5	Photographs

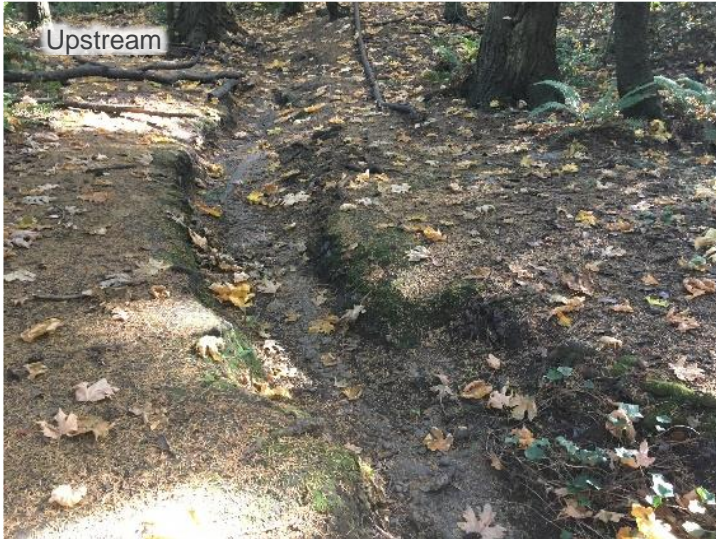
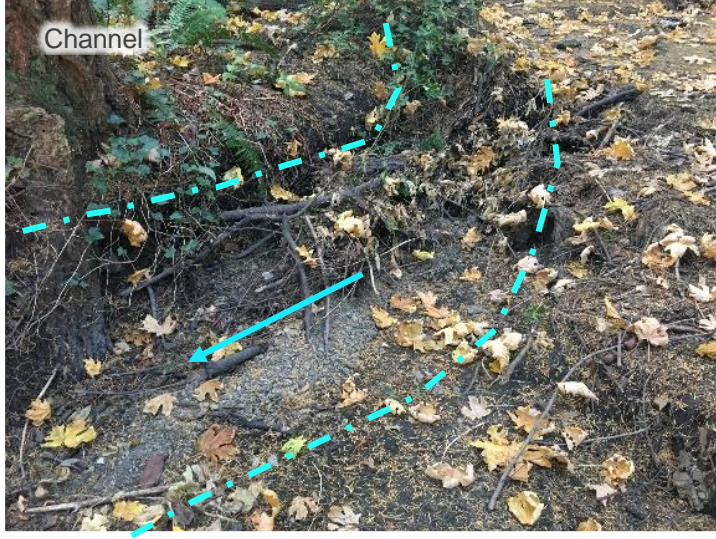
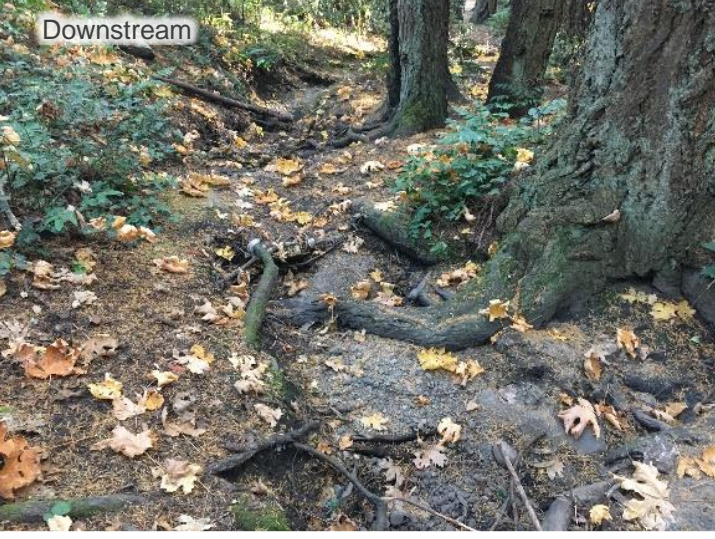
Channel Characteristic	Riparian Vegetation	Disturbance
	<ul style="list-style-type: none"> •Channel Width: 0.9 m (step), 2.3 m (pool) •Depth approx. 10 cm in step and 30 cm in pool •Dry/Intermittent flow •Primary Channel •Channel pattern: sinuous •Confined •Bed material: gravel 	<p>Mature Mixed Forest: Douglas fir (dominant) Big leaf maple Arbutus English holly English Ivy Dull Oregon-grape Sword fern Trailing blackberry Star flowered lily-of-the-valley</p>	<p>The channel was cleared defined at this location. Erosion under a root had caused a step pool morphology that had not been previously noted within the channel.</p>
Transect 6	Photographs

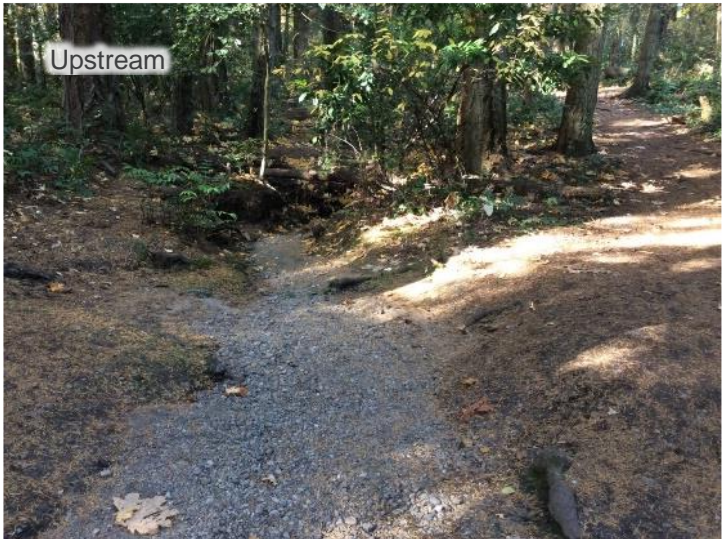
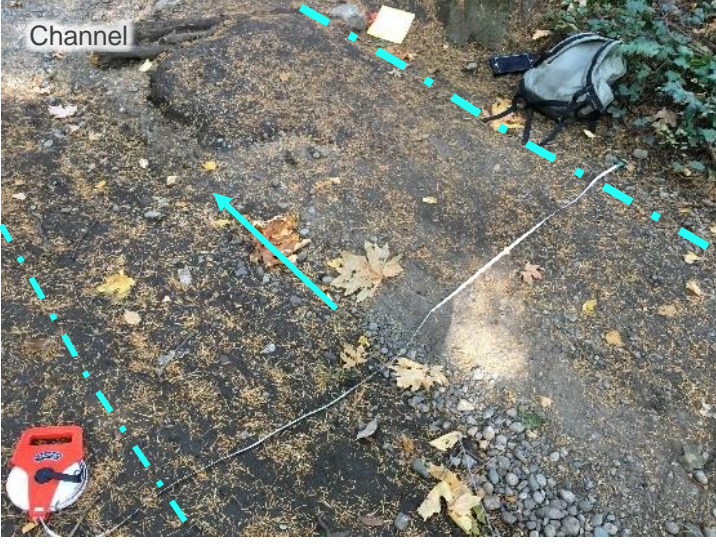
Channel Characteristic	Riparian Vegetation	Disturbance
Transect 7	<ul style="list-style-type: none"> •Channel Width: 2.3 m •Estimated depth 12 cm •Dry/Intermittent flow •Primary Channel •Channel pattern: straight •Unconfined •Bed material: fines with gravel 	Mature Mixed Forest: Douglas fir (dominant) Grand fir Arbutus English holly (dominant) Ocean spray Big leaf maple English Ivy Dull Oregon-grape Trailing blackberry Snowberry	<ul style="list-style-type: none"> • A wide hiking trail intersects the channel at this location. • This has caused substantial impacts to the channel. Flows have spread over the width of the footpath with is nearly twice as wide as the typical channel width
	Photographs

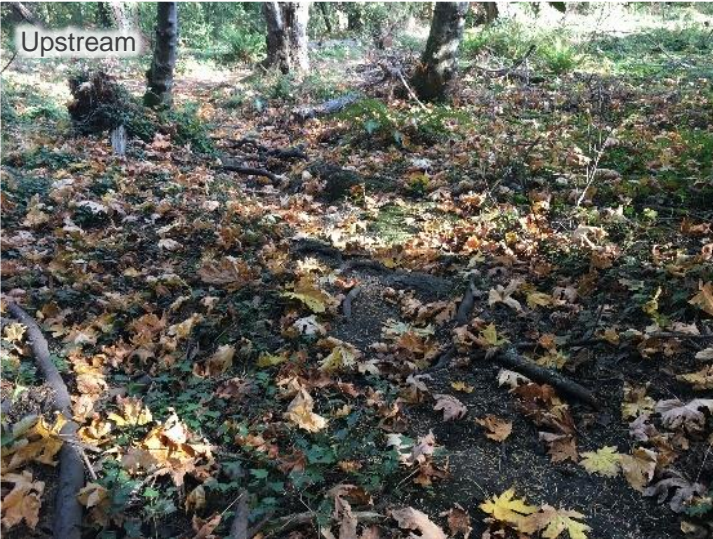
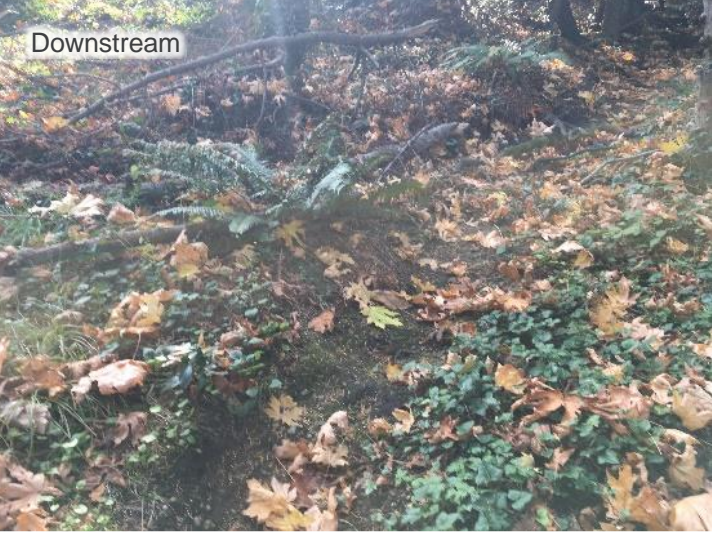
Channel Characteristic	Riparian Vegetation	Disturbance
	<ul style="list-style-type: none"> •Channel Width: 1.6 m (primary), 0.5 m (secondary) •Depth of primary channel approx. 18 cm •Depth of secondary channel approx. 10 cm •Dry/Intermittent flow •Primary Channel •Channel pattern: sinuous with occasional islands •Unconfined •Bed material: fines 	Mature Mixed Forest: Grand fir Douglas fir (dominant) Big leaf maple English holly (dominant) English Ivy (dominant) Dull Oregon-grape	<ul style="list-style-type: none"> • The channel in this location is braiding and highly impacted • It is difficult to discern the channel during period of non-flow
Transect 8	Photographs

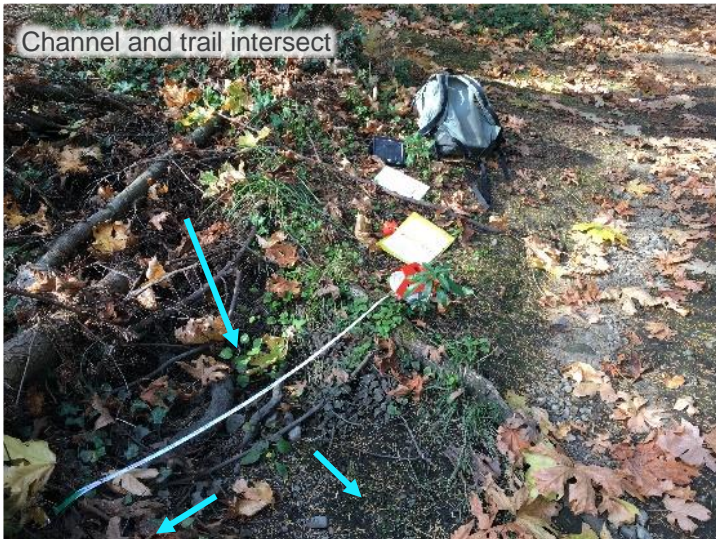
<p>Channel and trail intersect</p>

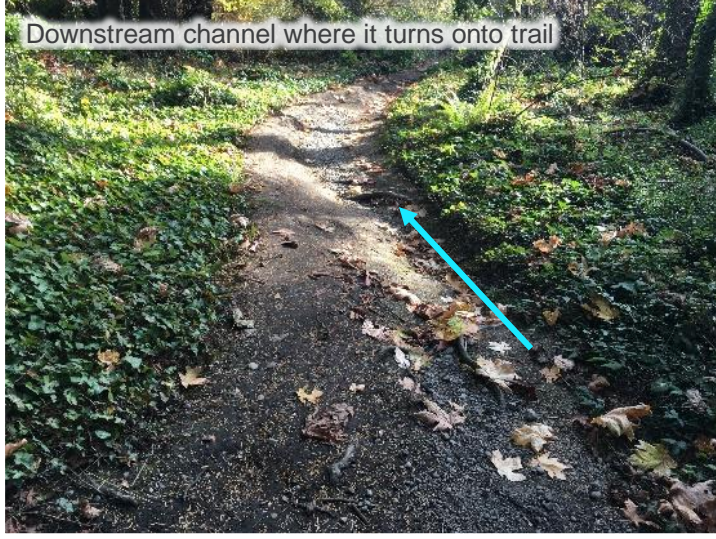
<p>Downstream channel where it turns onto trail</p>

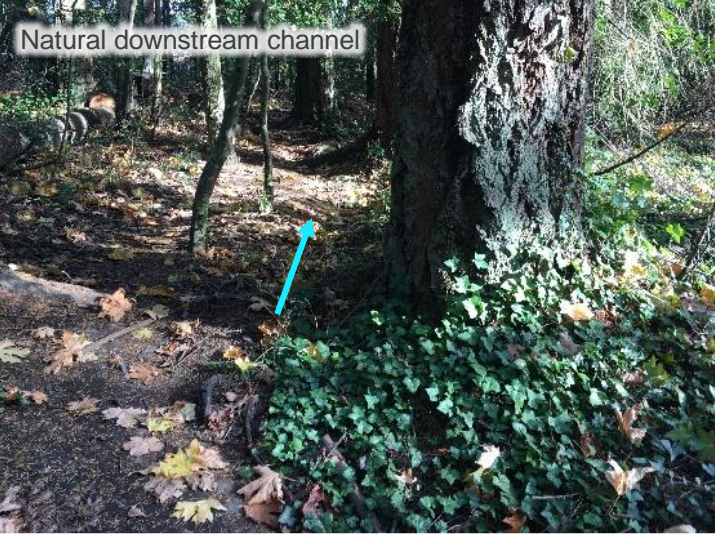
<p>Natural downstream channel</p>

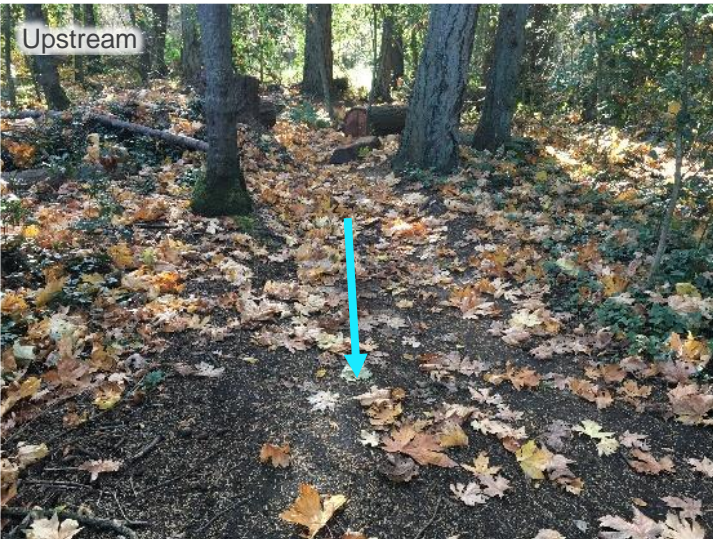
Transect 10	Photographs

Channel Characteristic	Riparian Vegetation	Disturbance
	<ul style="list-style-type: none"> •Channel Width: 1.1 m •Depth approx. 6 cm •Dry/Intermittent flow •Primary Channel •Channel pattern: sinuous •Unconfined •Bed material: fines 	<p>Mature Mixed Forest: Douglas fir (dominant) Big leaf maple Ocean spray Arbutus Dull Oregon-grape Sword fern English Ivy (dominant) English holly (dominant)</p>	<ul style="list-style-type: none"> • This is inferred to be the natural channel. Flows have diminished in this area due to the upstream diversion onto the footpath. • Municipal mapping does not indicate that Finnerty Creek is located in this area • Additional footpaths crisscross the stream channel here causing further degradation • Just a few meters away from the ditch along Arbutus Road another footpath crosses the stream perpendicular to flows, this has results in loss of a defined channel. • It is inferred that the flows discharge to the ditch in an eroded footpath as pictured in the downstream photograph.

<p>Upstream</p>

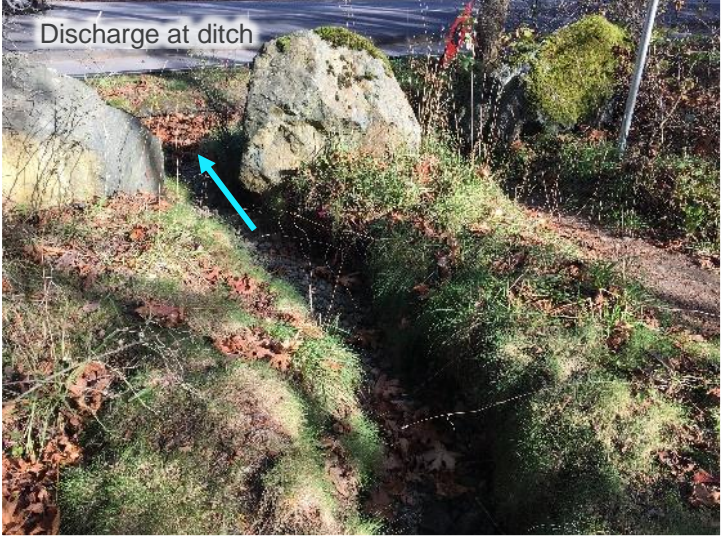
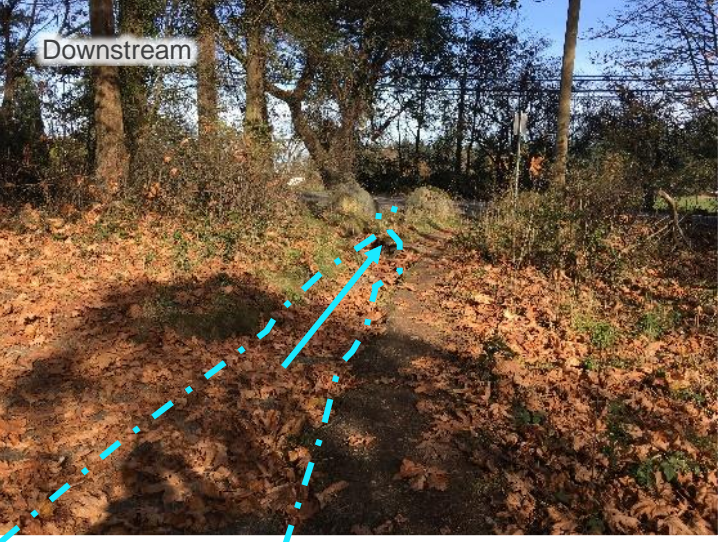
Channel Characteristic	Riparian Vegetation	Disturbance
Alternate Discharge Location due to Impacts	<ul style="list-style-type: none"> •Width of diverted channel variable but typically less than 1 m •Substrate was gravel from footpath •Dry/Intermittent flow •Secondary Channel (not natural channel, resulted due to impacts to stream) •Channel pattern: sinuous •Unconfined •Bed material: gravels from footpath 	Mature Mixed Forest: Douglas fir (dominant) Big leaf maple Ocean spray Arbutus Dull Oregon-grape Snowberry English Ivy (dominant) English holly (dominant)	<ul style="list-style-type: none"> • Another footpath intersects the diverted flows at a 90-degree angle and diverts flows towards the ditch along the footpath • Two large boulders at the trailhead have confined the flows where they discharge to the ditch causing scour/erosion
	Photographs

<p>Upstream flow eroded footpath</p>

<p>Discharge at ditch</p>

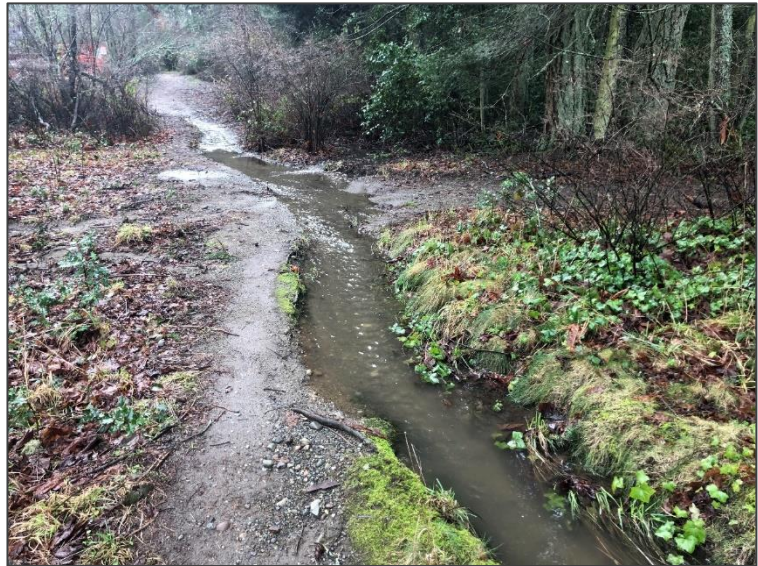
The first observance of flows within the creek followed a significant rainfall event which occurred on January 6th, 2020. Rainfall amounted to 36 mm of precipitation which resulted in flows within Finnerty Creek noted on January 7th. Flows were also observed on January 24th and 29th while conducting site visits for the CRD project. Weather data measured by Environment Canada indicates that heavy rain fell on January 22nd and 23rd (21.0 mm and 22.8 mm respectively). It was raining heavily on January 29th and had rained for twelve (12) consecutive days prior to the site visit. On January 31st record breaking rainfall occurred and 38.4 mm of rain fell within a 24 hour, it is inferred that the creek was flowing on and in the days following this storm event. Flows likely had occurred intermittently at other times during periods of heavier rainfall on days when McElhanney was not monitoring.

Photograph 2. January 29th, 2020 Finnerty Creek flowing on a footpath where it has diverted from the natural channel

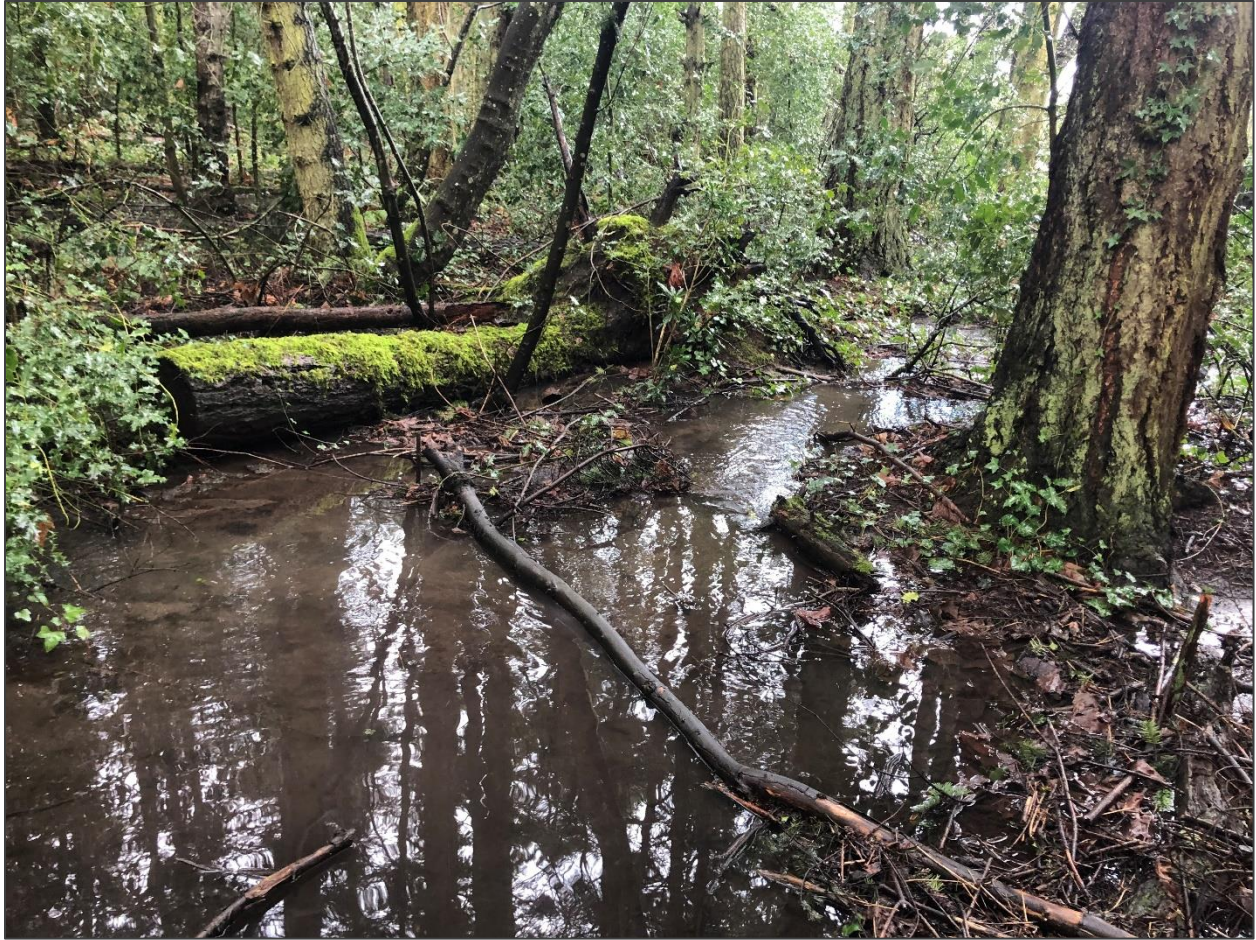
Photograph 3. Finnerty Creek on January 29th, 2020 flowing outside its banks over the forest floor between the original channel and the diverted channel

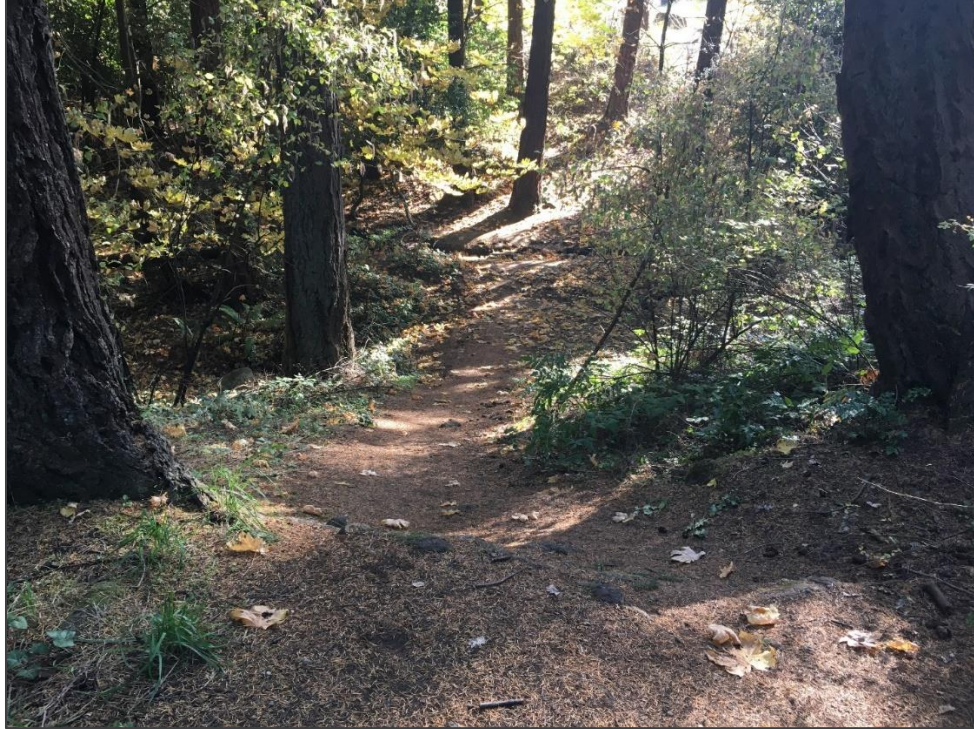
Photograph 4. Typical view of sloped topography south towards Finnerty Creek (located at the toe of the slope), encountered during the wetland search.

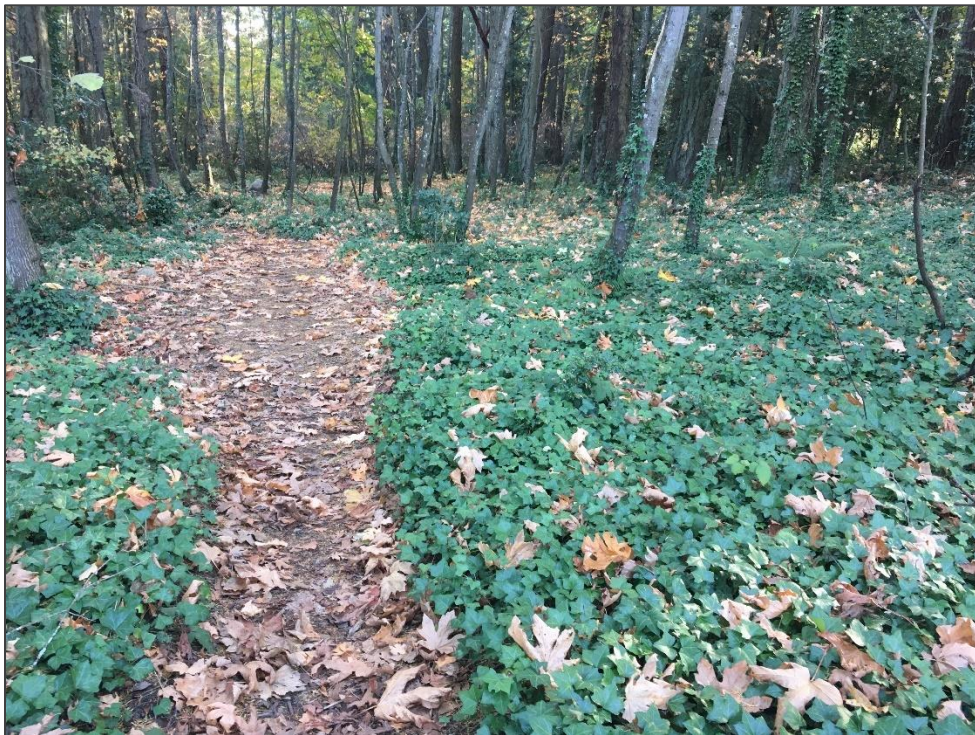
Photograph 5. Typical view of ecosystem and a footpath in low slope positions where the herbaceous layer is dominated by invasive English Ivy. No evidence of wetland encountered.
