**Haro Woods - Finnerty
Creek, Saanich, BC**

December 3, 2020 | Revision #0

**DRAFT Overview
Environmental
Assessment (EA) &
Hydrology Assessment**

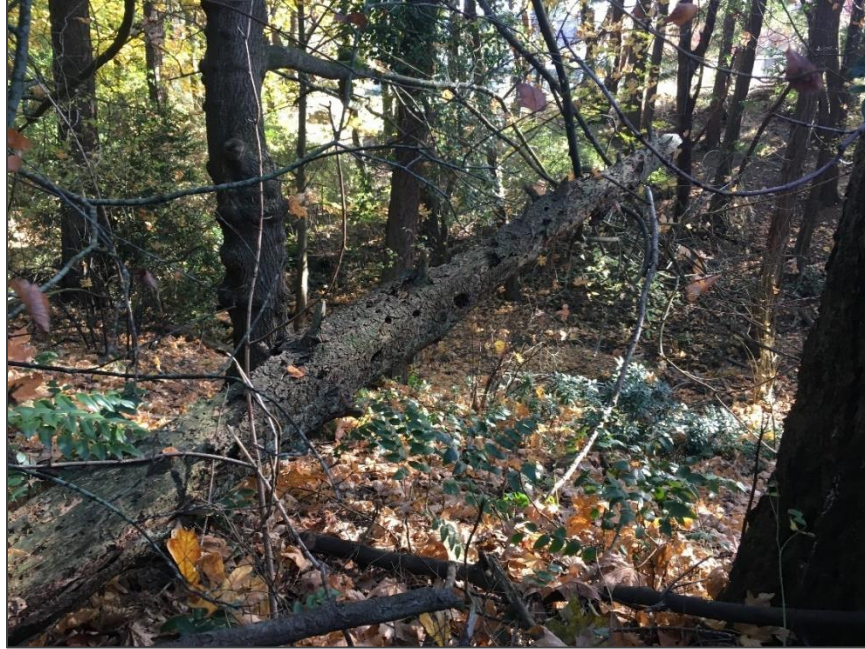
Photograph 6. Typical view of ecosystem in upper slope position above the ravine, steeply sloped landscape with no evidence of wetland.

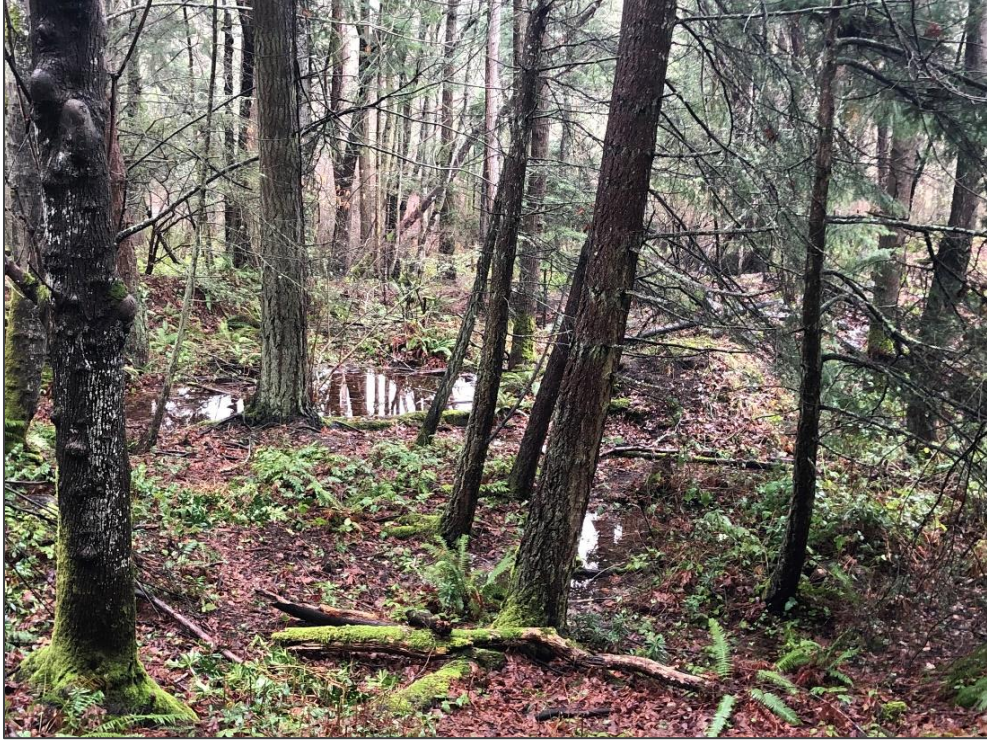
McElhanney conducted a second site visit to search for potential wetland indicators on the southern parcel of Haro Woods on January 29th, 2020. In this follow-up assessment two shallow open water ponds were located side by side in an isolated depression near the center of the search area. The pond is marked on **Error! Reference source not found.** and shown in Photographs 7 and 8.

It should also be noted that the ponded surface water was observed at the end of one of the wettest January's on record. Standing water could potentially be a puddle due to poor drainage during heavy rainfall. A single site visit does not provide enough information regarding the persistence of the ponded water observed to state with certainty that it is an ephemeral wetland vs a temporary pond in an area of poor drainage. It could potentially be an ephemeral wetland and is marked as such on **Error! Reference source not found.**. Additional site assessments would be required to accurately characterize this water feature to verify the persistence of standing open water, however the permanence of the hydroperiod was outside the scope of this assessment. It should be noted that it was an isolated basin, completely disconnected from Finnerty Creek or other watercourses. The source of water in this area is inferred to be rainfall runoff.

Photograph 7. Standing open water in isolated depressions identified on January 29, 2020 on the southeast parcel of Haro Woods

- It should be noted that the ponded water on southeast parcel of Haro Woods in the January 2020 field assessment was isolated and had no obvious impacts from pedestrian or bicycle use. Due to the lack of wetland vegetation and low habitat values for aquatic species, no specific habitat enhancement or protection efforts are recommended at this time.

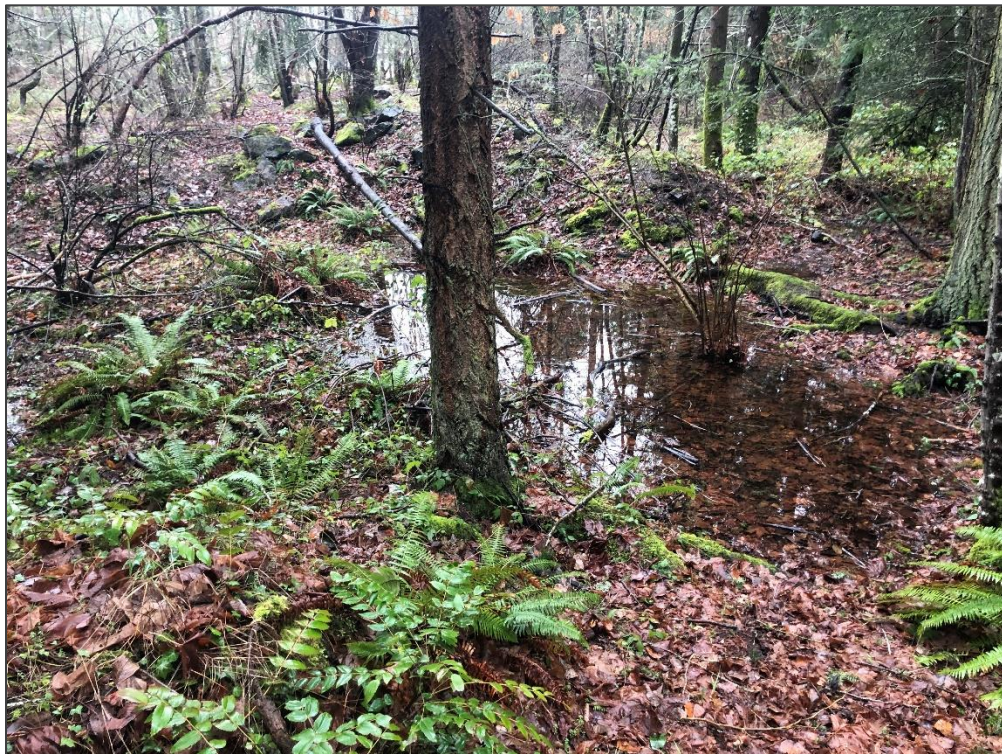
Photograph 8. Standing open water in isolated depressions identified on January 29, 2020 – note no hydrophytic vegetation observed

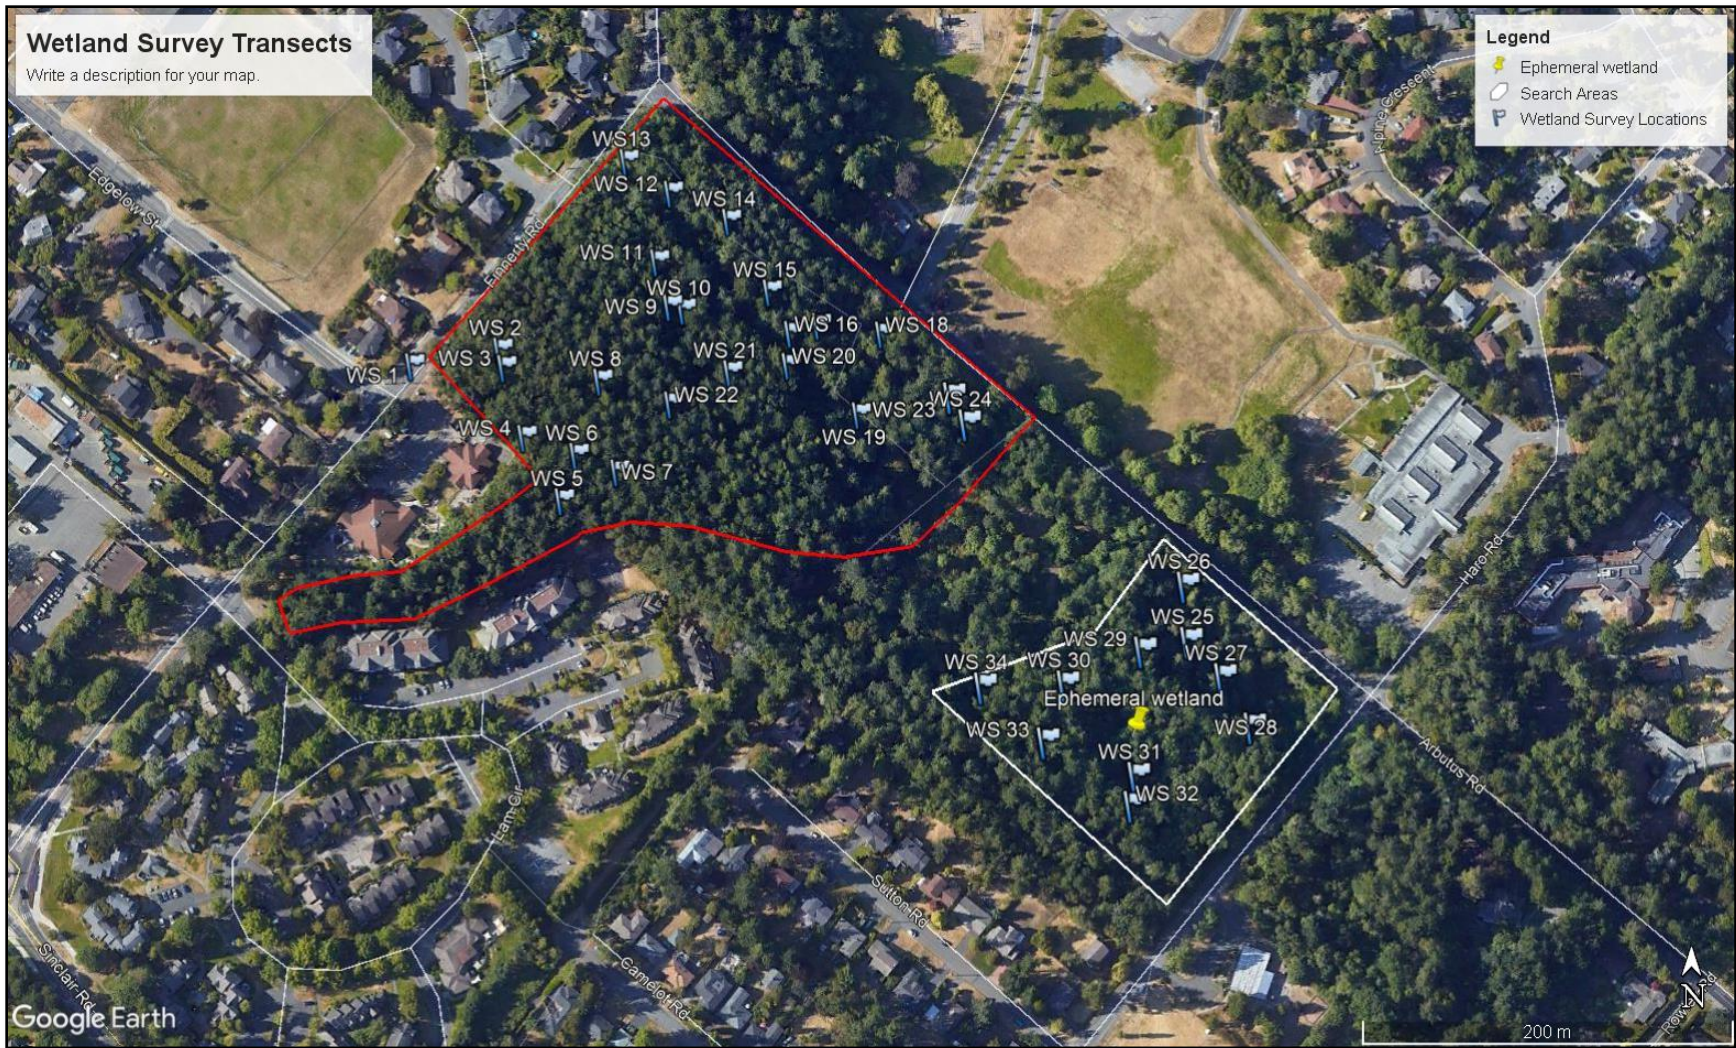
Figure 13. Wetland survey locations and results, the study area including the northern parcel is outlined in red and the southern parcel is outlined in white.
