TECHNICAL MEMORANDUM

Reference No. 1895826-029-TM-Rev0

CORDOVA BAY ROAD IN PKOLS (MT DOUGLAS PARK) BANK STABILIZATION, SHORT-TERM REMEDIATION DESIGN MEMORANDUM, SAANICH, BRITISH COLUMBIA

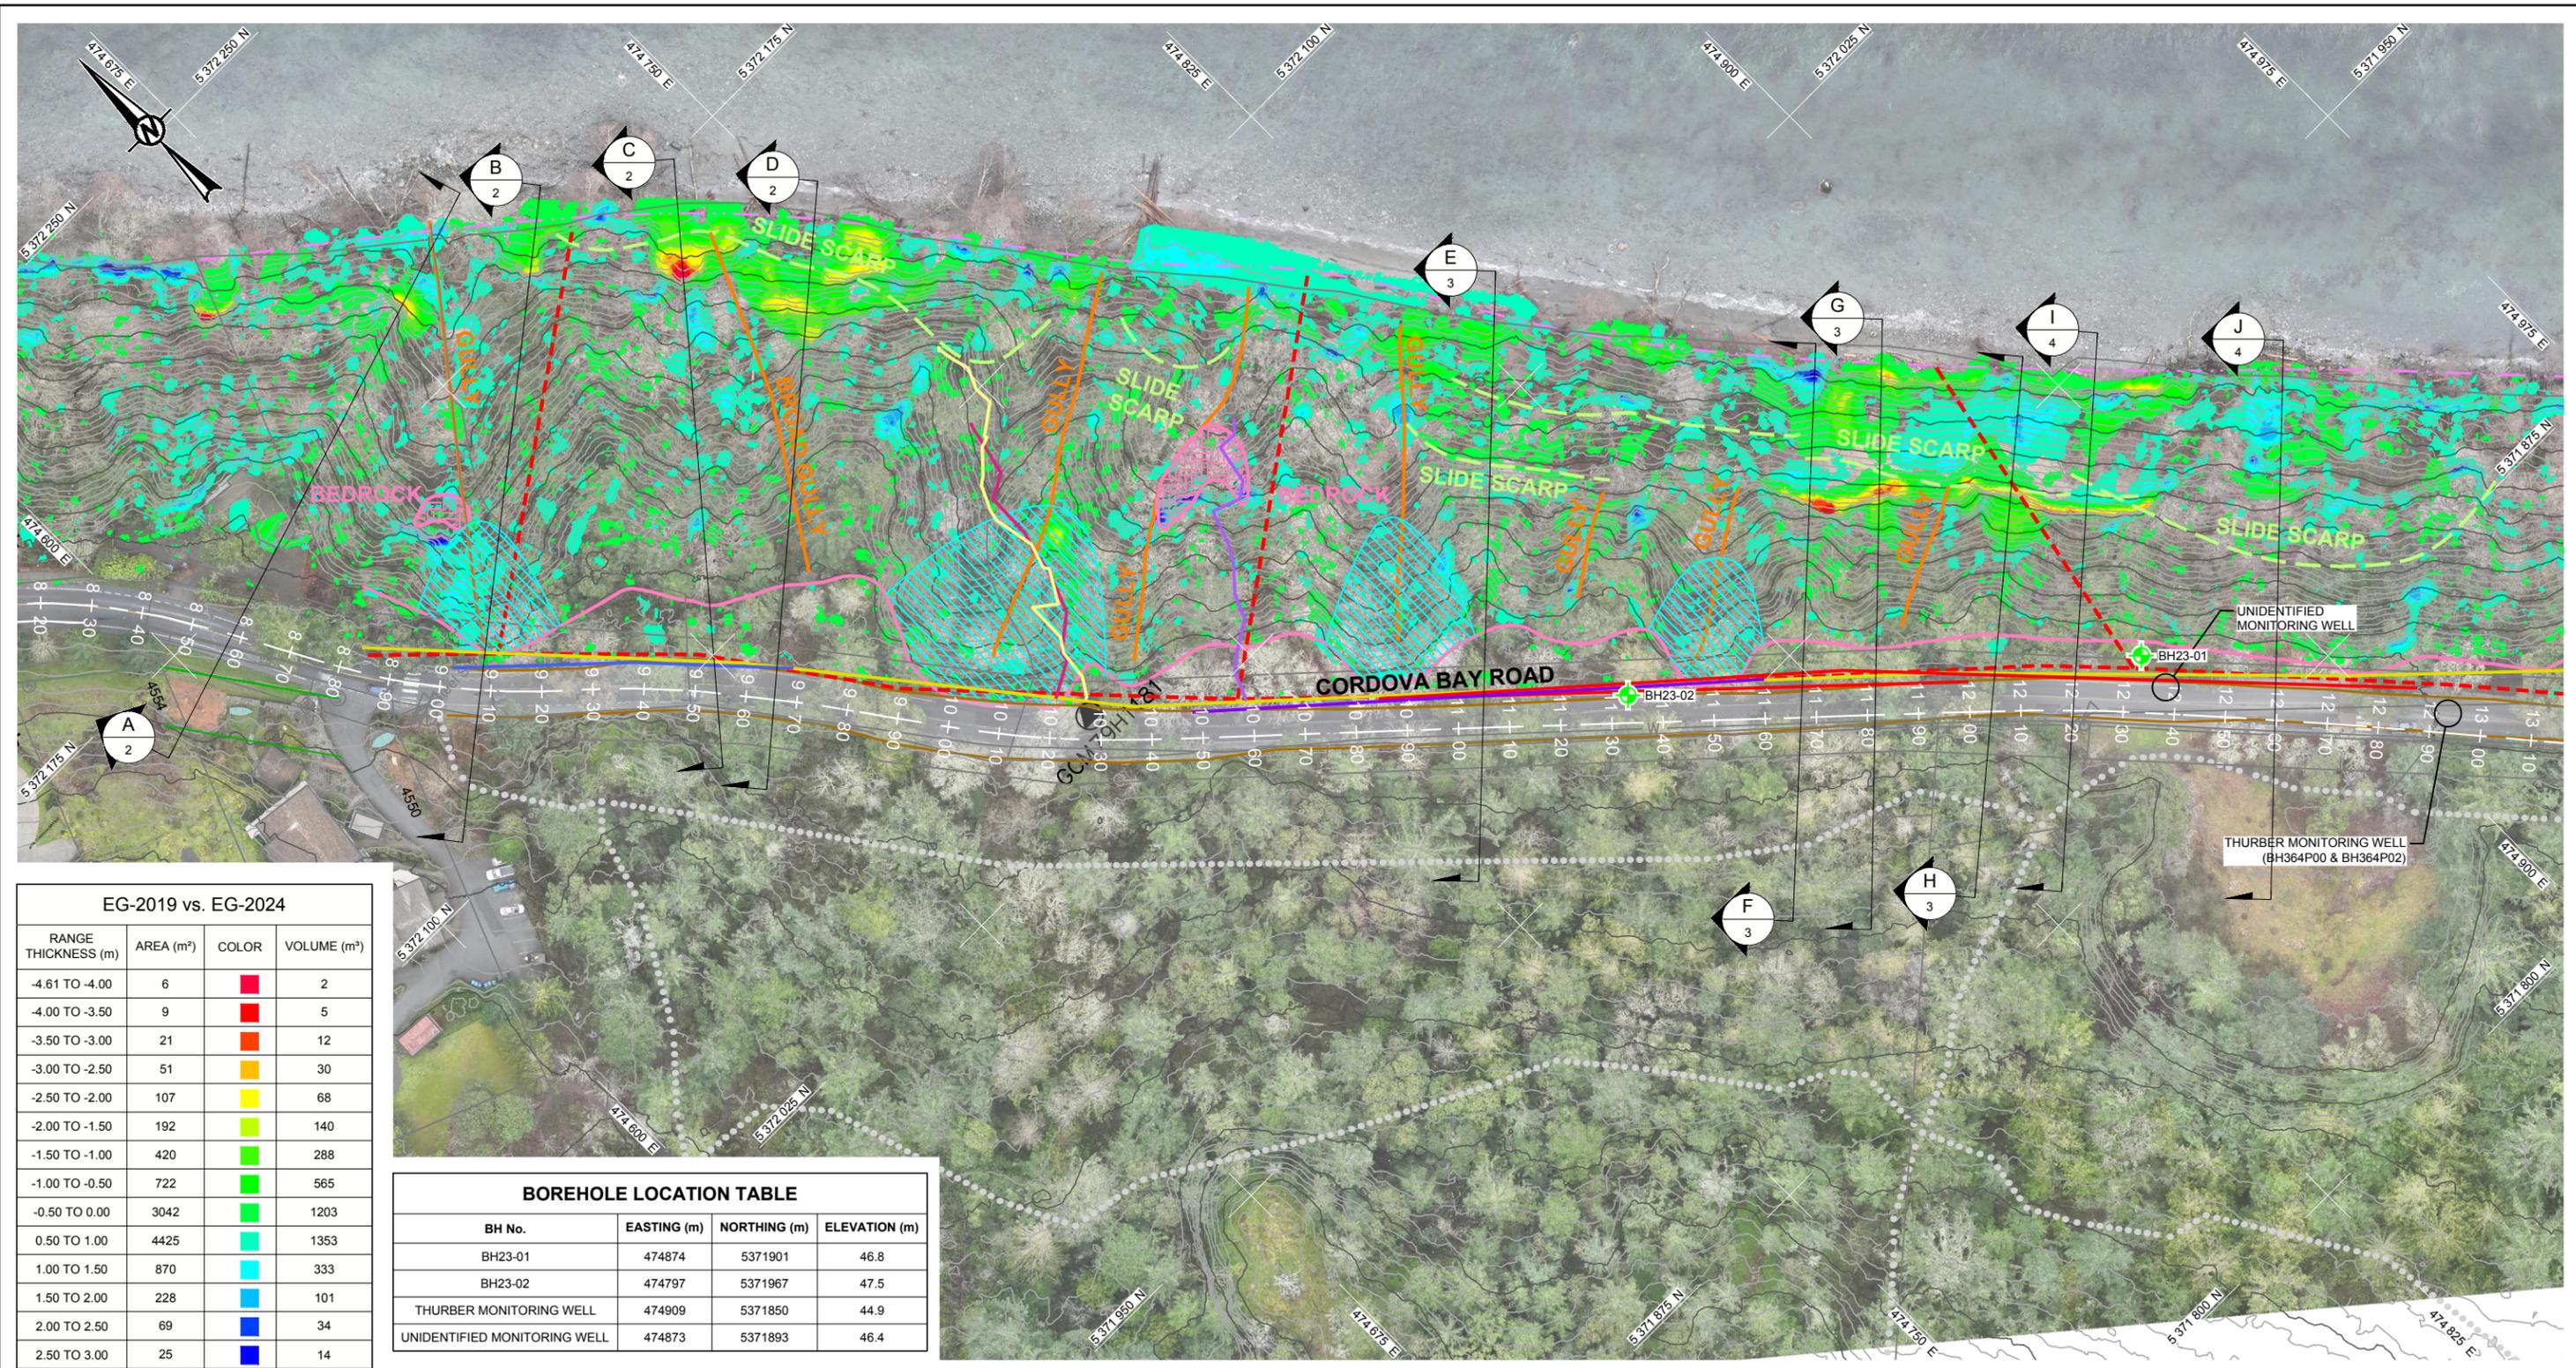
Figures 1 to 4 following the text of this report presents the results of the change detection analysis. Figure 1 shows a plan view, with the elevation changes represented by different colours in 0.5 m increment 'buckets'. Areas that lost elevation are represented by warm colours, with the loss magnitude increasing with redness. Areas that gained elevation are represented by cool colours, with gain magnitude increasing with degree of dark blue. Note that the bucket from 0.0 to 0.5 m gain is represented by no colour. The background photo for Figure 1 was taken during the drone survey. Figures 2 to 4 present critical slope cross-sections comparing LiDAR collected in 2024, 2019, and 2017.

Review of the change detection drawings revealed two main areas that have experienced slope deterioration over the past five years:

- 1) **Mid-slope scarp from Station 11+60 to 12+40 (Photo 1 in Attachment 1).** The head scarp appears to have receded about 1 to 4 m over a slope length of about 75 m. The change detection appears to show some soil deposition immediately below head scarp, but it is also possible that failed material had been deposited on the beach below the slope toe and subsequently been washed away by wave action. This area of the slope has lacked vegetation cover for many years.
- 2) **Slope toe failure at Station 9+45 (Photo 2 in Attachment 1).** An area about 8 m wide, 5 m long, and 2 to 5 m deep appears to have failed near the toe of the bluff.

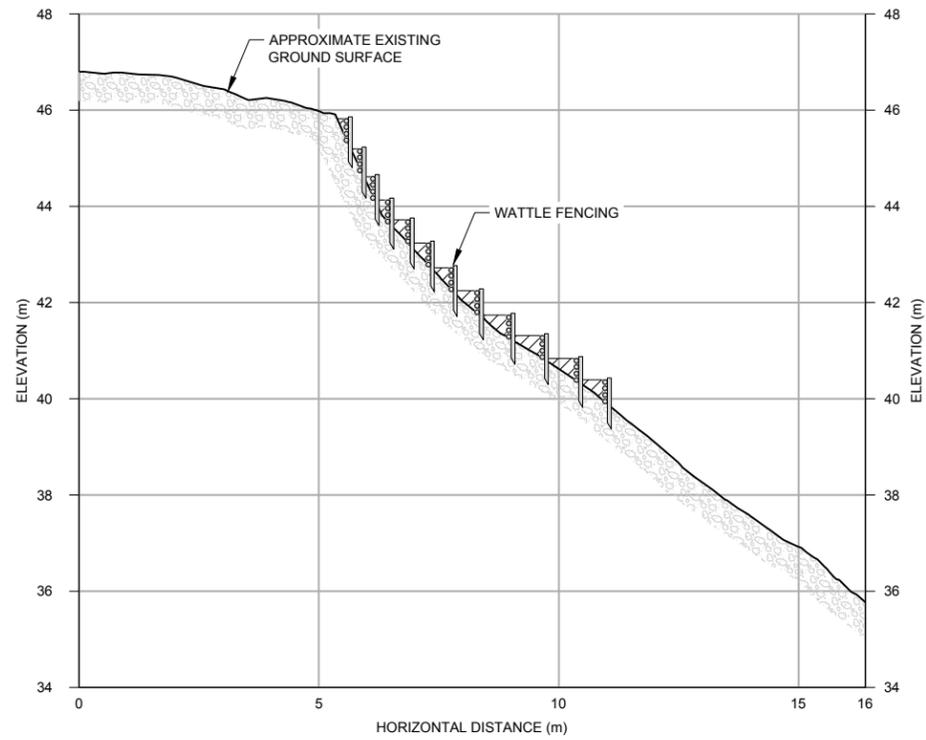
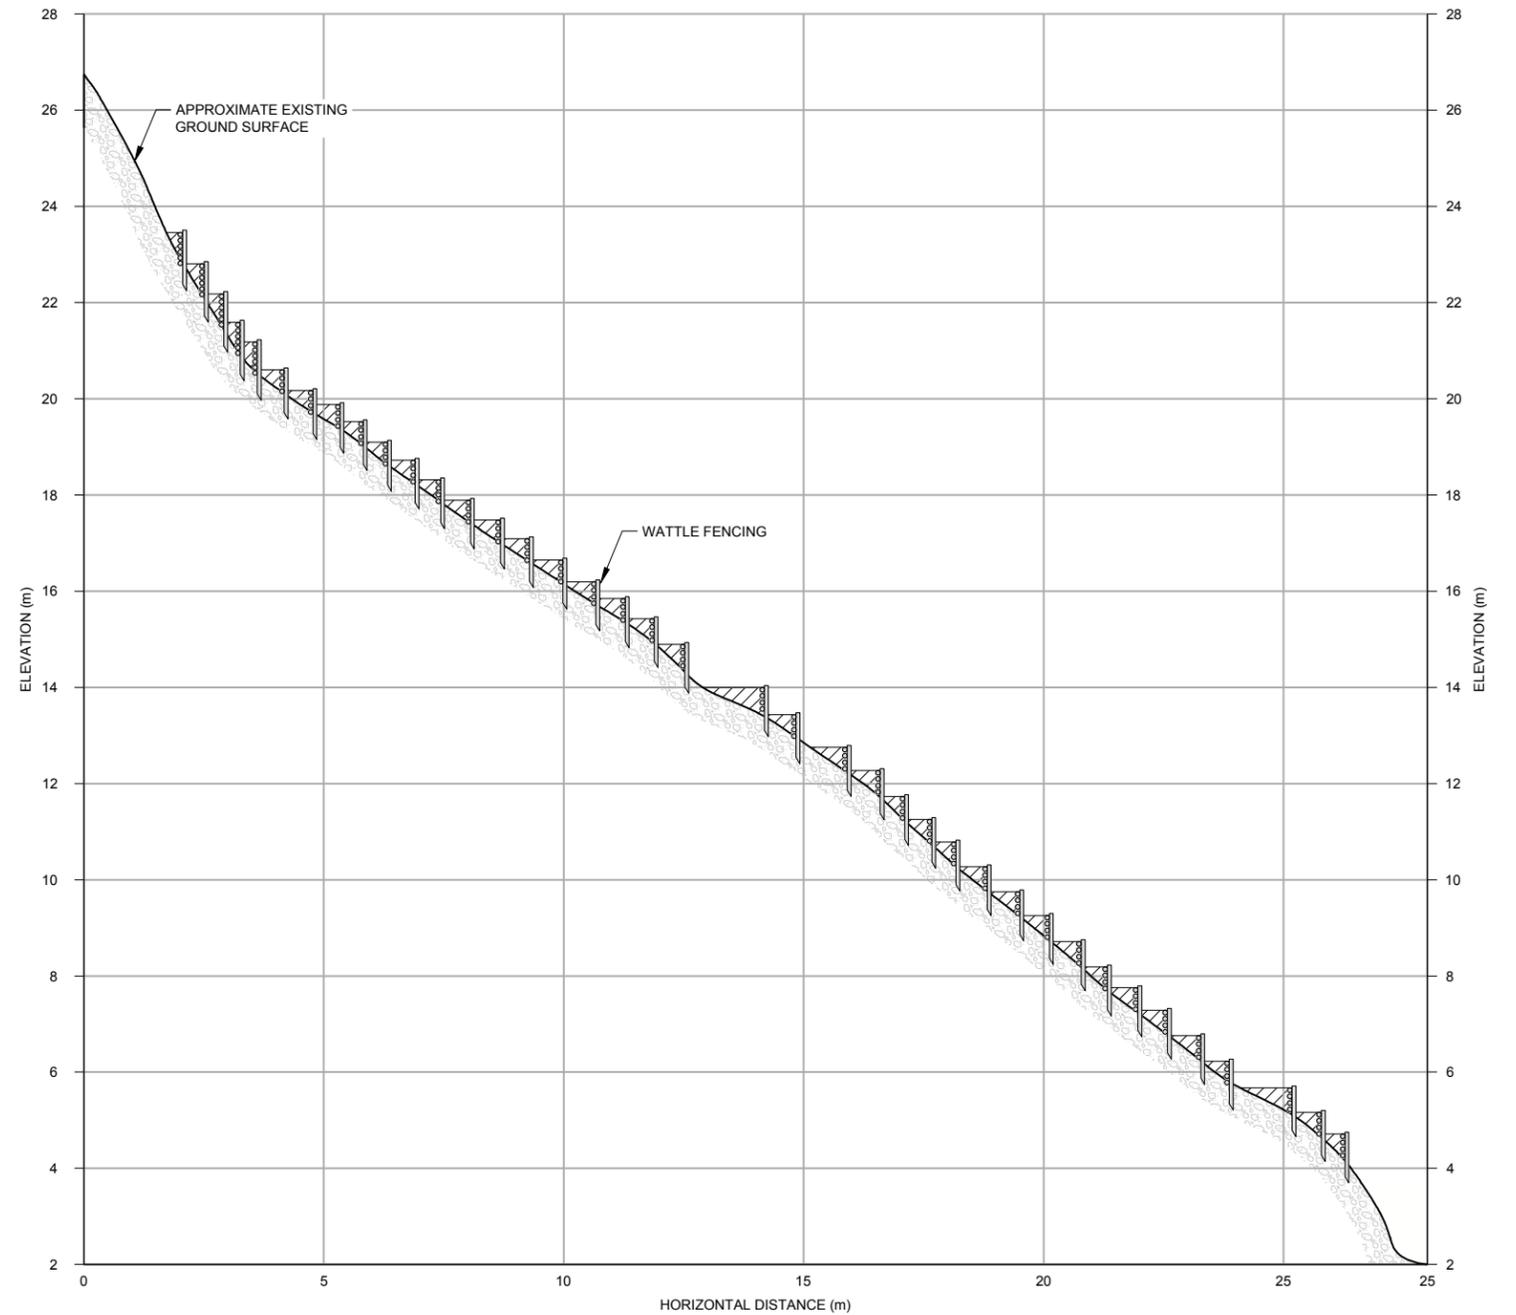
Figures 5 and 6 following the text of this report present preliminary drawings showing the proposed plan area of the wattle fences and two cross-sections. The estimated total length of wattle fences is 3990 m, comprising 3350 m allocated to mid-slope scarp from Station 11+60 to 12+40 and 640 m to the gully headwall on the upper slope from Station 10+80 to 11+00. The benching shown on Figure 6 will be created using existing exposed soil and will not require soil import. Note that the extent of the wattle fences in the selected treatment areas is based on preliminary discussion that WSP has had in recent months with Polster. WSP accompanied Polster on a site visit on 5 June 2024, following which Polster provided more detailed recommendations on wattle fence distribution and plant species. Therefore, the wattle fence distribution shown on Figures 5 and 6 is subject to change in a future version of this memorandum. This will also affect the costs discussed in Section 5.

WSP recommends addressing these areas with wattle fences. Wattle fences involve installing live local plant species using hand tools. Refer to the Polster reports in Attachment 2 for more information on wattle fences. This bioremediation option provides immediate near-surface support due to the benching of the wattle fences and the shear resistance of their implanted stakes. The support provided by the vegetation will improve with time as the wattle fences continue to grow and as other species move into the area. As previously mentioned, wattle fences also improve the stability of the slope through erosion protection and water absorption and protect deeper soils from deterioration due to environmental factors. Additionally, given that the wattle fences can be installed with hand tools and use natural material, WSP believes that this solution will be less disruptive and more attractive to the District and the public compared to other traditional engineering alternatives.

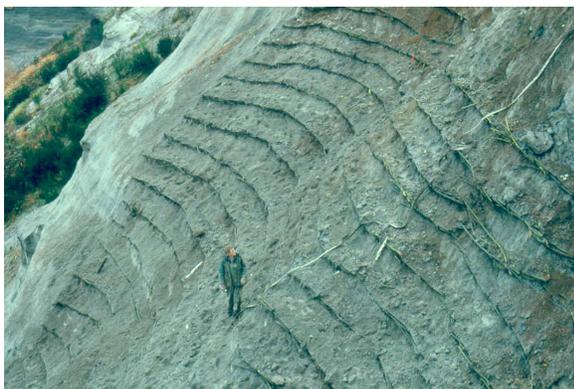
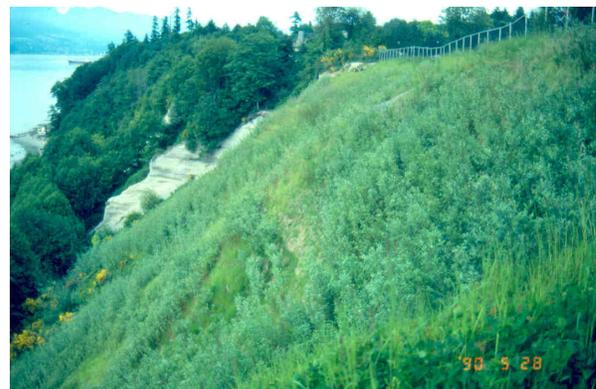
Photograph 1 and 2. Wattle fences were used to treat the Quadra sediments of the Point Grey cliffs. The average in-situ slope is 70°. Growth of the pioneering species used to construct the wattle fences started a successional processes that will see these slopes vegetated forever.

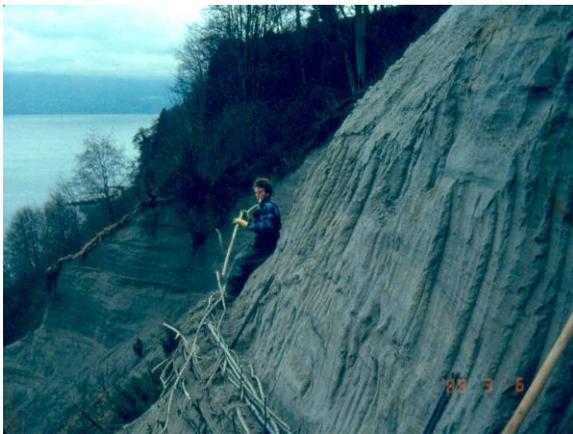
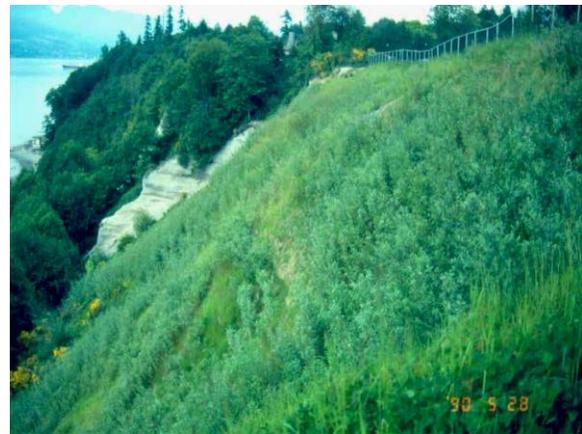
Treatment of the slopes above the beach (Photograph 2) can use soil bioengineering systems. Photographs 9 and 10 show a slope composed of Quadra sediments at the University of British Columbia that was treated using wattle fences over the winter of 1988/89. Wattle fences are short retaining walls built of living plant materials. These sprout and grow (Photograph 11) starting the successional process that eventually results in the initiation of a conifer forest on the slope (Photograph 12). Cost for treatment of the over-steepened slopes above the Mount Douglas Park beach would be about \$50/m of wattle fencing. A slope such as the one shown in Photograph 2 would require about 15 rows of wattle fencing so a cost of \$750 per meter of cliff would be experienced for this area. Careful measurement of all of the various scarps on this slope would be needed to determine a reasonable estimate of the cost of bioengineering on the slopes above the beach.

Photograph 9 & 10. Sand cliffs at the University of British Columbia (70°) were treated over the winter of 1988/89 (left). These sprout and grow into a cover of pioneering vegetation (right).

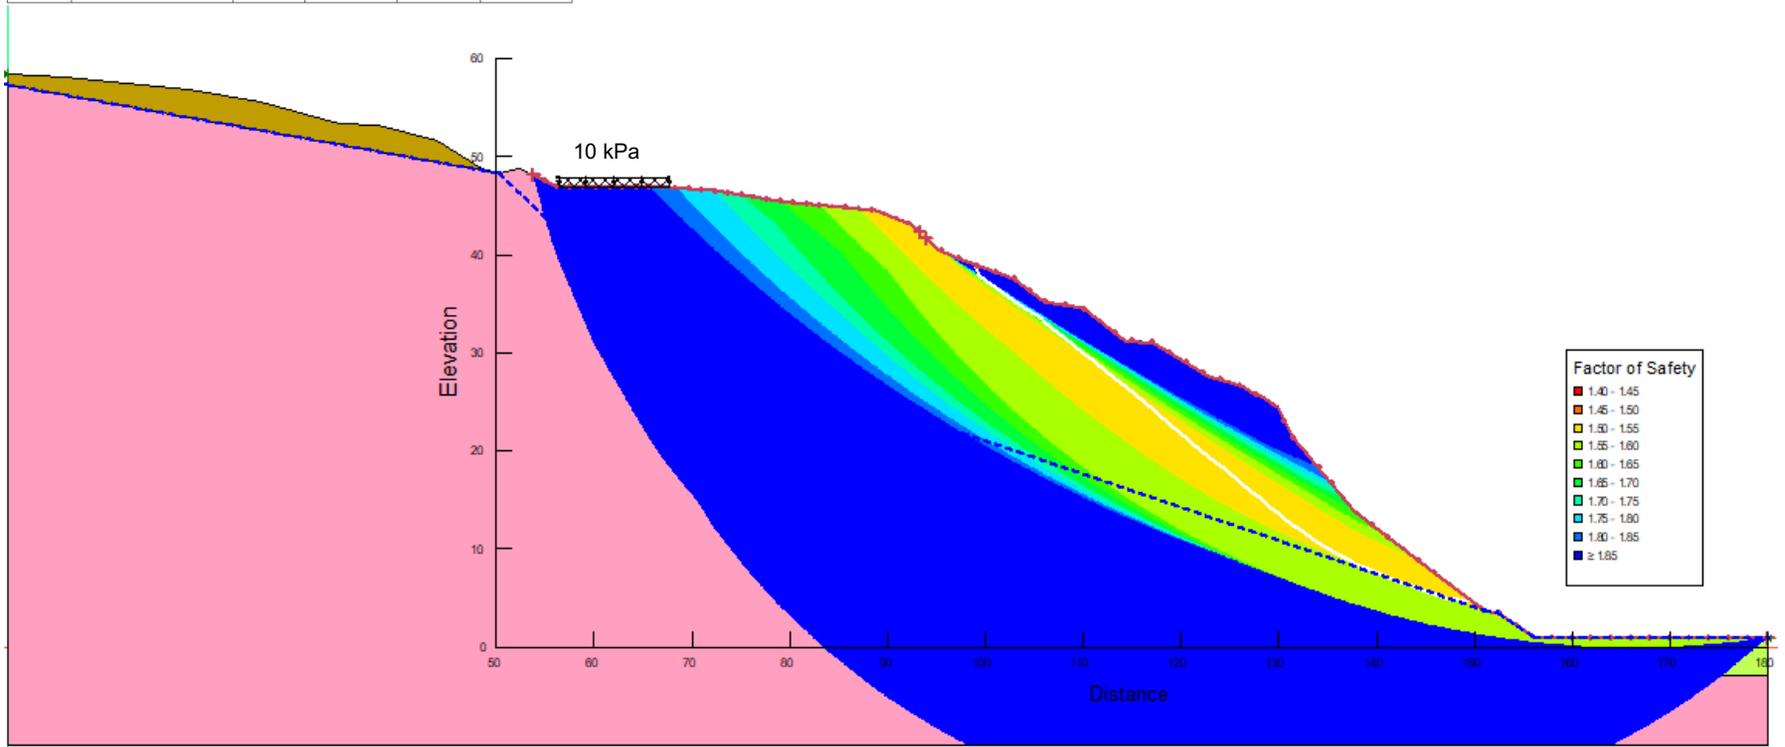
Condition	Station 9+70 Section B	Station 11+80 Section G	Station 12+20 Section I
Global slope	1.40	1.22	1.11
Slope toe	Not applicable	1.46	1.17
Mid-slope scarp	1.09	1.07	1.07
Mid-slope scarp with wattle fences	1.21	1.12	1.18

1.40

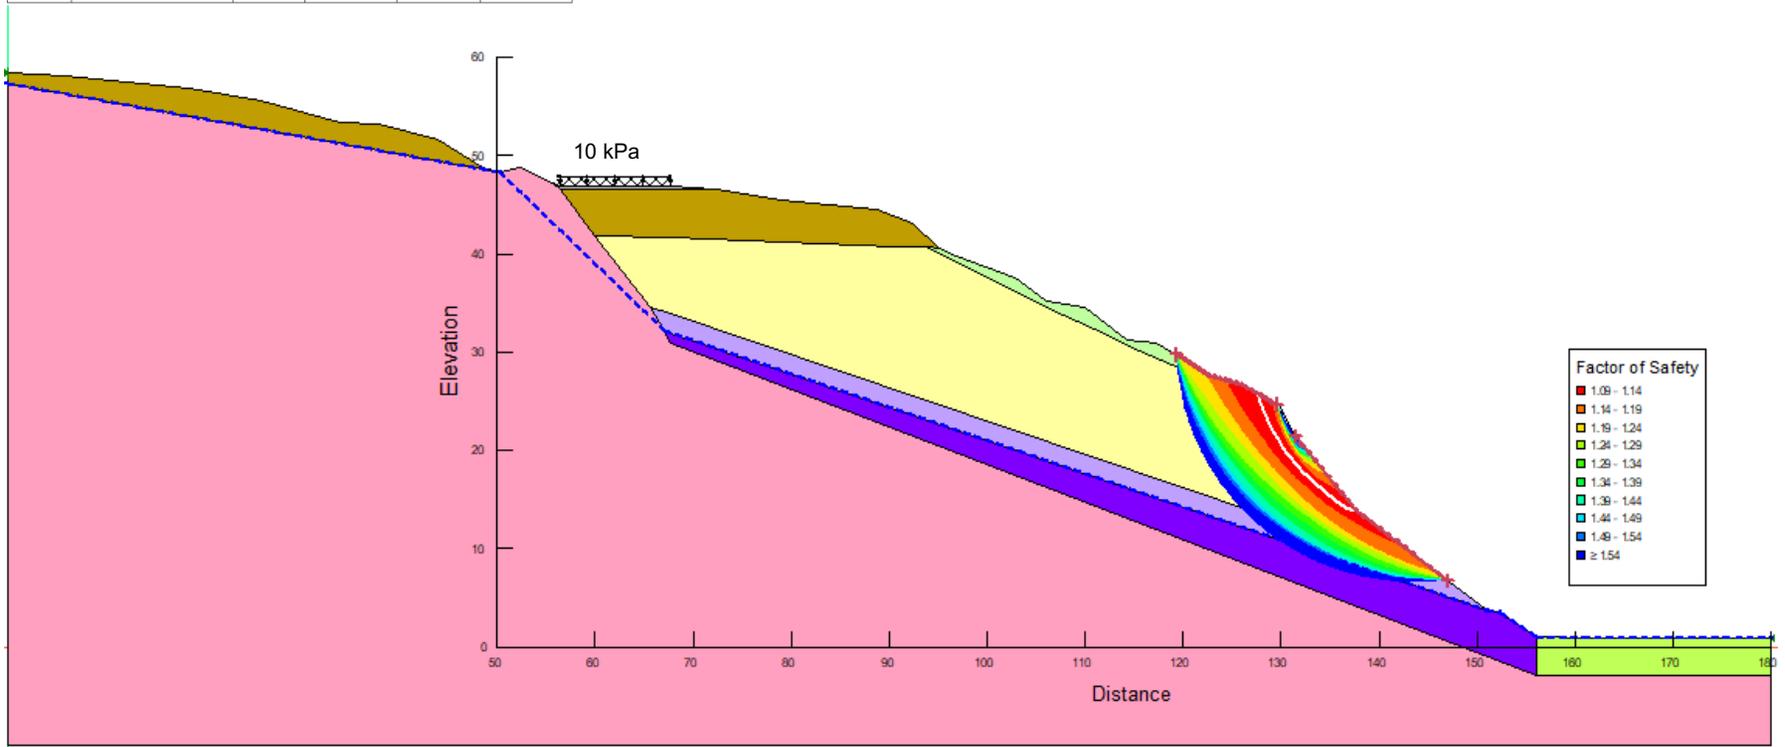
Slope stability analysis of the existing mid-slope scarps indicated a FS between 1.0 and 1.1, indicating that these areas are susceptible to shallow slips surfaces in the short-term. The analysis also indicates that the wattle fences would increase the FS by about 0.1, which would reduce, but not eliminate, the risk of failure in the short-term. Note that the slope stability analysis only incorporates the increase of near-surface cohesion due to the wattle fences, and does not include its other benefits, such as water absorption and erosion protection. The wattle fences would also protect the soils on the slope from environmental deterioration due to wet-dry cycles, freeze-thaw cycles, and riling, which can act to reduce the strength of affected soils. In this way, wattle fences would help to maintain the high strength of the natural soils at depth within the slope.

1.09
