TREE INVENTORY TABLE

TREE PRESERVATION MEASURES

PROJECT
4171 Cedar Hill Road
Victoria, BC

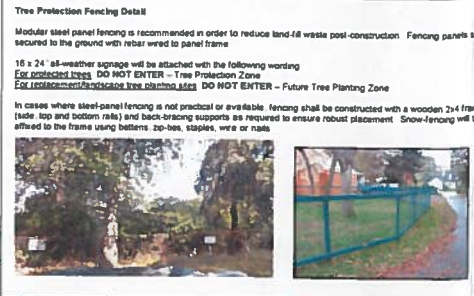
TREE PROTECTION FENCING SIGNAGE
(Signs shall be 18x36" and made to sustain all weather conditions)

Modular steel panel fencing is recommended in order to reduce land-fill waste post-construction. Fencing panels shall be secured to the ground with rebar w/epoxy to panel frame.

18 x 24 weather-protected signage will be attached with the following wording:
 Ex. protected trees, DO NOT ENTER - Tree Protection Zone
 Ex. replacement trees, DO NOT ENTER - Future Tree Planting Zone

In cases where steel-panel fencing is not practical or available, fencing shall be constructed with a wooden 2x4 frame (with top and bottom rails) and back-bracing supports as required to ensure robust placement. Snow-fencing will then be affixed to the frame using bottom: top-rails, staples, wire or nails.

- Tree Fencing:**
 - Tree protection fencing shall be installed to the District of Saanich standards at the locations indicated on this drawing prior to the site servicing and tree permit being issued (see fencing detail on plan).
