Cordova Bay Road @ Sayward Hill

Major Route: Cordova Bay Road Minor Route: Sayward Hill

Intersection Type: 3-leg south approach
East/West Route: Cordova Bay Road
Weather: Clear and dry

Vehicle Data

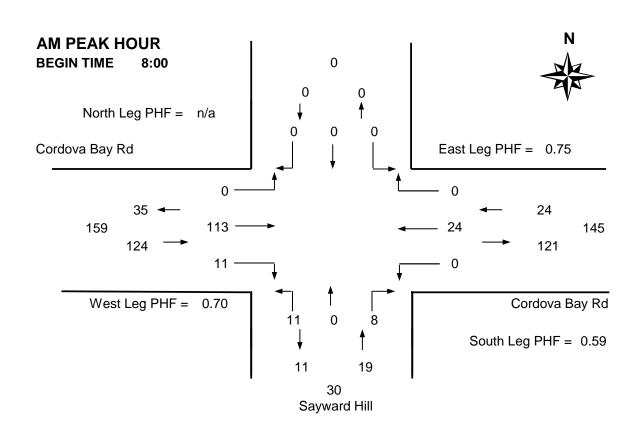
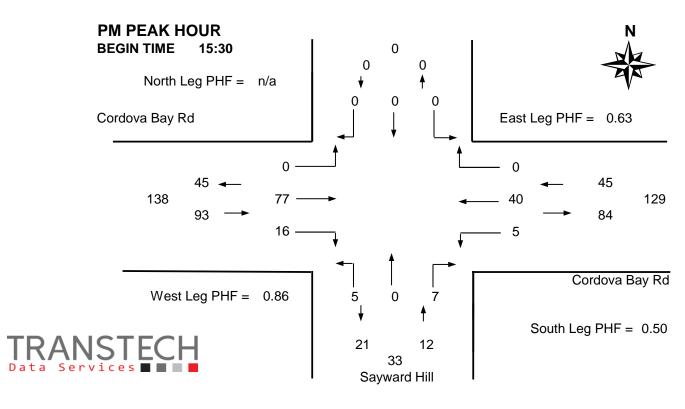
Intersection Type: 3-leg south approach East/West Route: Cordova Bay Road Weather:

Bicycle Data
