Saanich Stormwater Management Tour

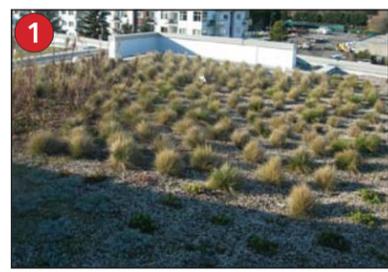
1 - Raven Building
 4396 West Saanich Road.
Land Use: Commercial building.
Completion Date: 2011.
 First private LEED Gold building in Victoria.
Stormwater Feature: Green roof.
Watershed: Colquitz Creek.

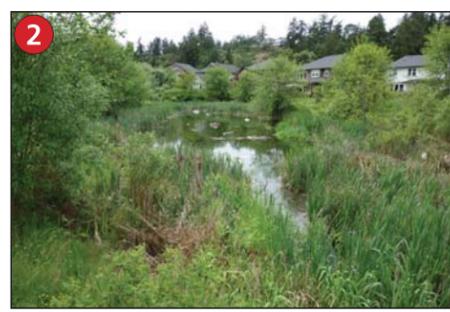
2 - South Valley Park, Wilkinson Valley
 4100 Hatfield Road.
Land Use: Formerly agricultural land converted to Single Family Residential and Park. **Completion Date:** 2007.
Stormwater Features: Bioswales, permeable paving and stormwater wetlands and creeks. An existing drainage ditch was completely redeveloped as a series of wetlands and creeks to address increased runoff from new housing, improve aesthetics and provide a community amenity and wildlife corridor.
Watershed: Colquitz Creek.

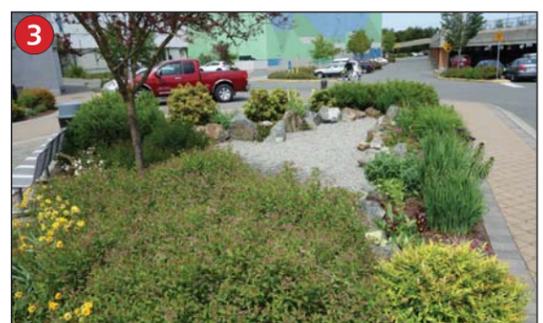
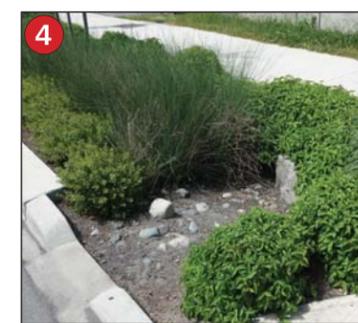
3 - Saanich Centennial Library
 3100 Tillicum Road.
Land Use: Municipal Building. **Completion Date:** 2007.
Certification: LEED Silver.
Stormwater Features: Permeable paving, underground storage and decorative dry river beds with underdrains for stormwater retention and treatment.
Watershed: Colquitz Creek.

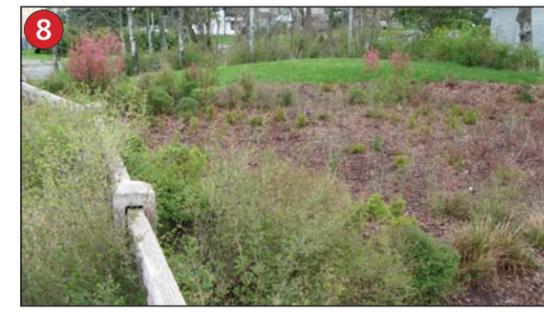
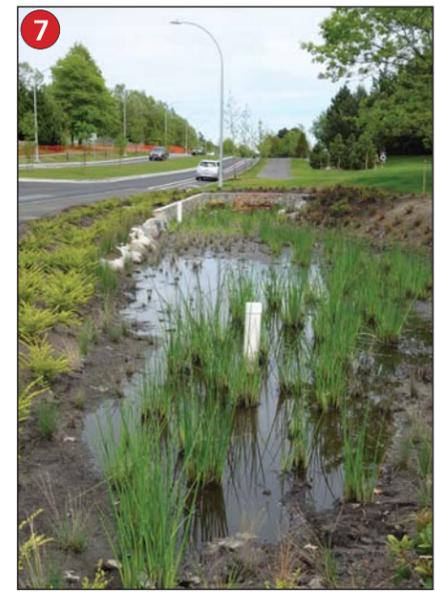
8 - Kenmore Park/Mamich Pond
 1700 Block Kenmore Road.
Land Use: Municipal Park/Single Family Residential. **Completion Date:** 2007.
Stormwater Features: A rain garden takes up much of the park site (.09 ha) to help reduce the amount of pollution reaching creeks and streams. A vegetated swale parallel to Kenmore was preserved when the adjacent subdivision was developed to help remove pollution from surface runoff water. The rain garden is planted with many varieties of native plants.
Watershed: Douglas Creek.

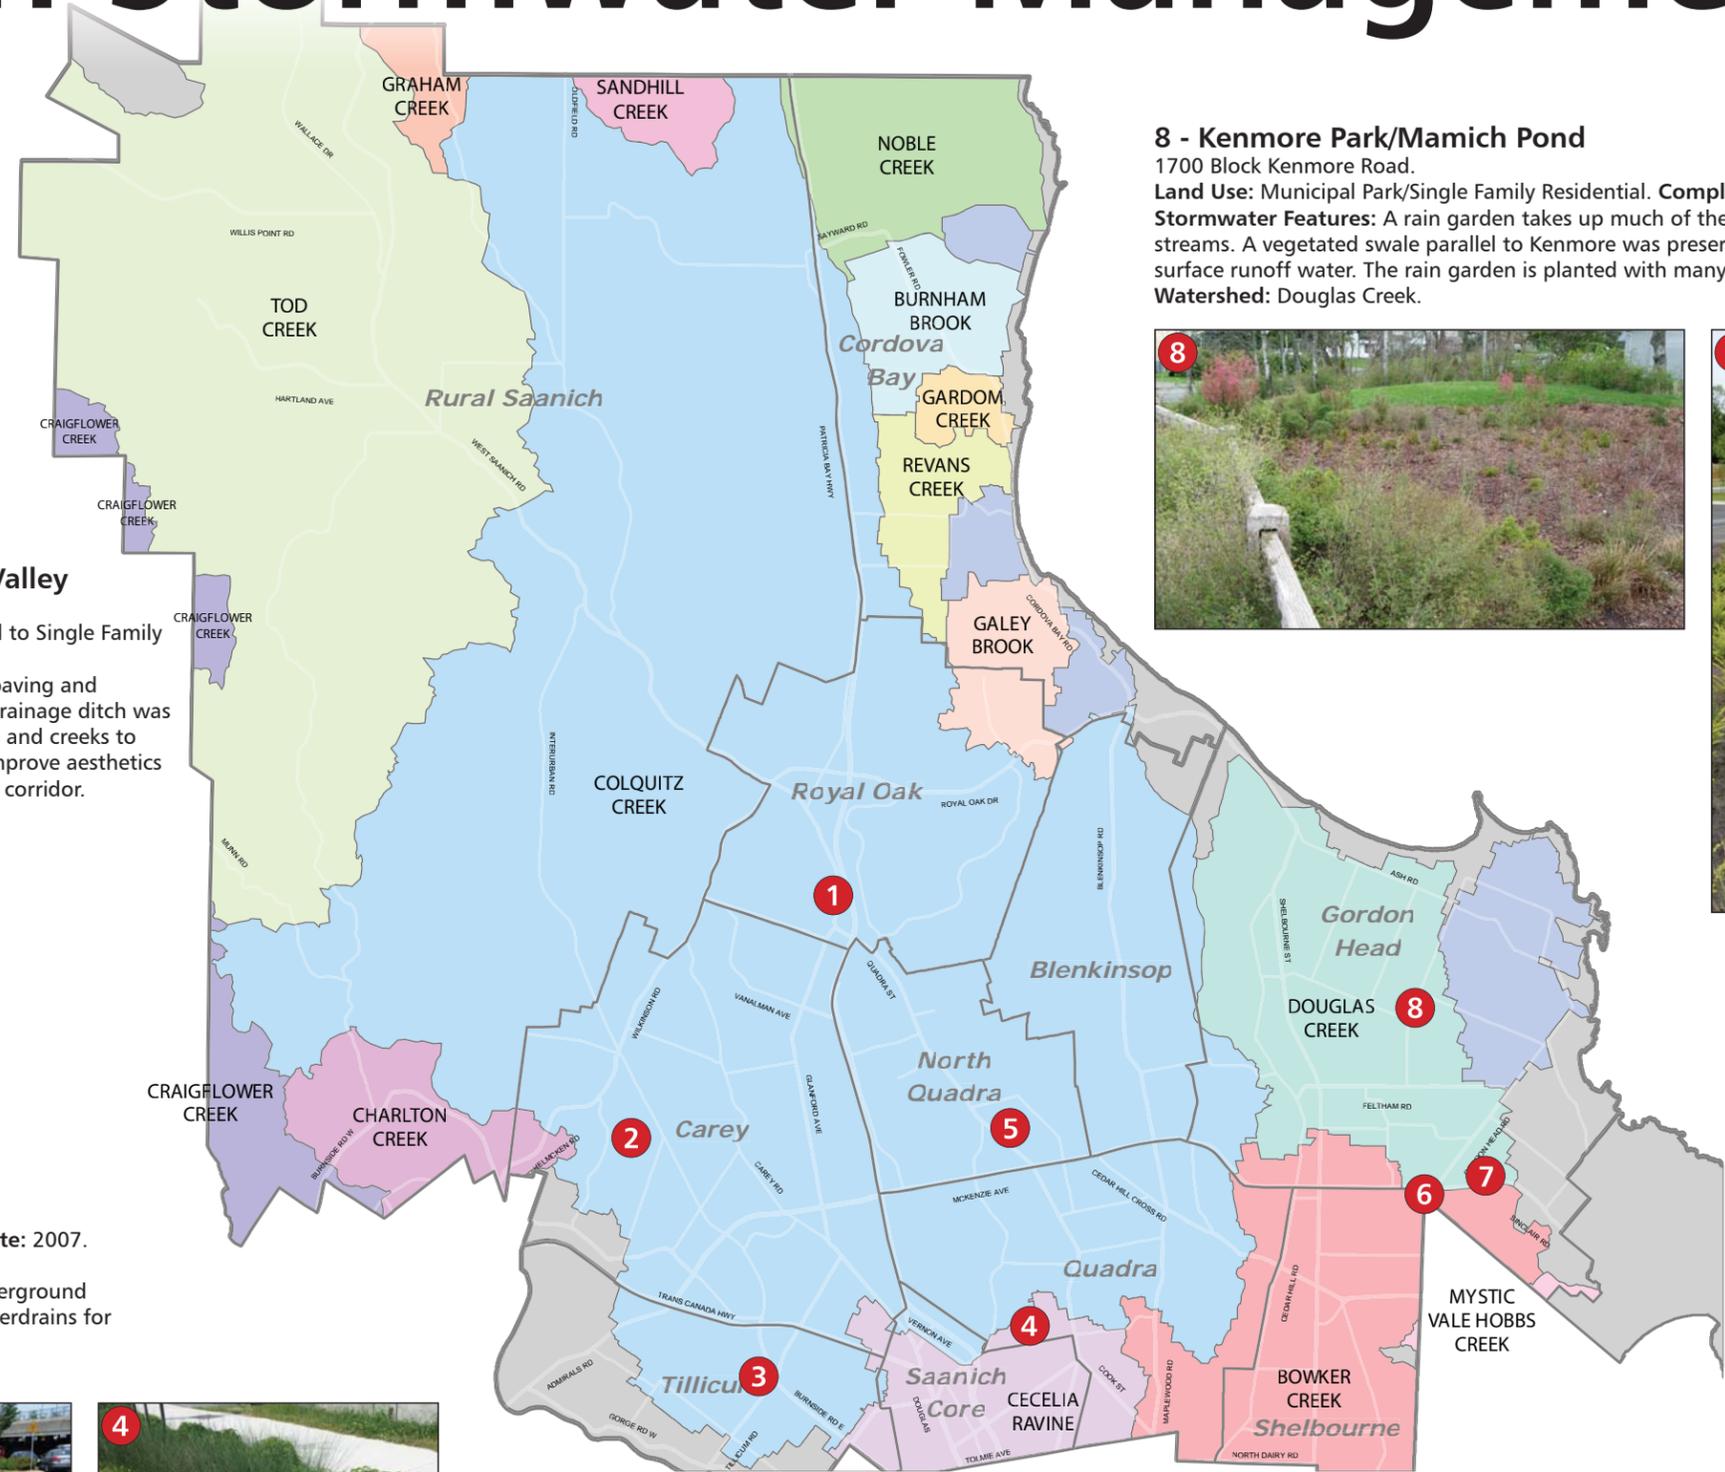
5 - TD Canada Trust Building
 4000 Quadra Street.
Land Use: Commercial Building.
Completion Date: 2003.
Stormwater Features: A number of small rain gardens are used between the lines of parking stalls and adjacent to the building to reduce road runoff by allowing stormwater to soak into the ground. Curb cuts allow water to enter from the parking surface.
Watershed: Colquitz Creek.
