Restoring a Creek

To bring the salmon home, the Friends of Mount Douglas Park Society, the District of Saanich and other partners launched an ambitious project in 2010 to restore the creek and its banks.

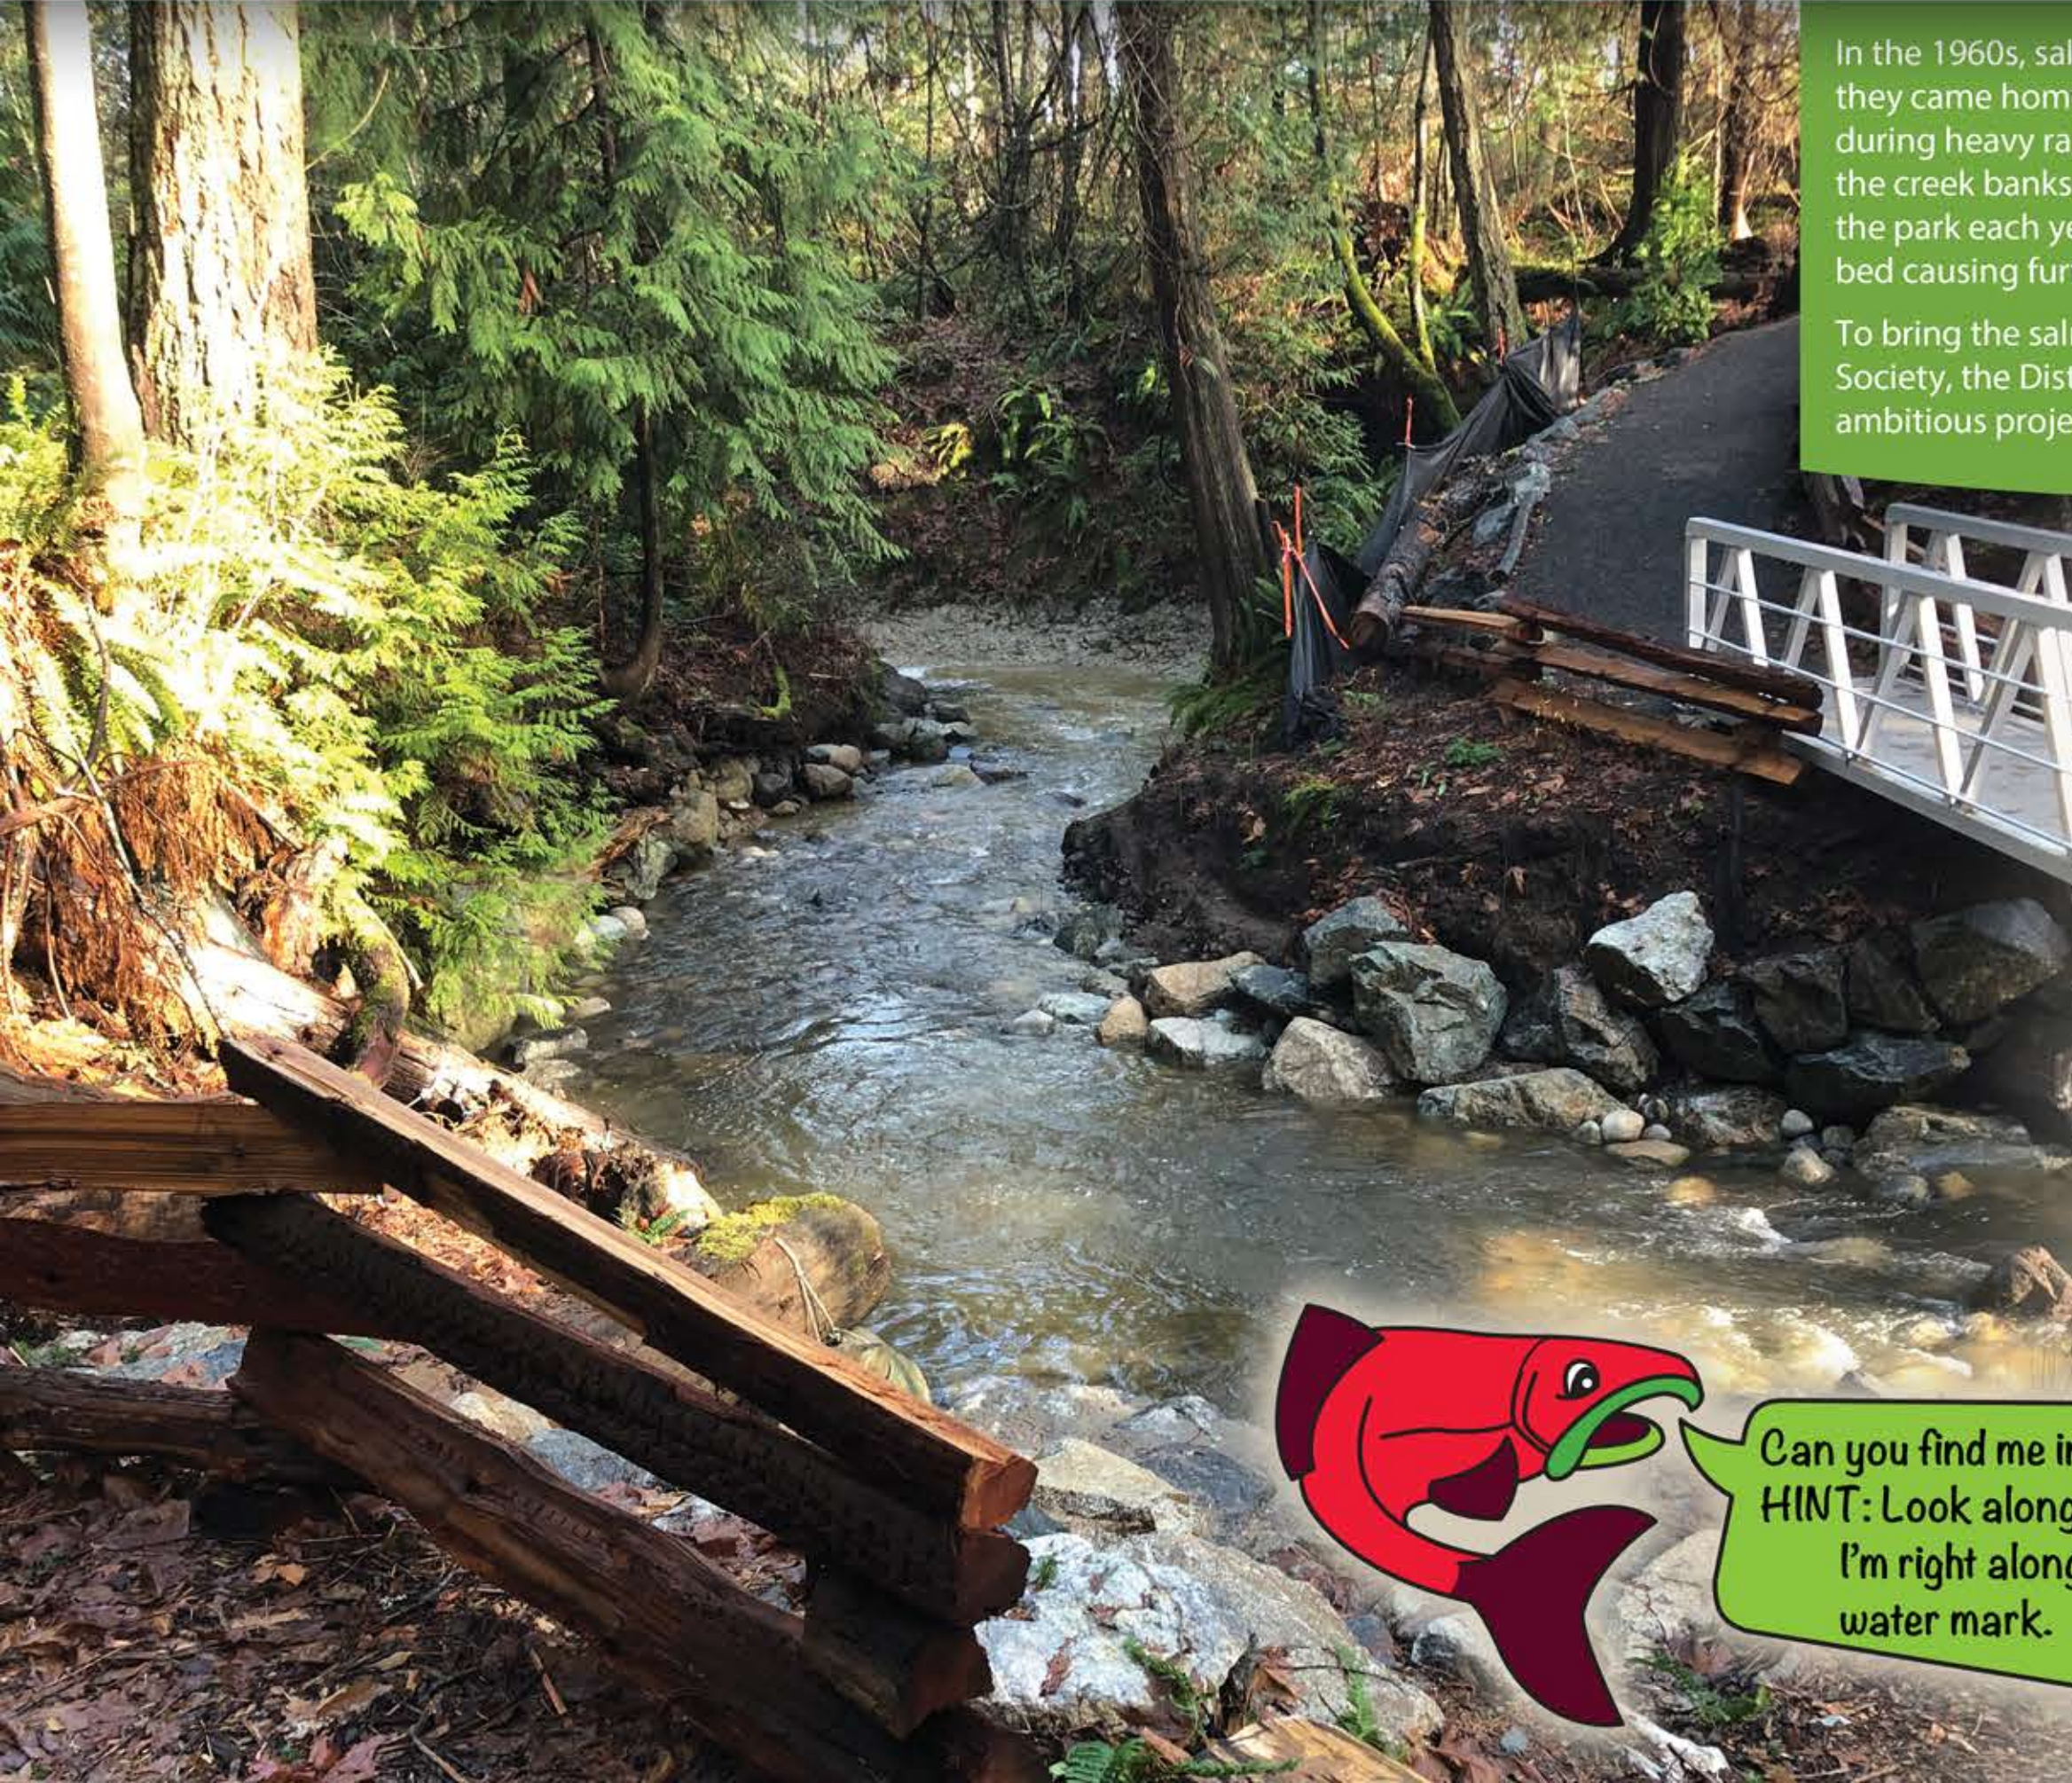
This photo was taken shortly after the bridge was installed in 2021 and illustrates several key elements to restoring a creek. The bridge itself provides a safe crossing, especially when the water is high and helps protect sensitive salmon habitat from unnecessary foot traffic. The filter fence is placed during construction to prevent sediment from entering the creek. It typically remains in place for several months afterwards to allow the soils to settle. Large rocks help to prevent erosion during high water flow, and the riffles help to add oxygen to the water. The pools that are created allow fish and their food to hang out.

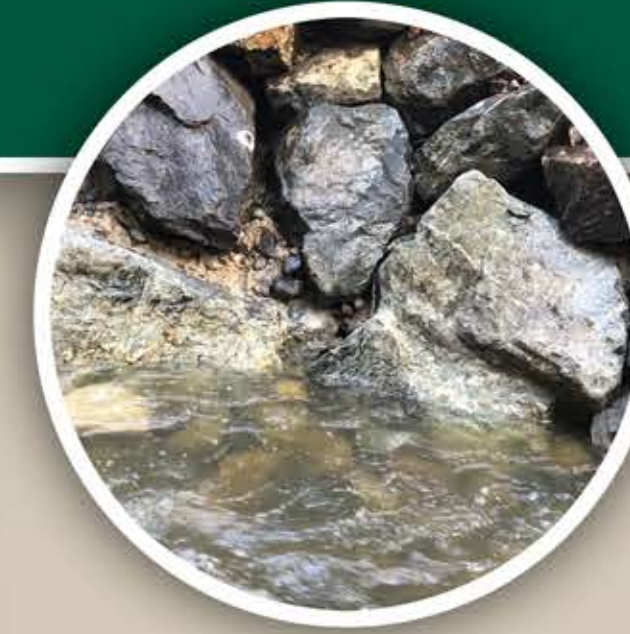
Large boulders have been added to stabilize the creek banks during high water flows.

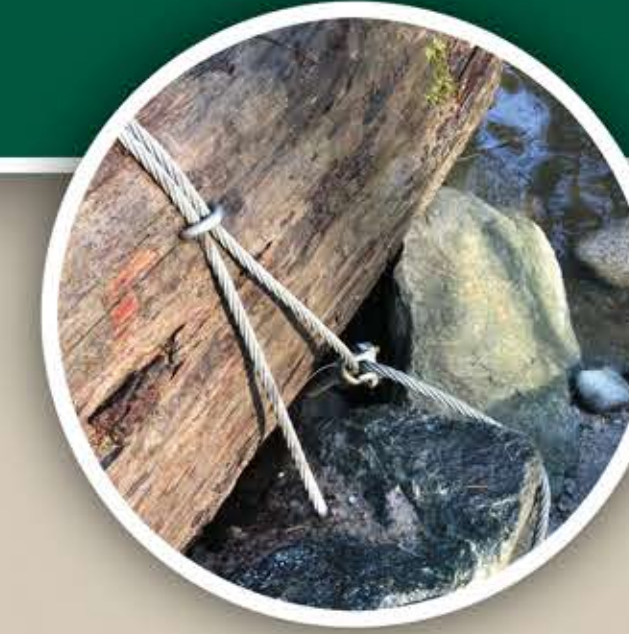
The crew added logs and other large woody debris to enhance the creek habitat. Woody debris changes the water flow creating places for fish and other creatures to hide, hunt, or rest.

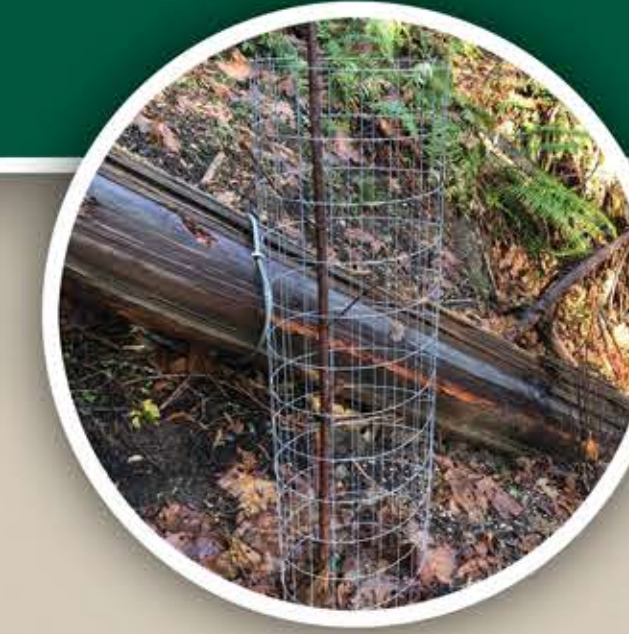
Hundreds of native trees (such as Cedar – XPA) and shrubs were planted on the banks of the creek, but many had to be protected from deer who like to munch on young plants and rub their antlers on the trunks, killing them.

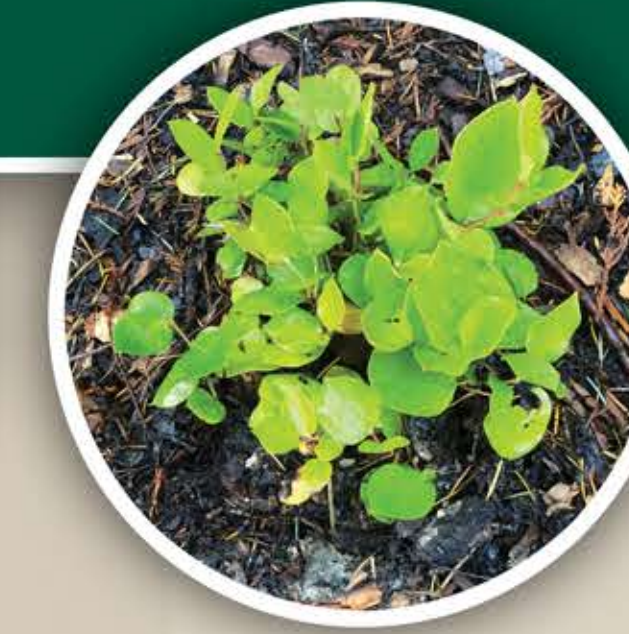
DAK,ILĆ (Sala) pictured above, ELILE, (Salmonberry), SKEKĆES (Red Huckleberry), KÁTELĆ (Oceanspray) and SENI,ILĆ (Dull Oregon grape) were just some of the native plants added to the park.

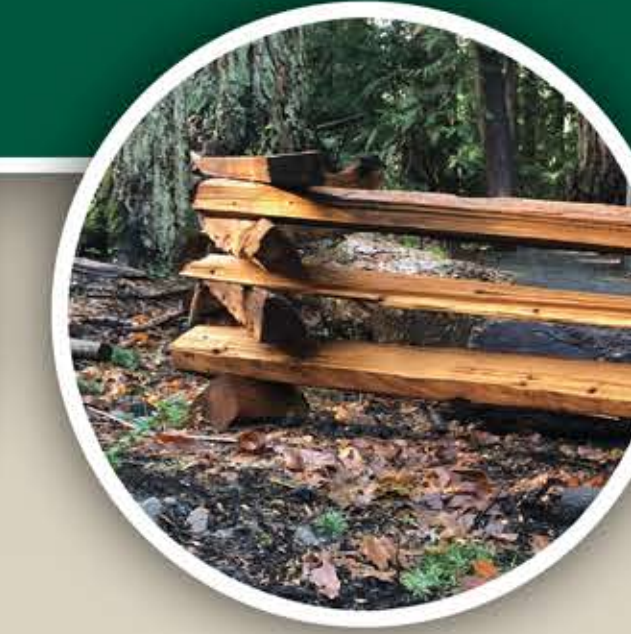
A new split-rail fence helps designate the trail so that the stream banks and stream bed can recover.

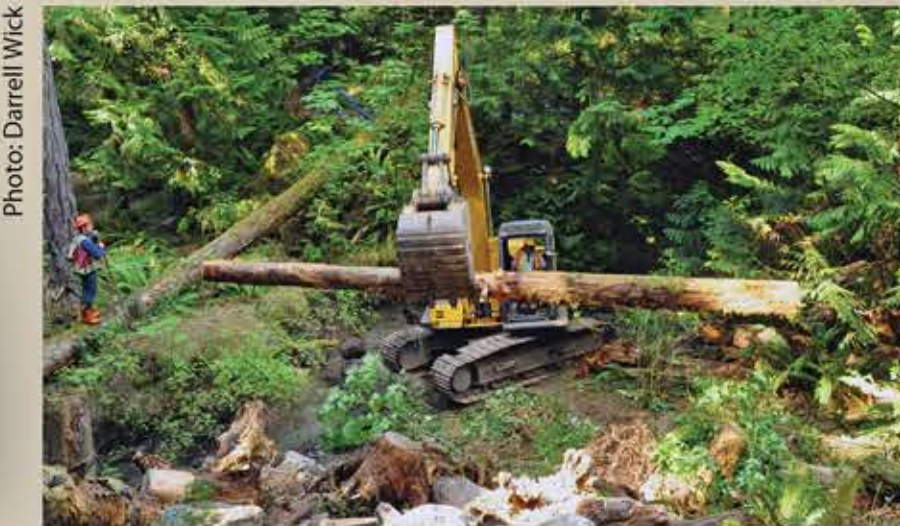
Before any of this work could begin, crews had to divert the water from the creek so that they could work in a dry creek bed. They also widened the creek in places to help slow the water during heavy rains.

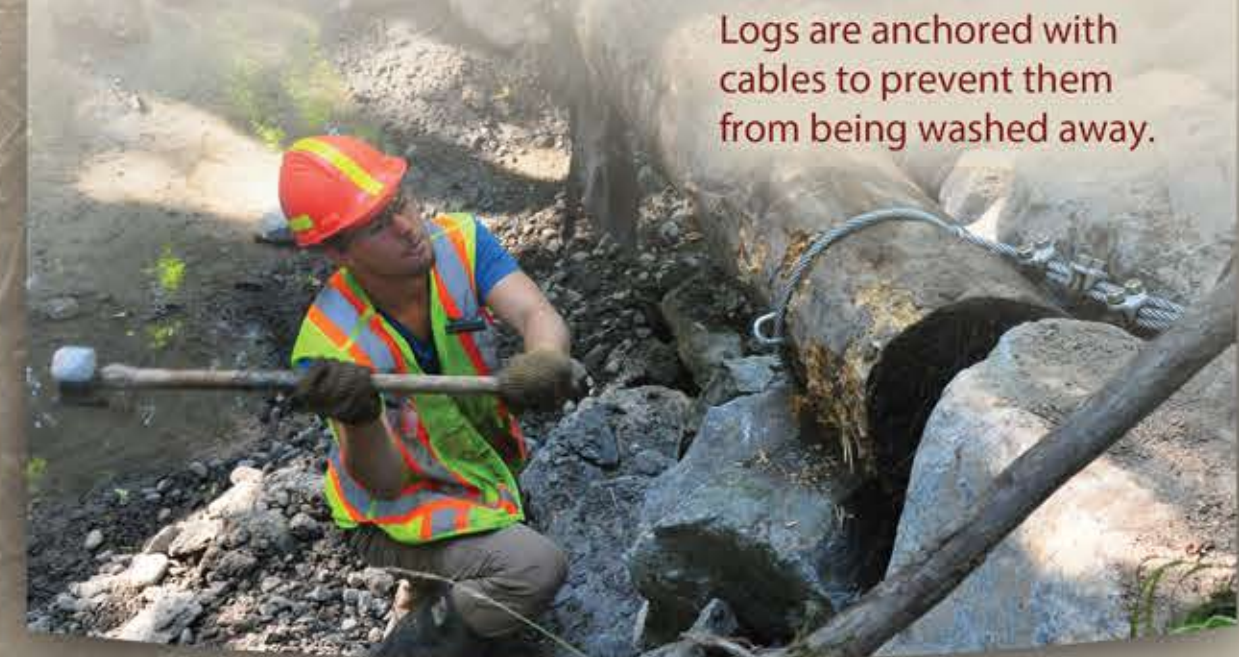
Logs are anchored with cables to prevent them from being washed away.
